**Re: Submission of Final Report of Technical due diligence study for the project "Godhra Expressway Private Limited (GEPL)".**

**Technical Diligence for 4 Laning of  
Godhra-Gujarat/ Madhya Pradesh  
border Section of NH-59 from km  
129.300 to km 215.900 in the State of  
Gujarat**

**For Virescent Infrastructure Investment  
Manager Private Limited (For the purpose of  
Highways Infrastructure Trust)**

**FINAL REPORT**

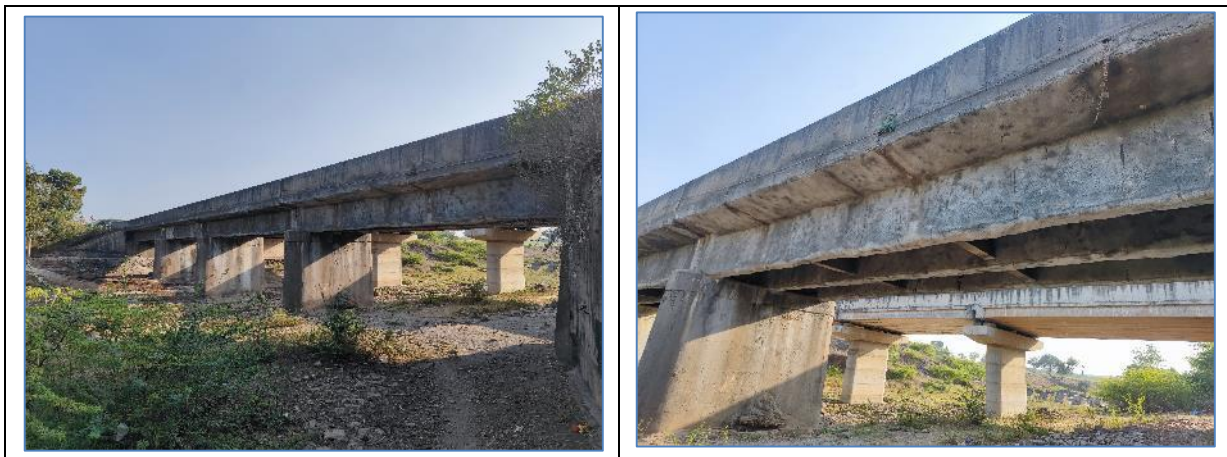
- Concrete quality -doubtful
- Carbonation depth - 0 to 20mm
- Probability of Corrosion risk 10%

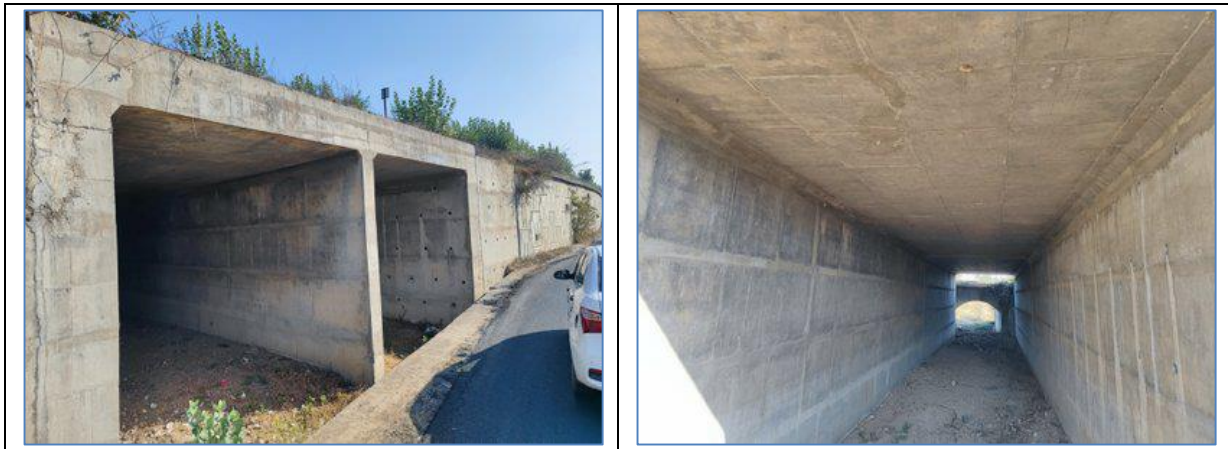
- Overall condition is good but Hairline cracks observed on side walls.
- Leaching observed in construction joint at median location.
- Minor Corrosion stains observed on top slab.
- Stone pitching is provided on abutment location quadrant slopes is in good condition.

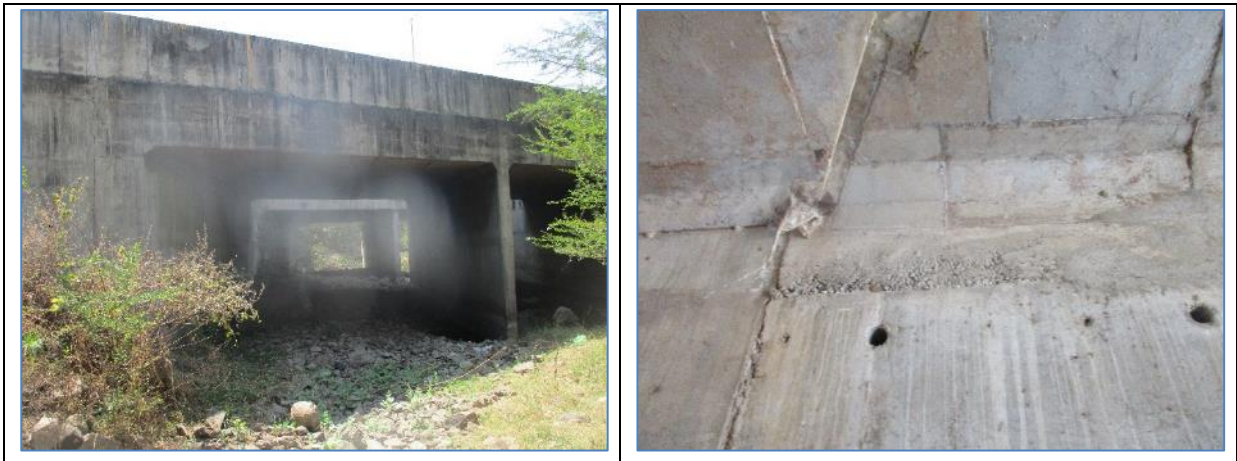
- The bridge is in skew of nearly 20 degrees.
- Minor Honey combing observed on side walls.
- Top slab is in good condition.
- RCC crash barrier is provided is in good condition.
- Stone pitching is provided on abutment location quadrant slopes is in good condition.

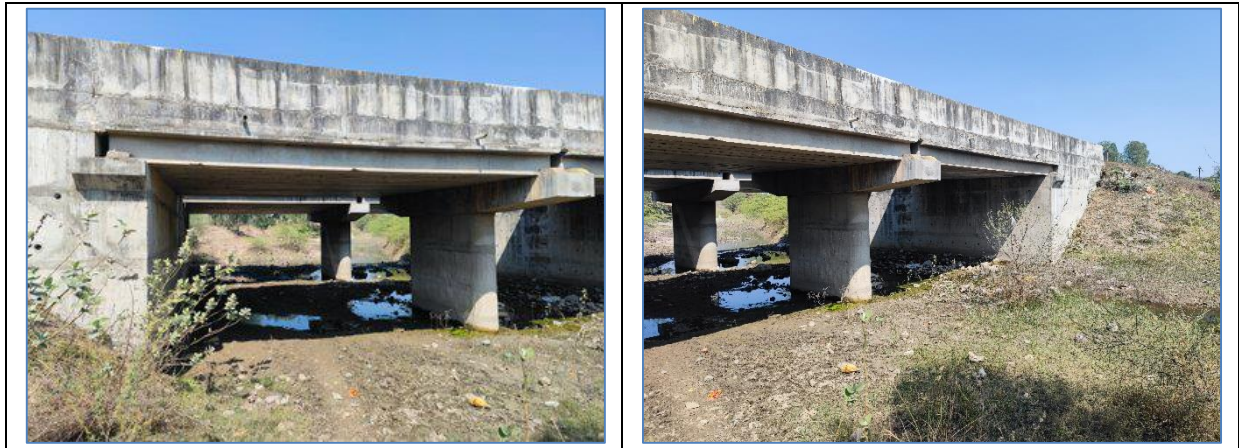
- Minor damages observed on bottom of RCC precast panels and abutment cap.
- Honey combing observed on pier cap.
- Minor Corrosion stains observed on pier cap.
- RCC crash barrier is provided is in good condition.
- Stone pitching is provided on abutment location quadrant slopes is in good condition.

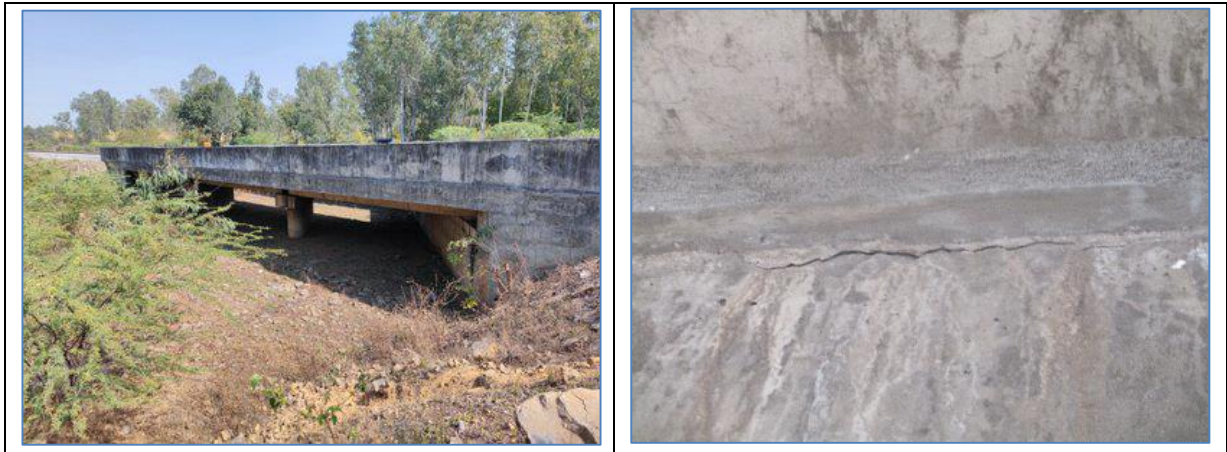
- The bridge is in skew of nearly 20 degrees.
- Minor Spalling observed on pier cap.
- RCC Solid slab is in good condition.
- RCC crash barrier is provided is in good condition.
- Stone pitching is provided on abutment location quadrant slopes is in good condition.

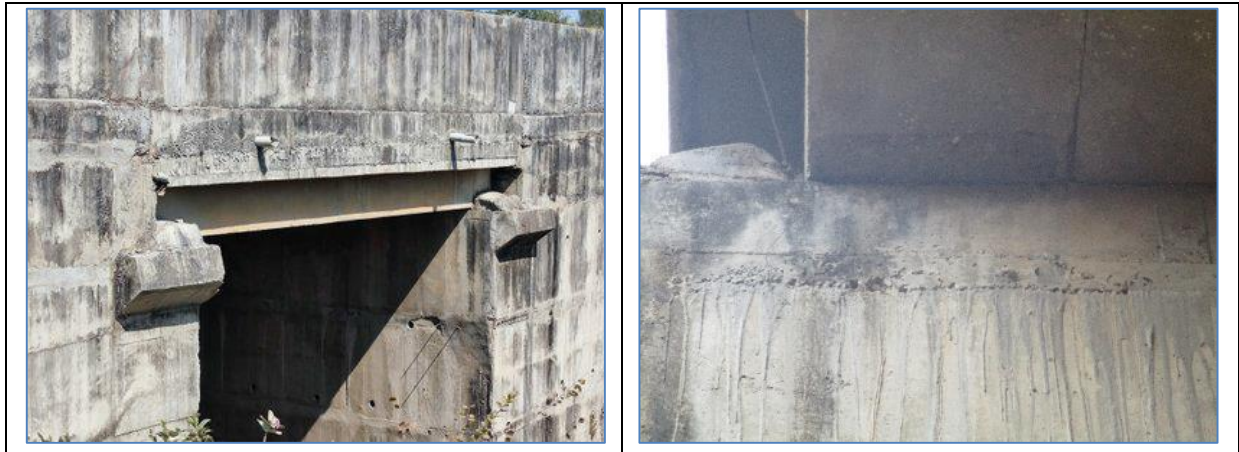
- Minor Honey Combing observed on side walls.
- RCC precast panels is in good condition.
- Damp spots observed on bottom of RCC Precast Panels.
- RCC crash barrier is provided is in good condition.
- Stone pitching is provided on abutment location quadrant slopes is in good condition.

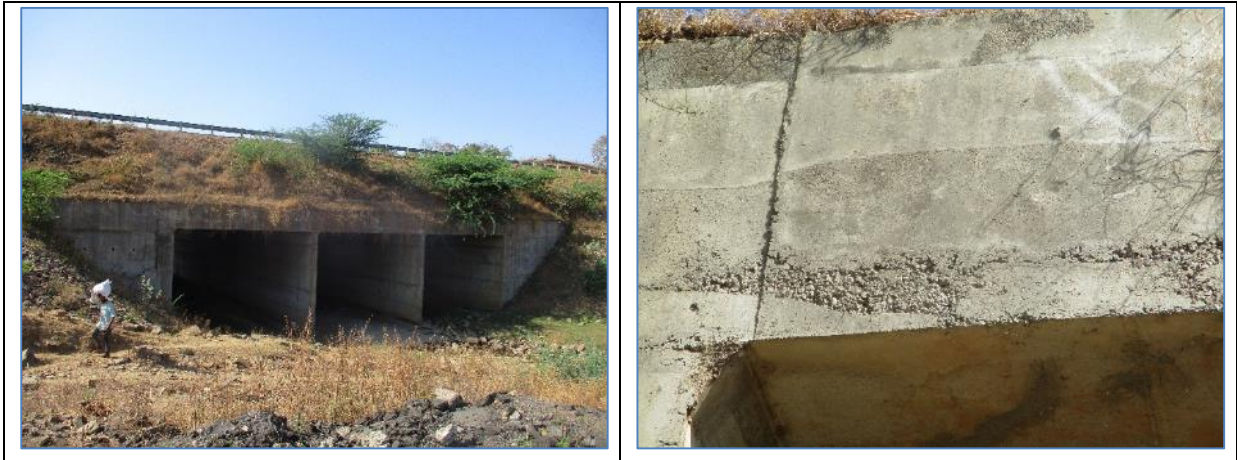
- Minor Honey combing observed on top slab.
- Metallic crash barrier provided is in good condition.
- Stone pitching is provided on abutment location quadrant slopes is in good condition.

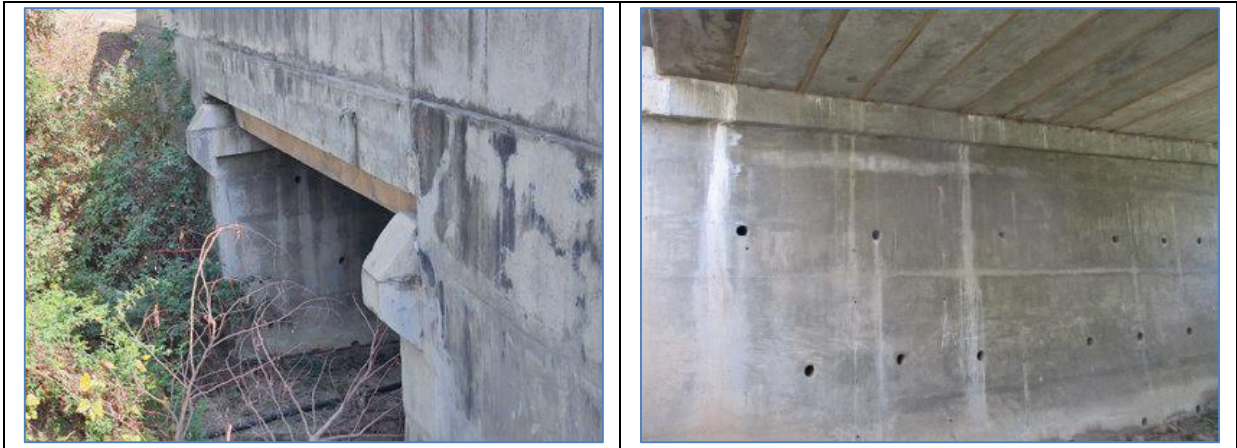
- Side walls are in good condition.
- Minor Spalling observed on abutment cap at LHS A1.
- Damp spots observed on bottom of RCC Precast Panels.
- RCC crash barrier is provided is in good condition.

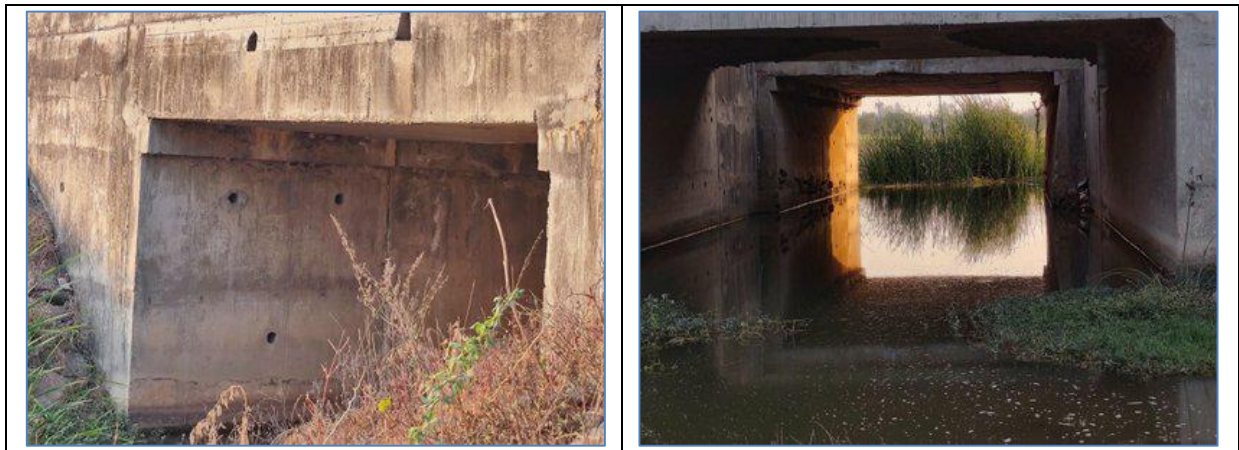
- Old bridge of span 1 x 6.7 m is widened by 2.6 m on RHS and new two-lane bridge of span 1 x 6.7 m is constructed beside the old bridge.
- Side walls are in good condition.
- Small portion of Median wall damaged.
- Top slab is in good condition.
- RCC crash barrier is provided is in good condition.
- Stone pitching is provided on abutment location quadrant slopes in good condition.
- Crash barrier damaged and Reinforcement exposed.

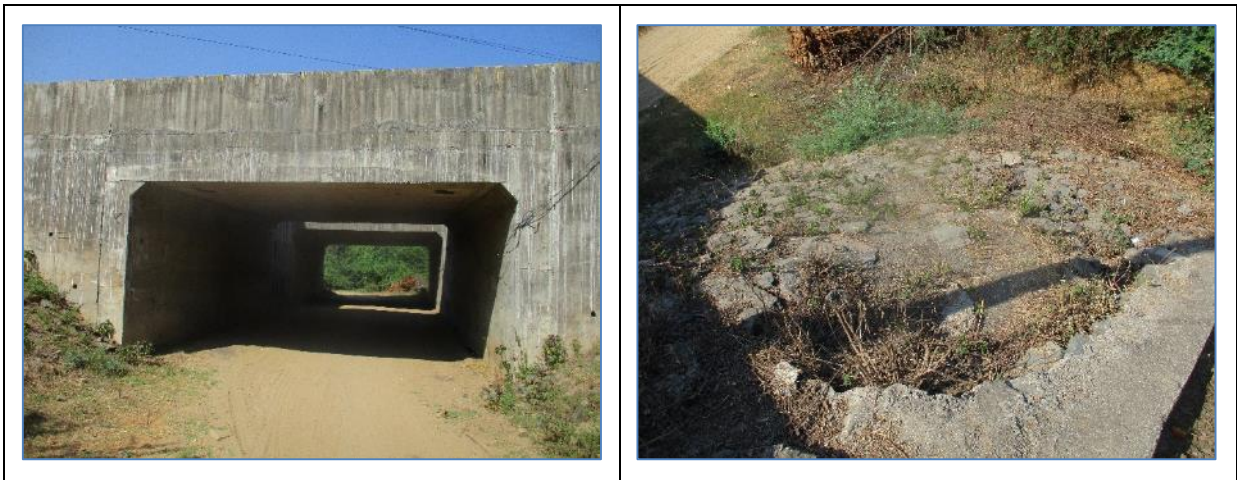
- Side walls are in good condition.
- RCC crash barrier is provided is in good condition.
- Stone pitching partially damaged.

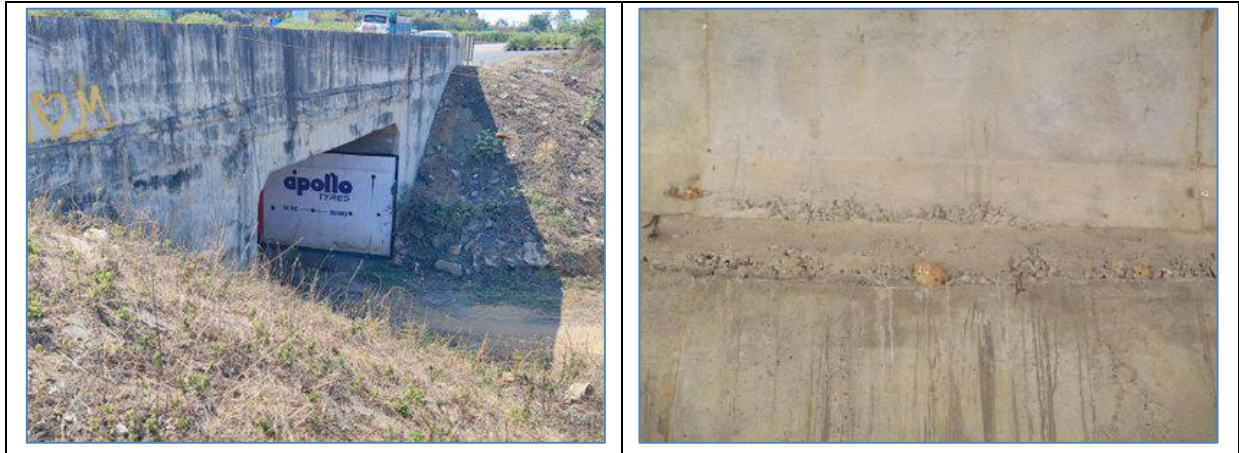
- Side walls are in good condition.
- Honey combing observed and steel exposed on side wall.
- RCC crash barrier is provided is in good condition.
- Stone pitching partially damaged.

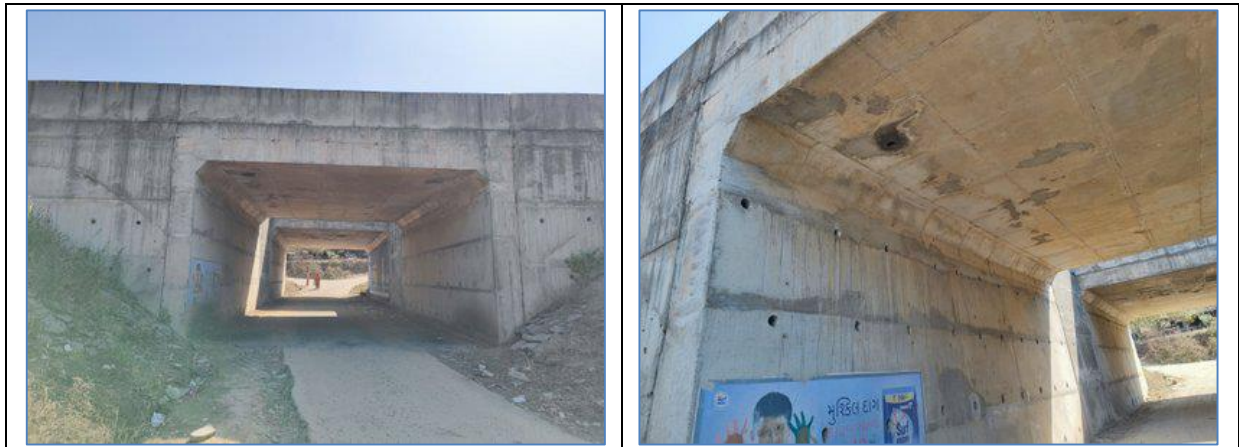
- Side walls are in good condition.
- RCC crash barrier is provided is in good condition.
- Stone pitching is partially damaged.

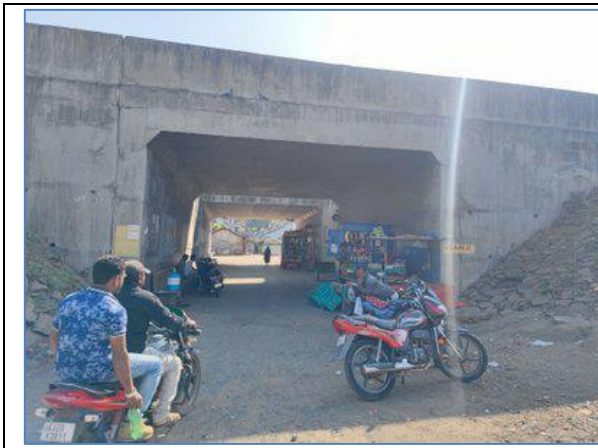
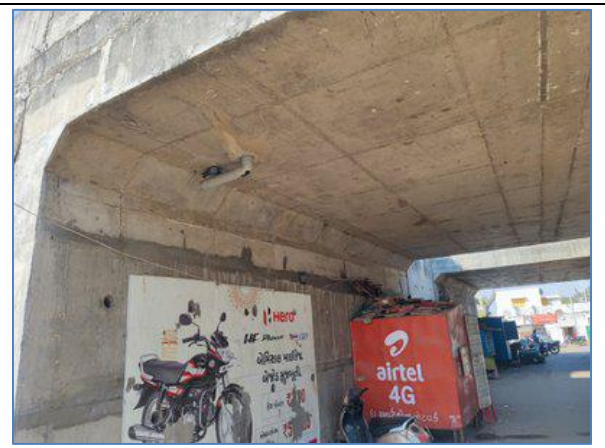
- RCC crash barrier is provided is in good condition.
- Stone pitching partially damaged.

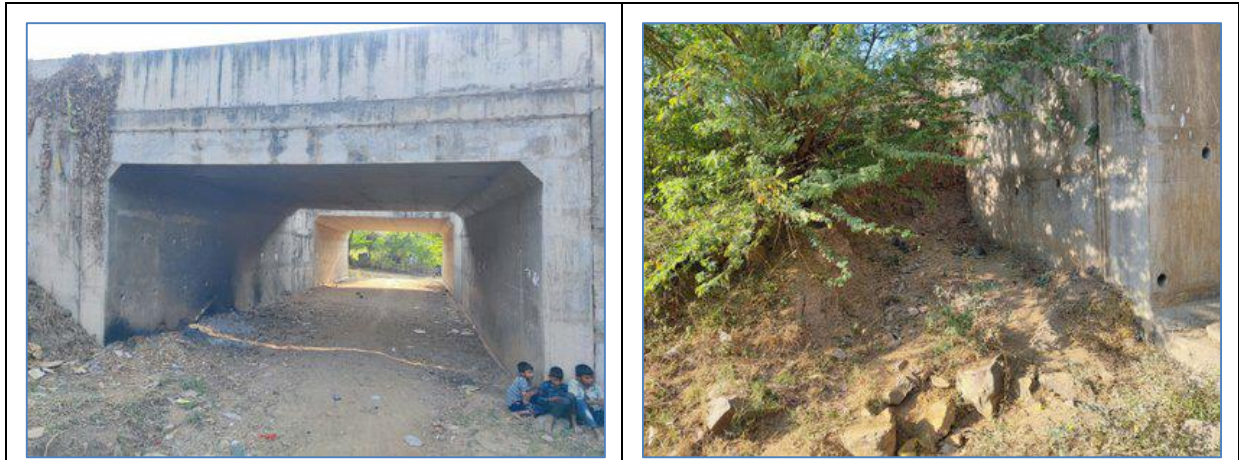
- Side walls are in good condition.
- RCC crash barrier is provided is in good condition.
- Stone pitching partially damaged.

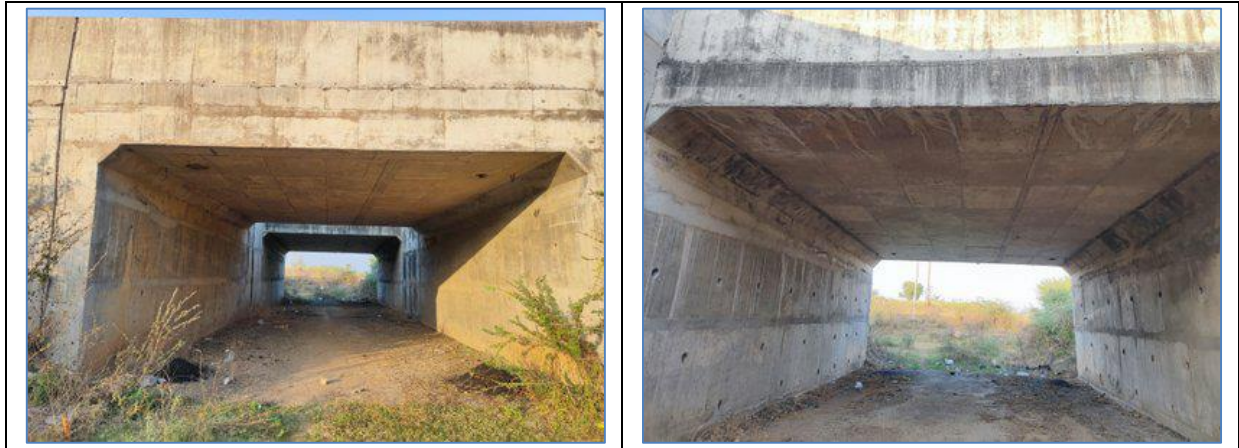
- Side walls are in good condition.
- RCC crash barrier is provided is in good condition.
- Minor damage on Stone pitching.
