**Re: Submission of Final Report of Technical due diligence study for the project "Jodhpur Pali Expressways Pvt. Ltd".**

**Technical Due Diligence for 4 Laning of Jodhpur to Pali Section of NH 65 from Km 308 to Km 366 & includes bypass to Pali starting from Km 366 of NH-65, connecting NH-14 at Km 114 in the State of Rajasthan**

**For Virescent Infrastructure  
Investment Manager Private Limited  
(For the purpose of  
Highways Infrastructure Trust)**

# **Final Report**

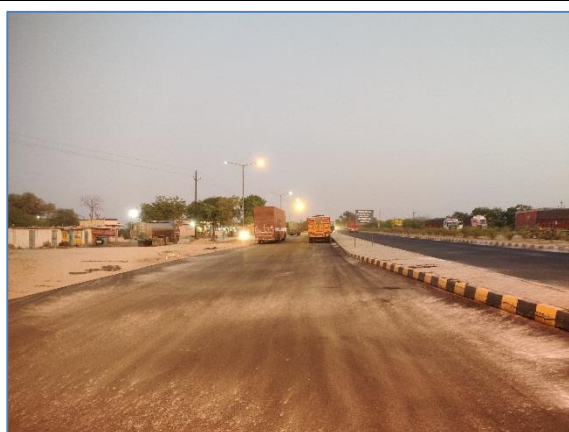
Truck Lay bye on LHS km 350.400

The Project Road has one Truck lay Bye at km 350.500 on LHS side. It has been provided with Flexible Pavement and the condition appears to be good. Truck lay bye provided with Toilet Blocks. Separator is provided between main carriageway and Truck lay bye portion. Lighting in the form of single arm and Double arm poles have been provided on outer edge of the truck lay. 5 Single Arm & 4 Double arm lights are observed and almost all are found to be in good condition.

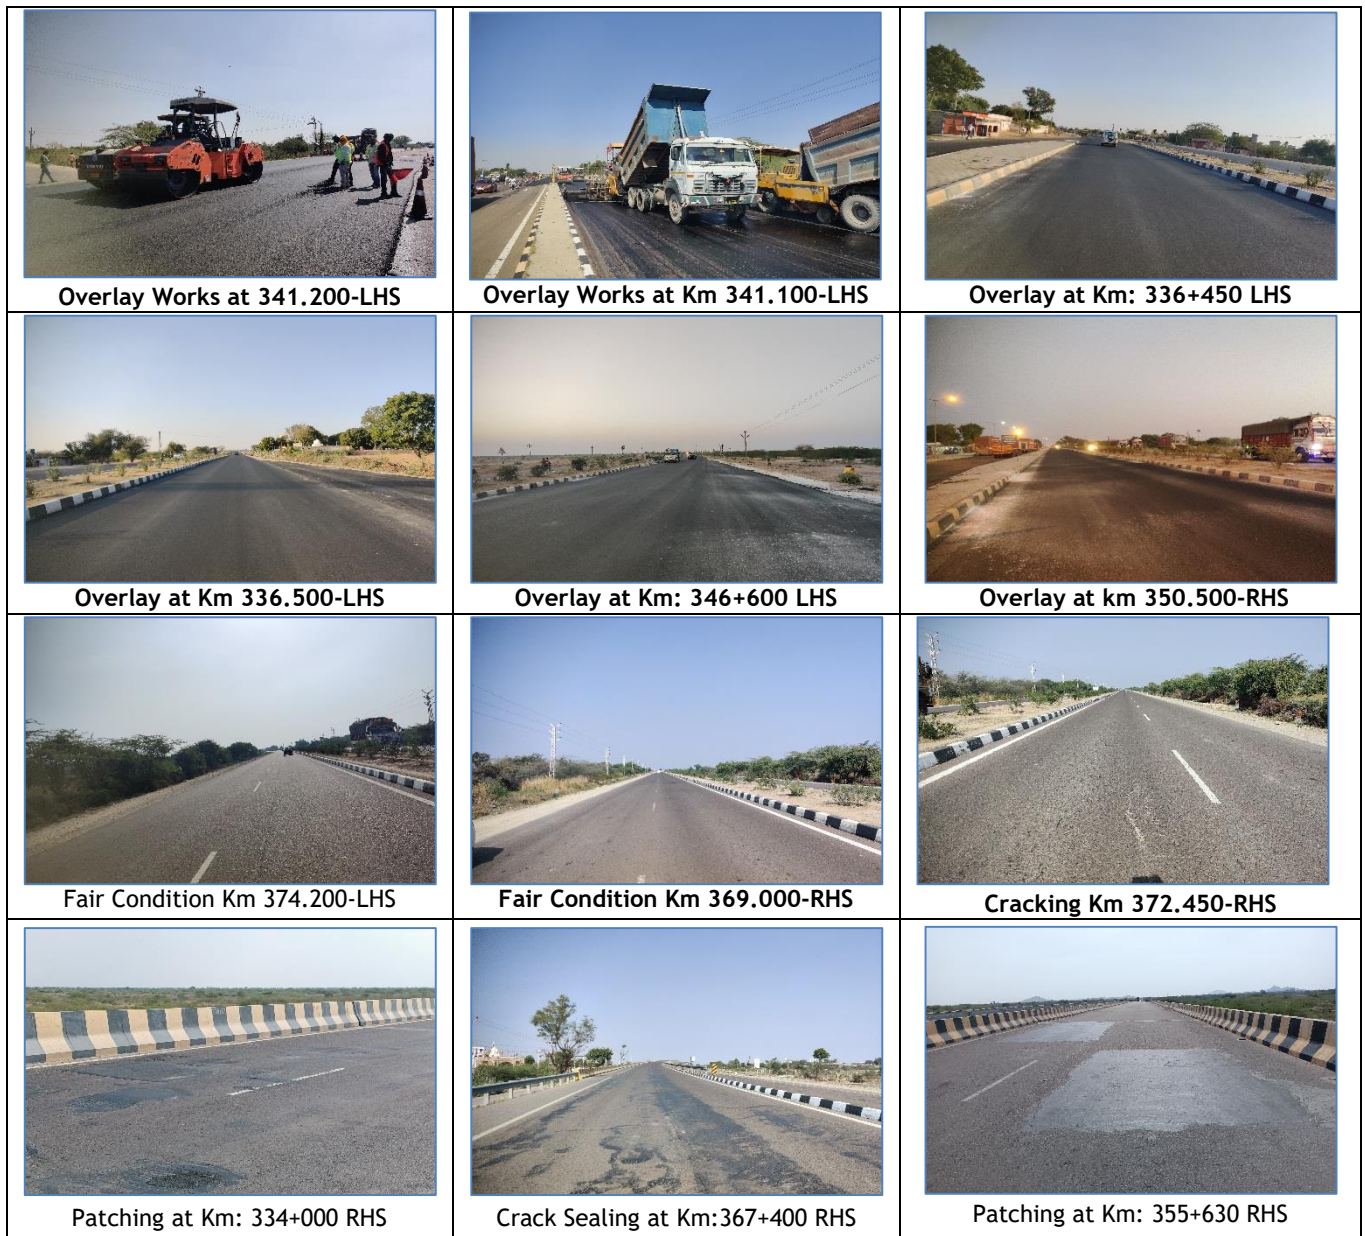
The present condition of pavement appears to be good except minor surface related distresses such as minor cracking and raveling is observed along the project road at few locations and the riding quality is satisfactory. These are mainly surface related distresses and the cracking appears to be top-down cracking. Longitudinal cracking is noted at few locations. No potholes are seen along the project. Patches have been observed at few locations. Rutting is seen between km: 346 to km: 347 (i.e., Rohet village section) along the wheel paths in LHS carriageway. During site visit it is observed that major maintenance work is in progress. Few photos are presented below showing existing pavement condition:

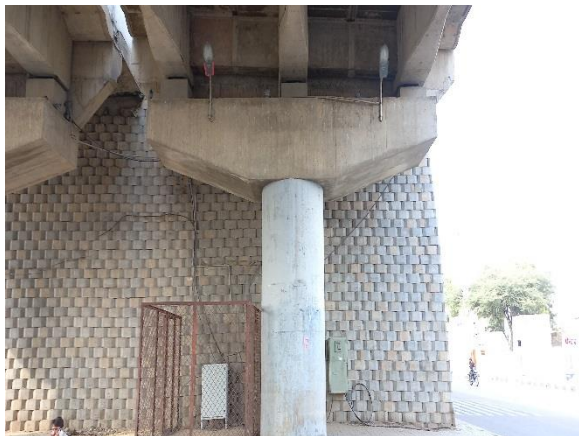
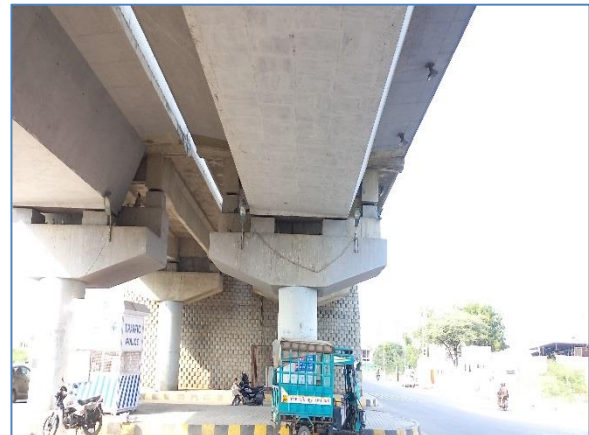
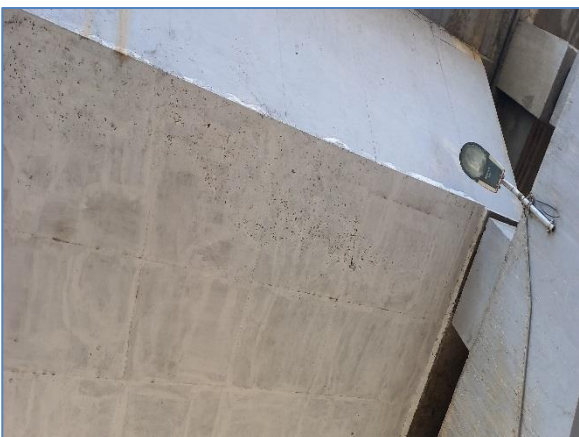
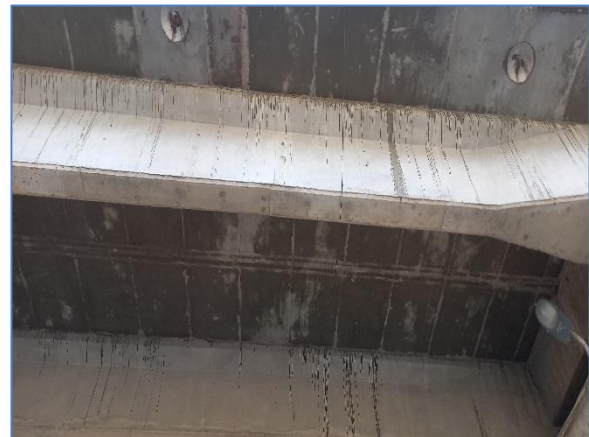
BR. NO.315+886

- Minor Honey comb observed on girders, cross girders and Dirt walls at couple of locations.
- Corrosion stains were observed on A1 to P1 location.
- When heavy vehicles are passing vibrations observed.

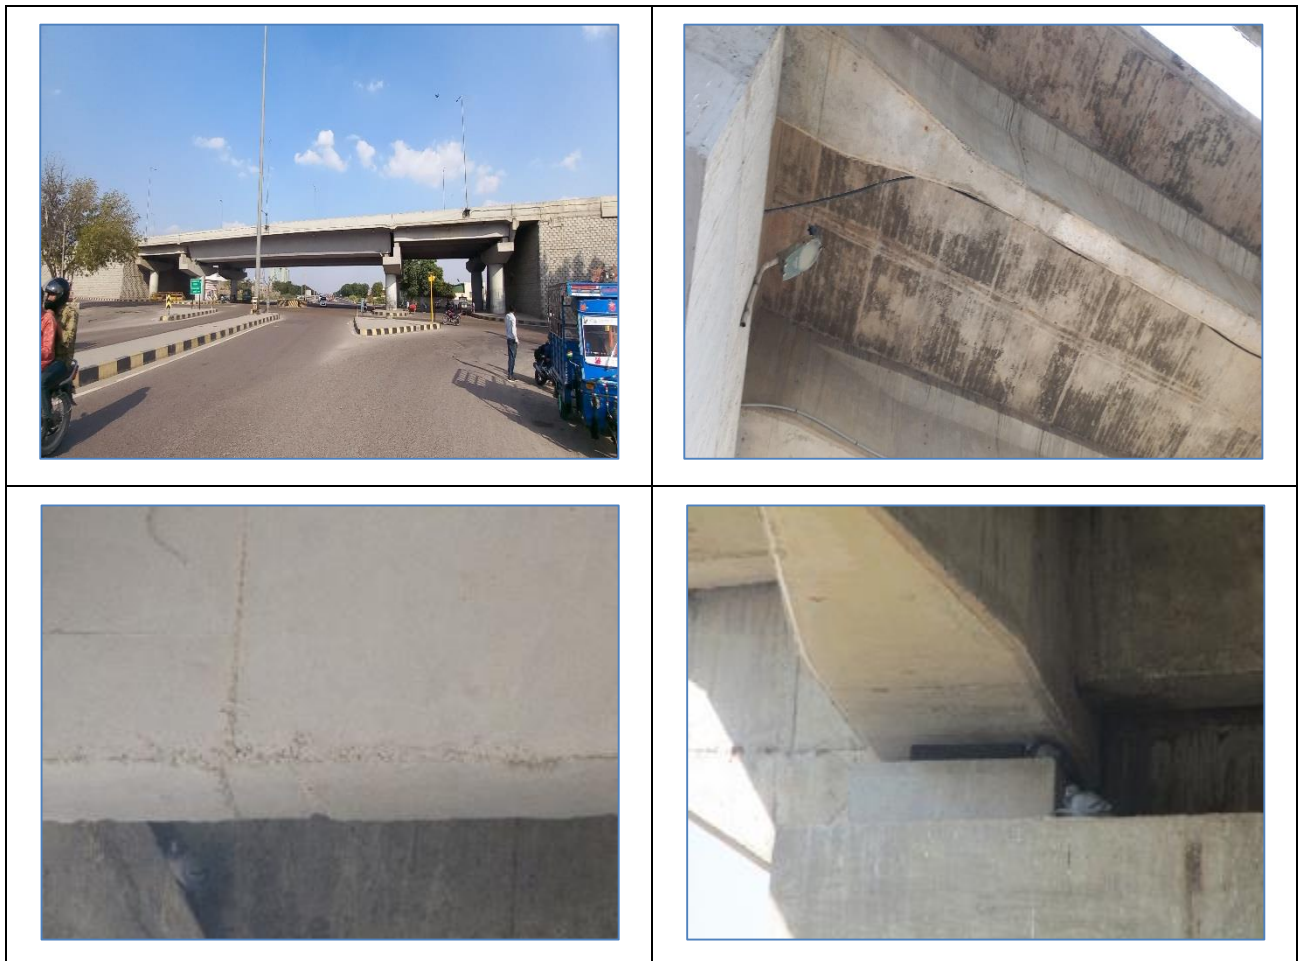
BR. NO.323+988

- Corrosion stains were observed soffit of Deck and Girders.
- Minor Honey combing observed on girders.

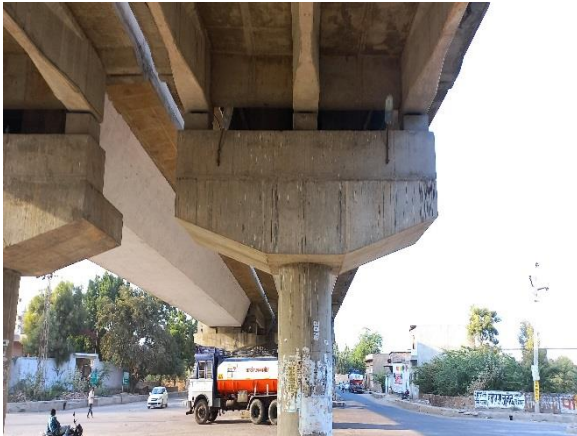
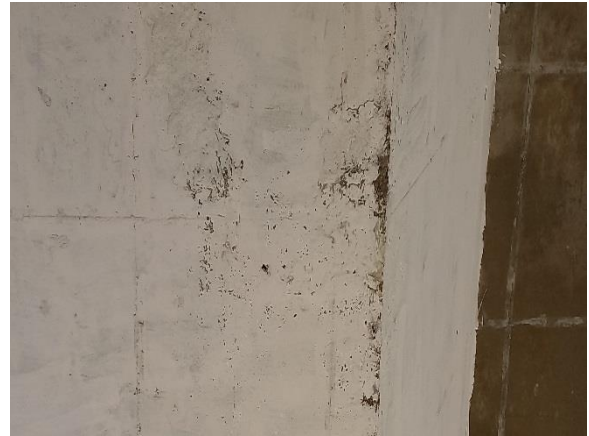
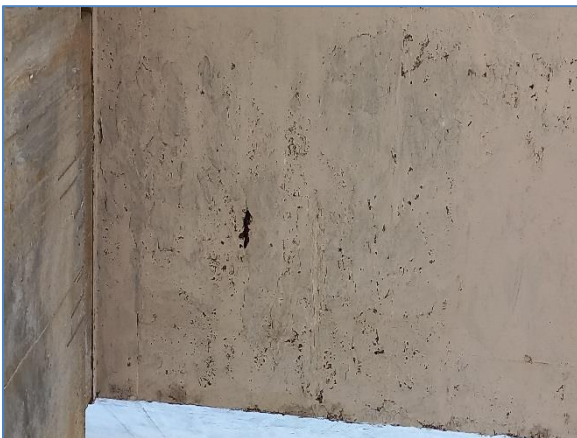
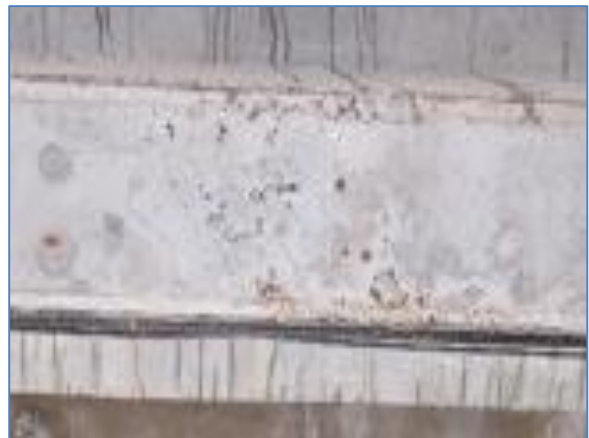
BR. NO.323+988

- Corrosion stains were observed on bottom of the girder.
- Minor honey combing observed in soffit of girder & slab.
- Steel observed on top slab at P2 to A2 location.

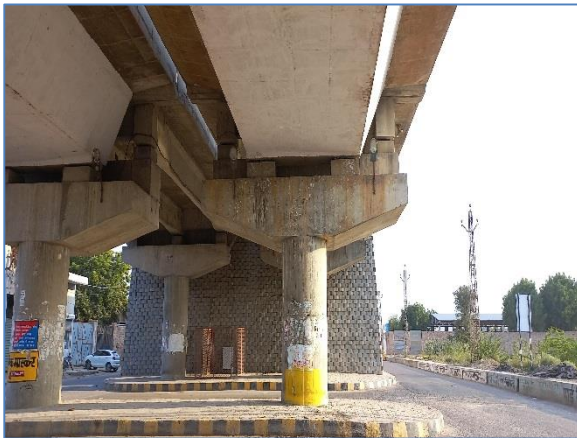
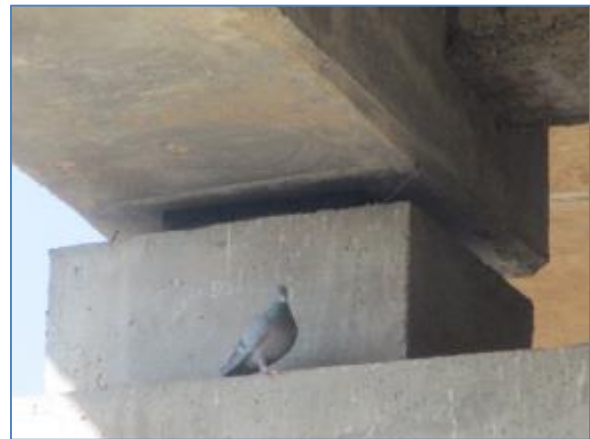
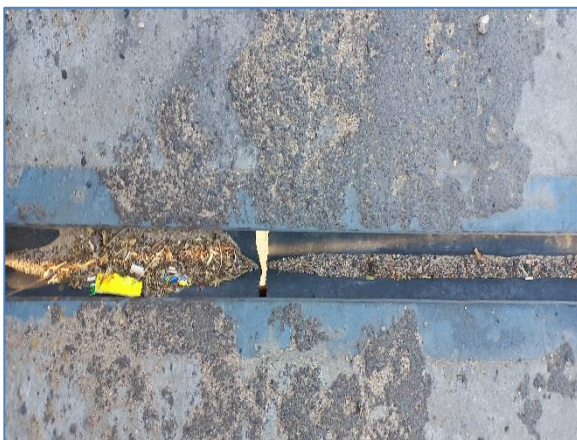
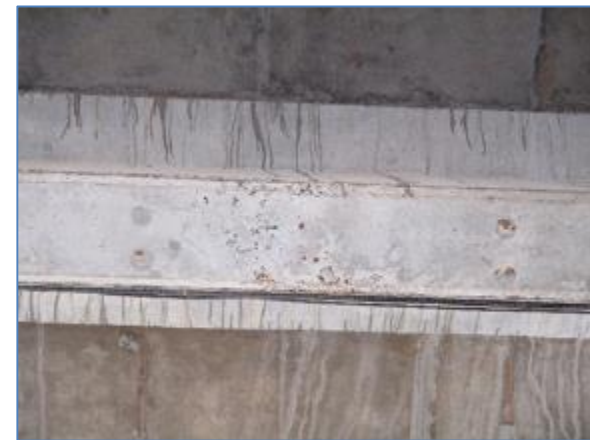
BR. NO.318+642

- Honeycomb observed on soffit girders.
- Corrosion stains were observed on bottom of girder.
- Rubber sealant damaged at P2 expansion joint.

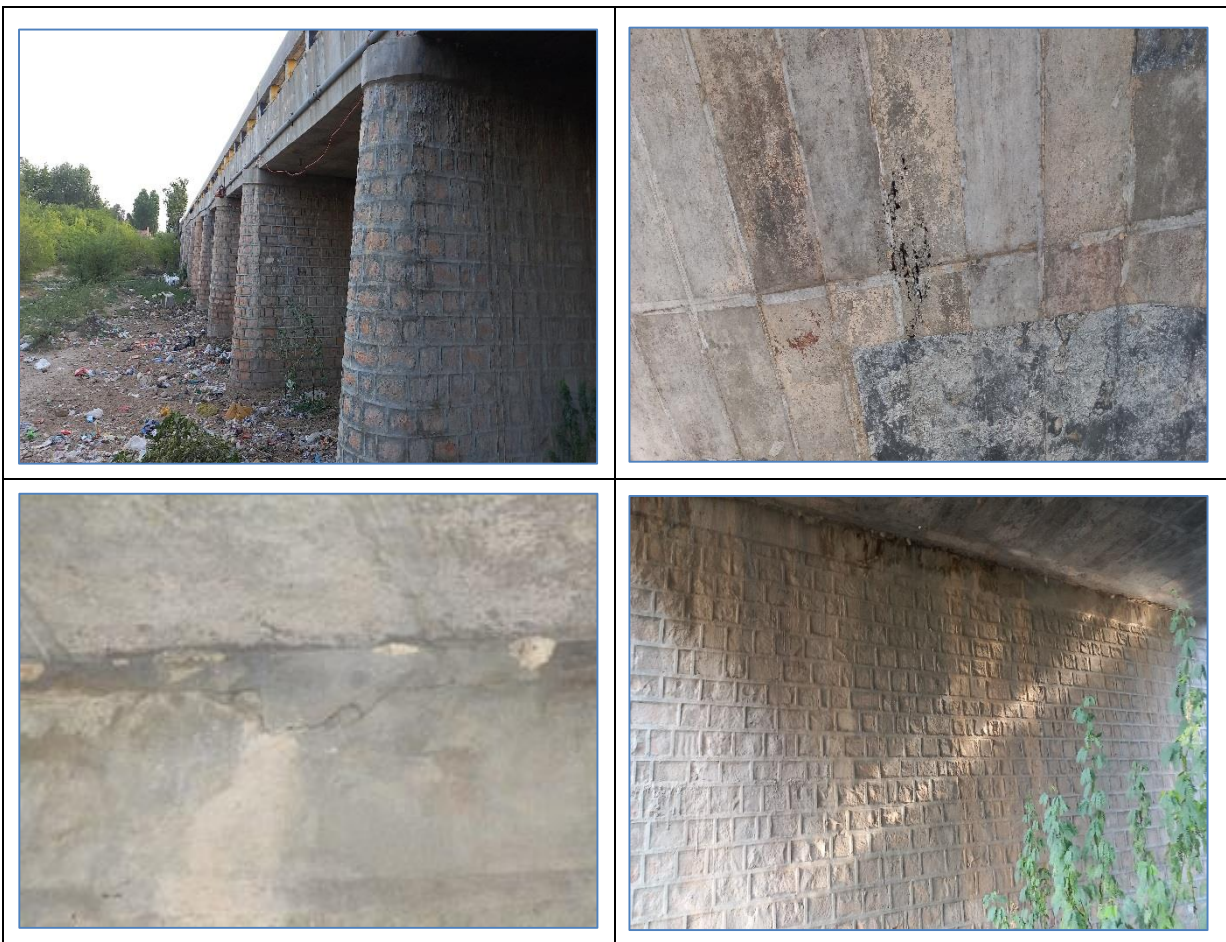
BR. NO.318+642

- Minor Cracks were observed on pier cap at some locations.
- Spalling and Reinforcement exposing on Deck slab in Span-3.
- Minor Cracks were observed on substructure.

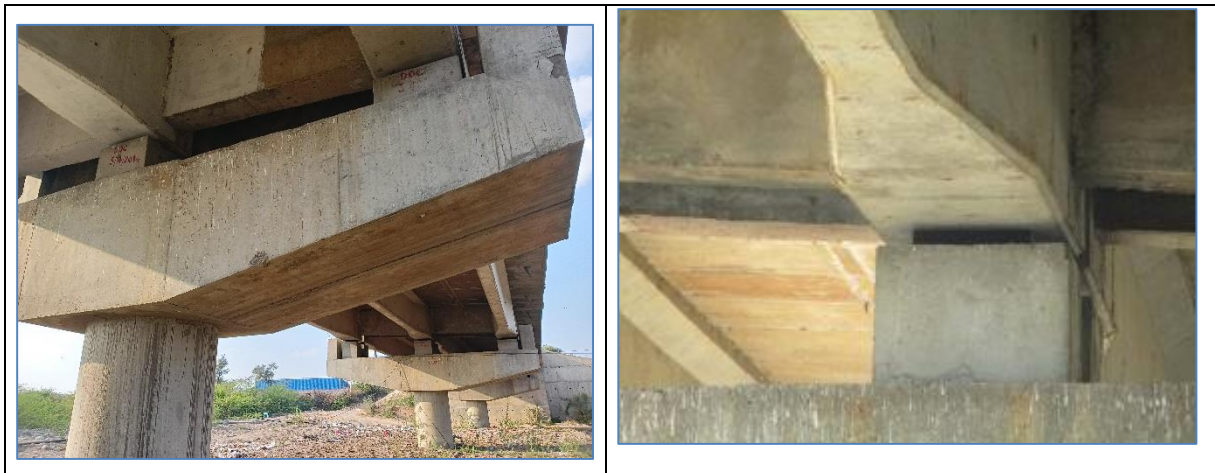
BR. NO.333+998

- Sealant rubber damaged in expansion joint at P3 and P4 location.
- Hair line Cracks observed on top slab & Girder bottom.
- Minor Corrosion stain and Minor Honey comb observed on girders.

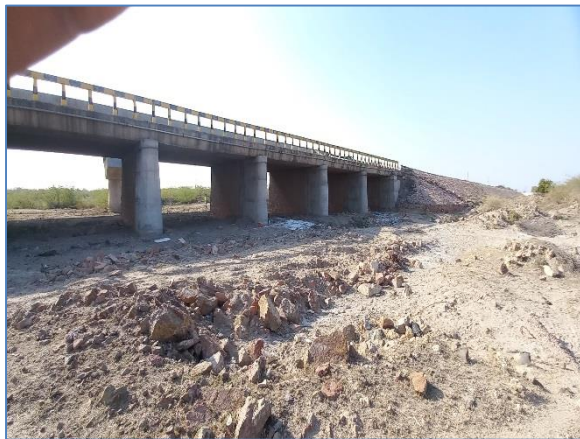
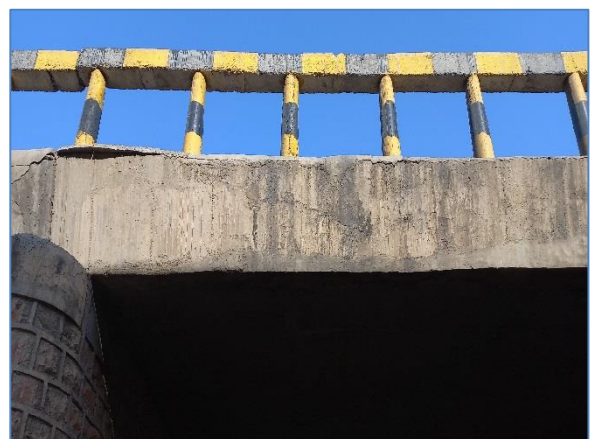
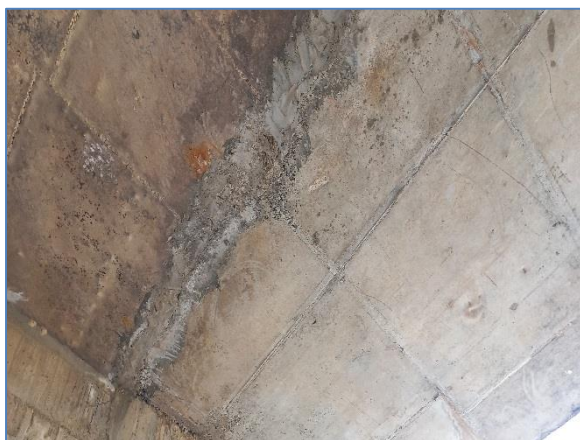
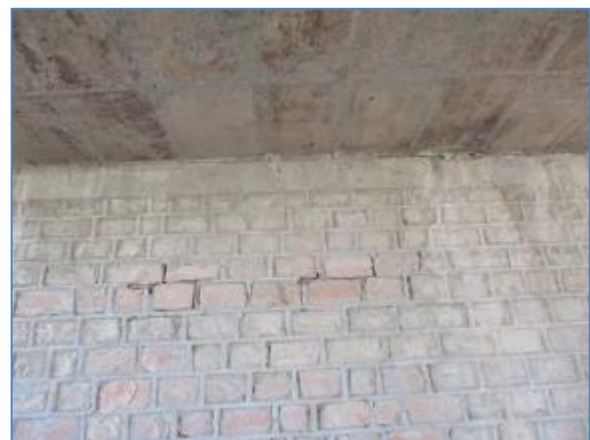
BR. NO.333+998

- Minor Cracks observed on top slab, side walls and pier cap.
- Previous repair works are done.
- Structure is in fair condition.

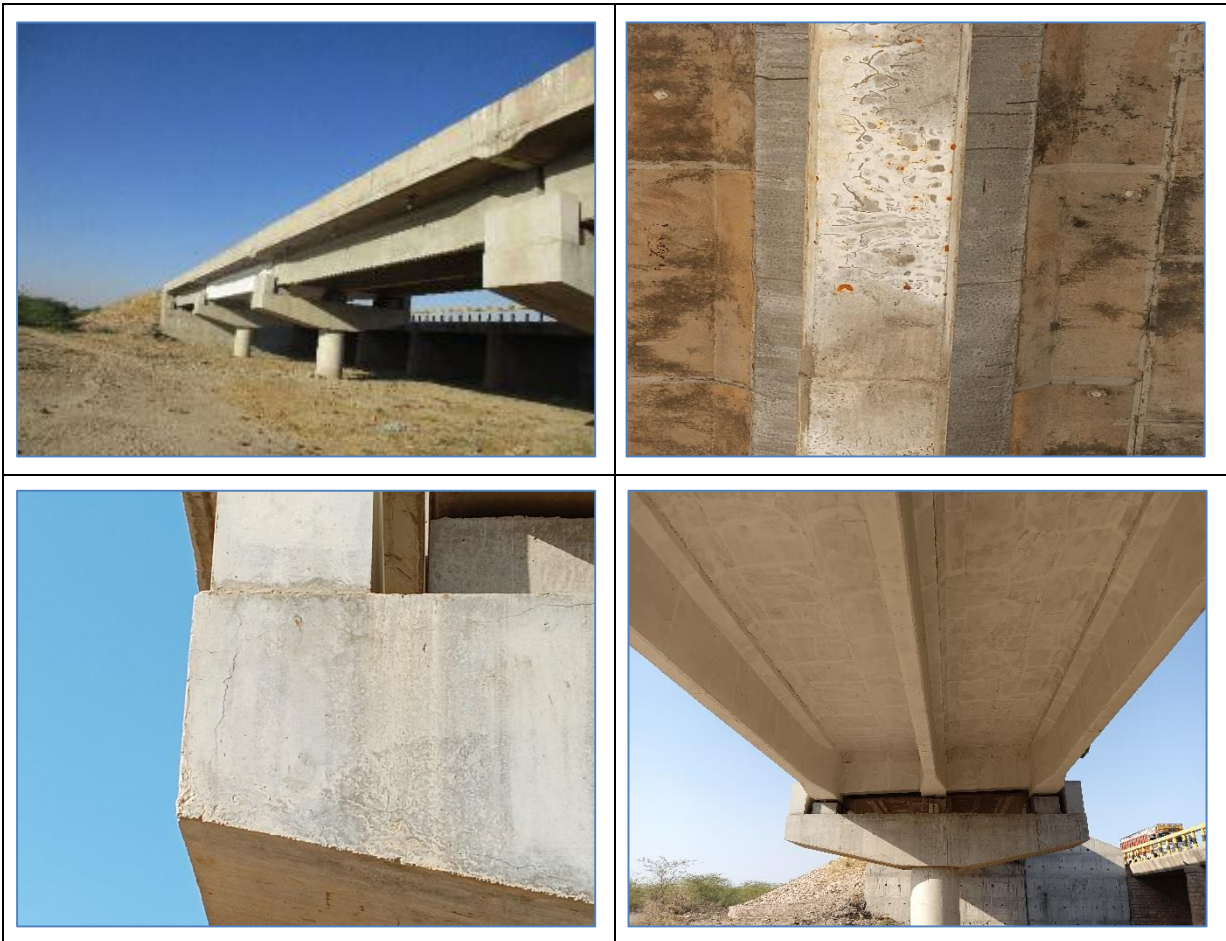
BR. NO.334+830

- Minor Cracks observed on top slab, Girders and Pier cap.
- Honey comb observed on girders and cross girders.
- Corrosion stains were observed on bottom of girders and pier cap.

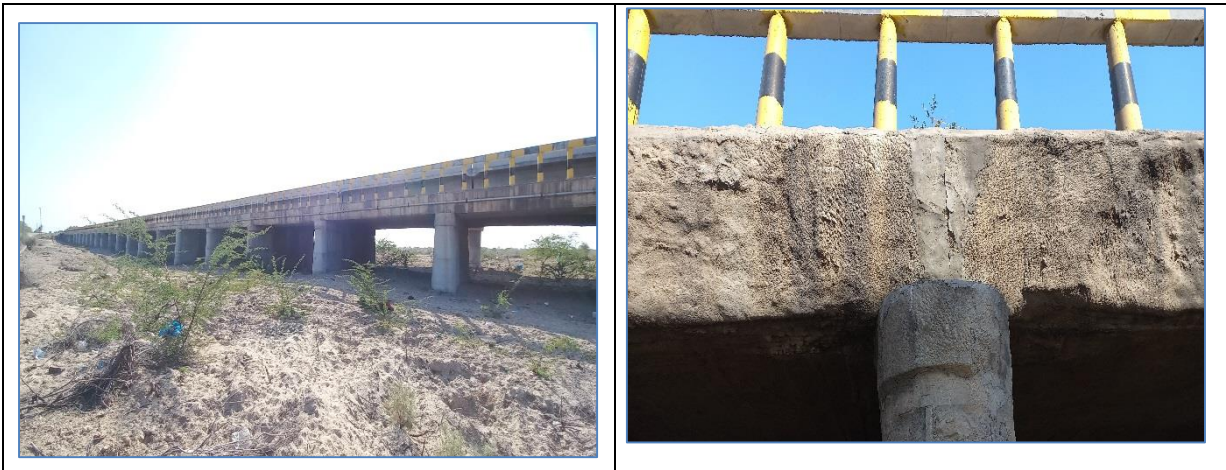
**BR. NO.334+830**

- Honey comb and spalling on top slab and Cracks observed on side wall and pier cap.
- Small portion Steel exposed on top slab near P3 and P4.
- Minor Spalling & Reinforcement exposed on Hand Railing.
- Shotcrete work done for top slab and pier cap.

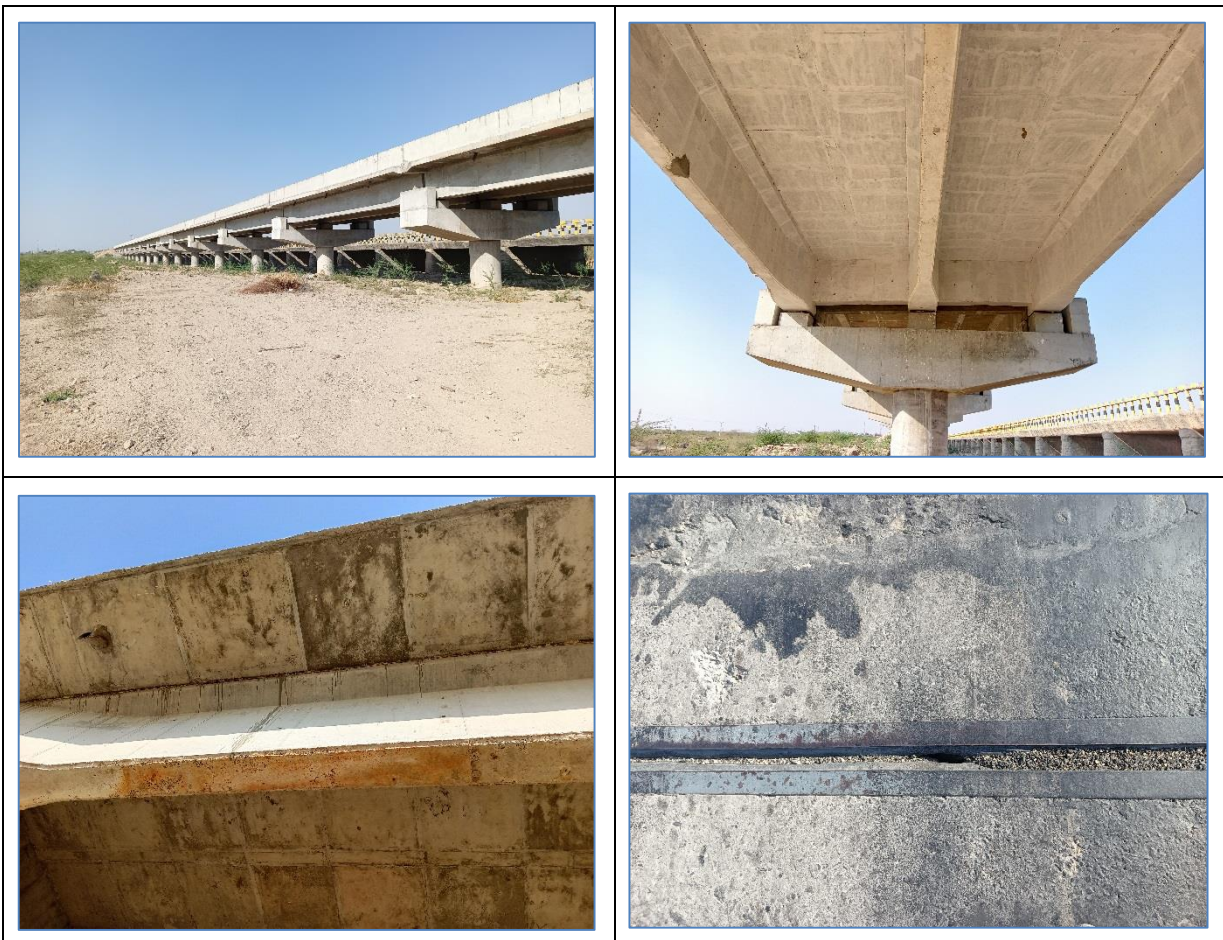
BR. NO.349+230

- Corrosion stains observed on bottom of girders.
- Rubber sealant damaged in all Expansion joints & Filled with Silt.

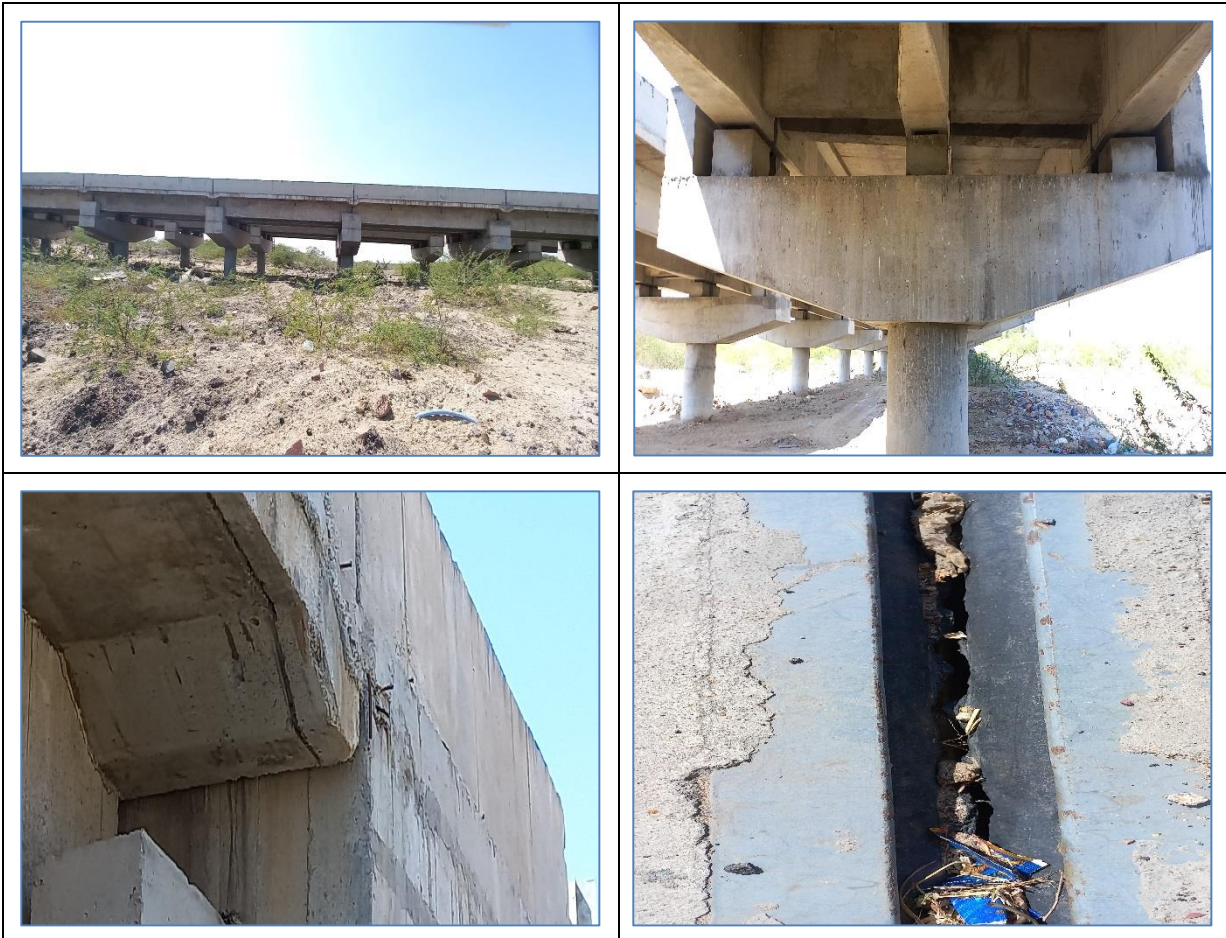
BR. NO.349+230

- Steel exposed on dirt wall at A1 side and P4 pier cap.
- Honey combing & Corrosion stains are observed on bottom of the girders.
- Rubber sealant damaged in Expansion joint on P2, P3, P6, P7, P9, A2 locations.

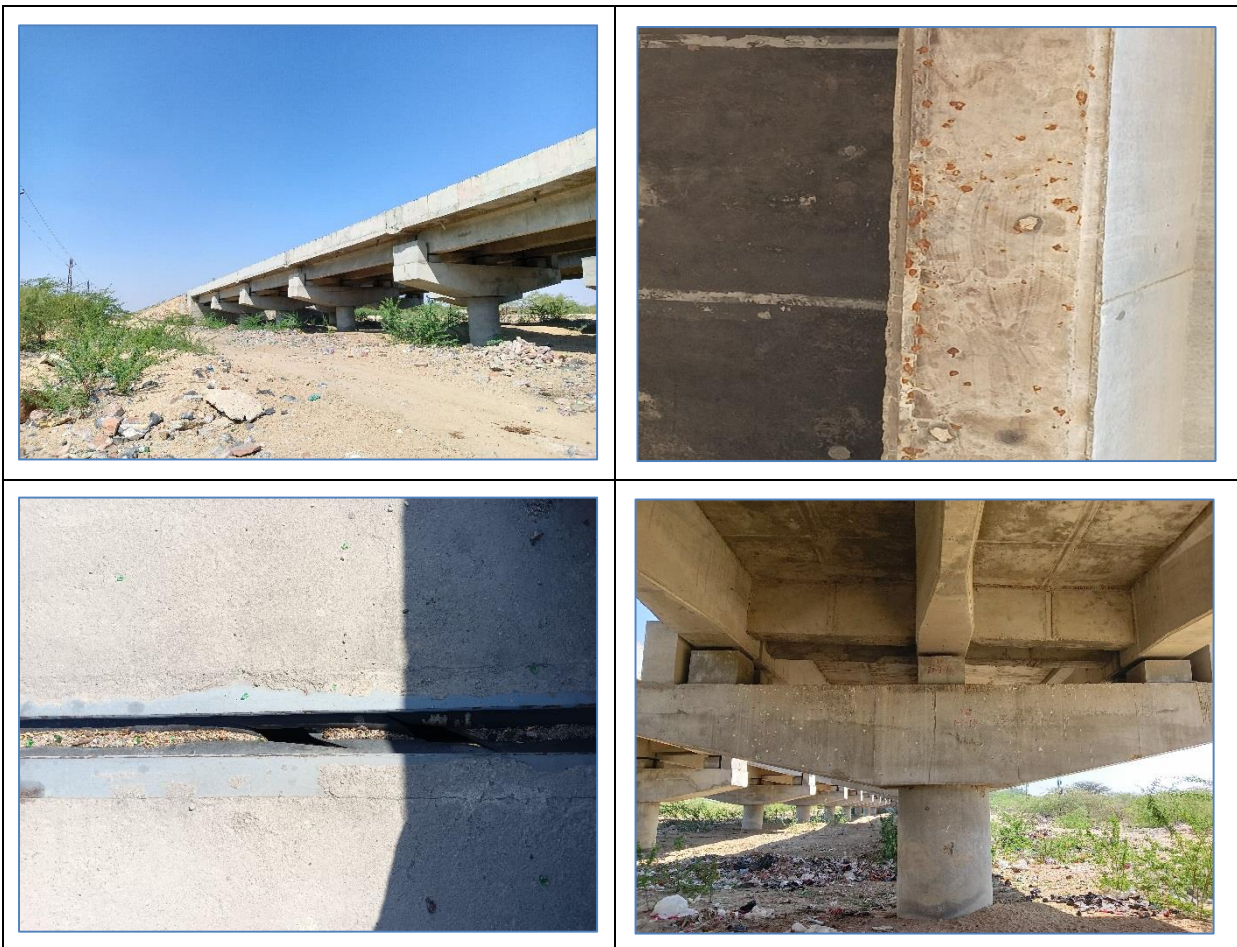
BR. NO.354+690

- Honey comb observed on bottom of the girder.
- Minor Corrosion stains were observed on bottom of the girders.
- Rubber sealant damaged in Expansion joint on A1, P5 locations.

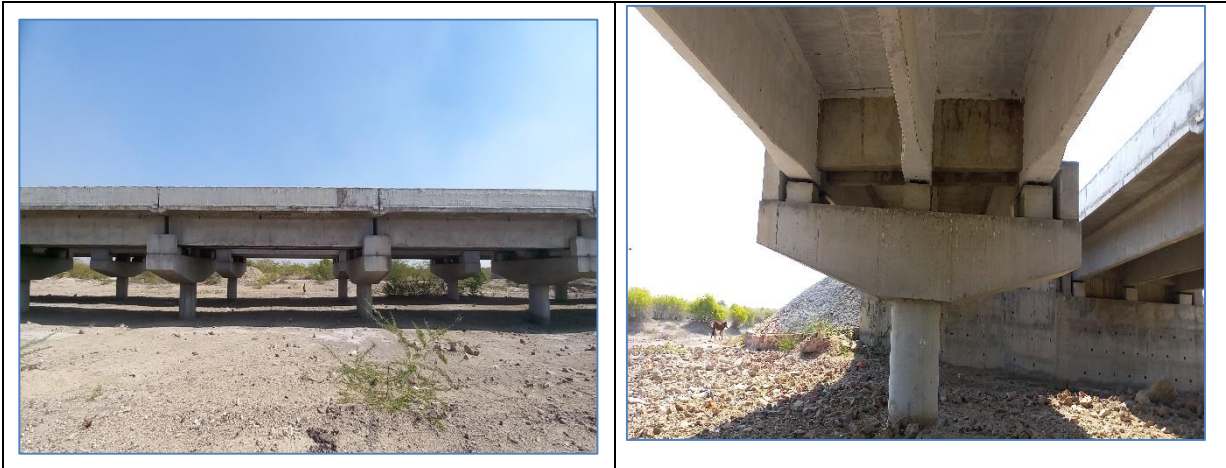
BR. NO.354+690

- Hair line cracks were observed on top slab and bottom of girders.
- Corrosion stains were observed on bottom of the girders.
- Rubber sealant damaged in Expansion joint on P4, P6, P7, P8 locations.
- Spalling & steel observed on girder bottom.

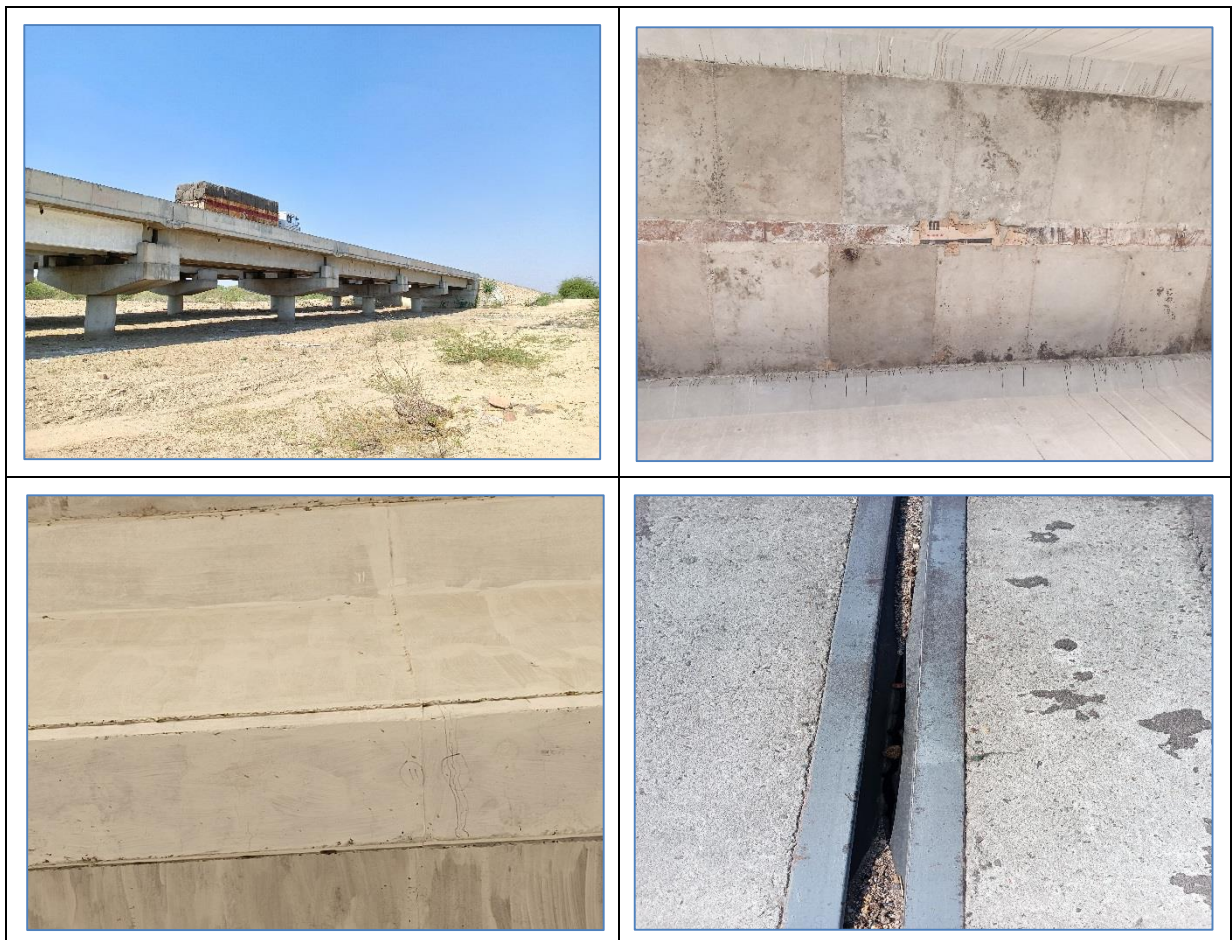
BR. NO.371+373

- Steel exposed on P5 cross girder.
- Hair line cracks were observed on top slab.
- Corrosion stains were observed on bottom of the girders.
- Rubber sealant damaged in Expansion joint on P4, P6, P7, P8 locations.

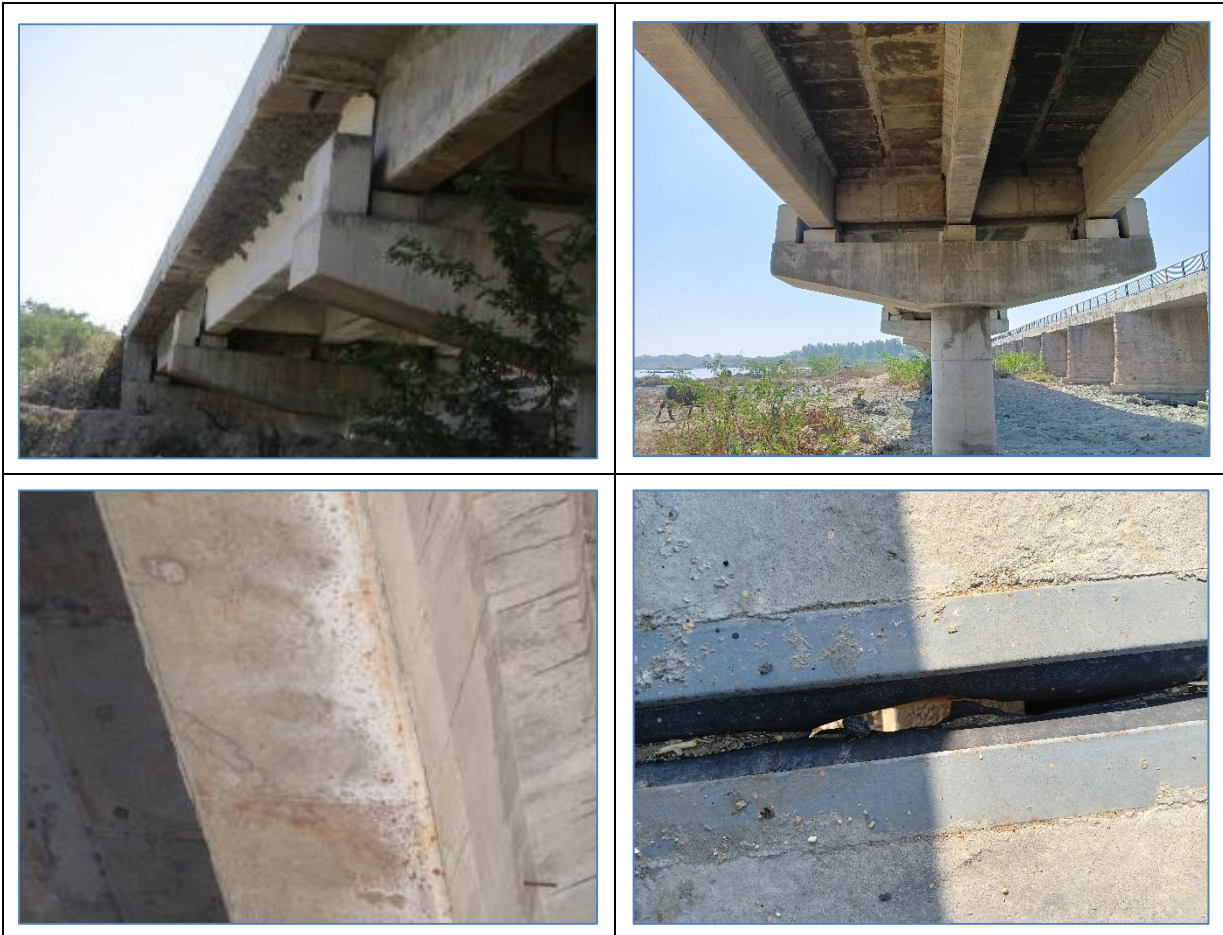
BR. NO.371+373

- Corrosion stains were observed on bottom of the girders.
- Rubber sealant damaged in Expansion joint on P1, P3, P4, P7, A2 locations.
- Vibrations observed while heavy vehicles were moving on structure.

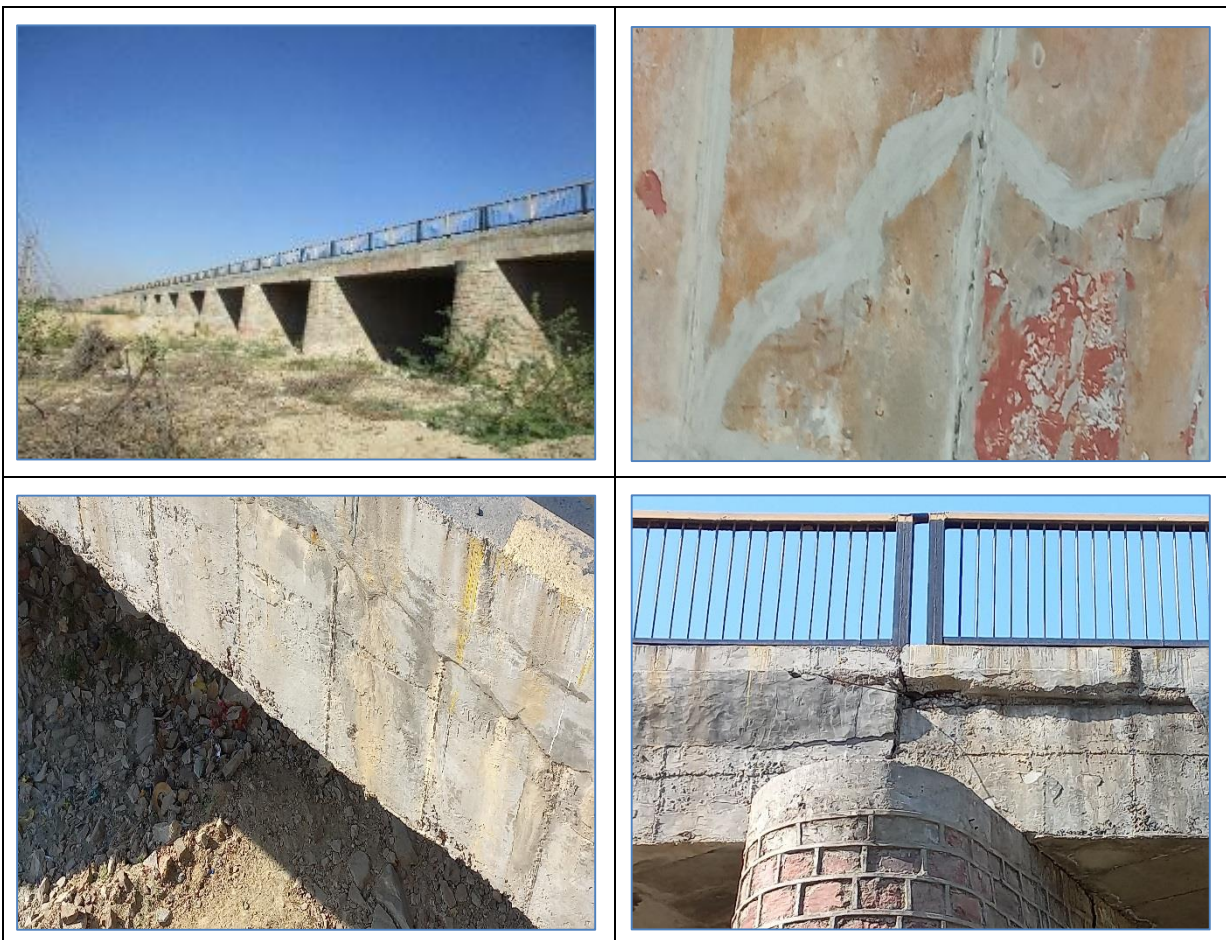
BR. NO.335+285

- Minor Cracks & Honey comb observed on top slab.
- Previous repair works are observed.
- Minor Corrosion stains were observed girders at A2 side.

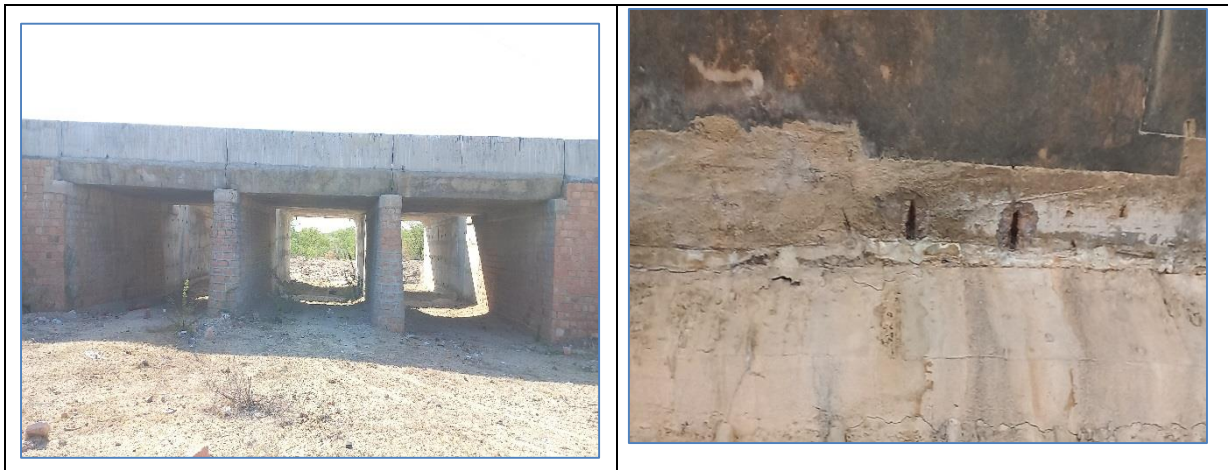
BR. NO.335+285

- Hair line cracks observed on deck slab & pier cap.
- Delamination observed on pier cap.
- Spalling and steel observed on top slab.

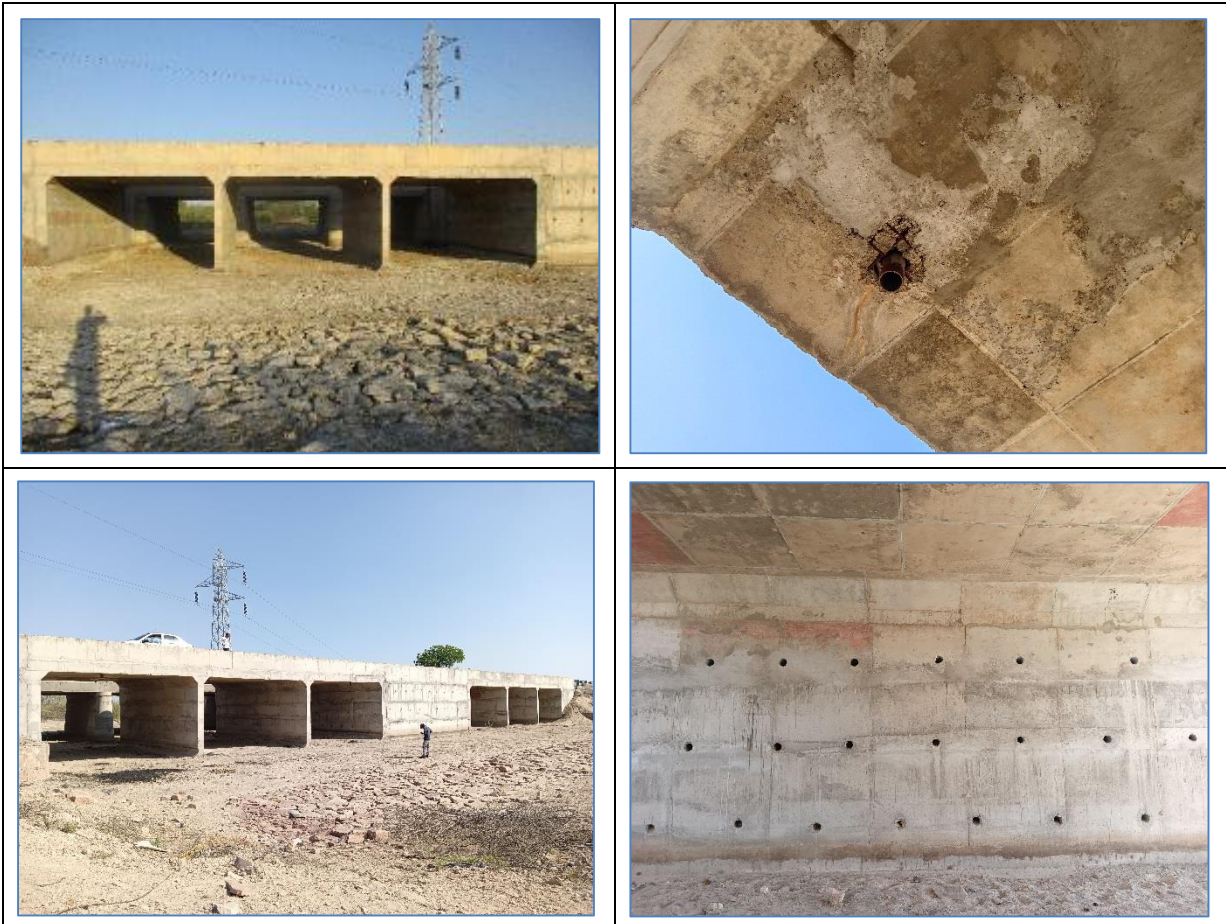
BR. NO.338+736

- Steel exposed at the down take pipe.
- Structure condition good.

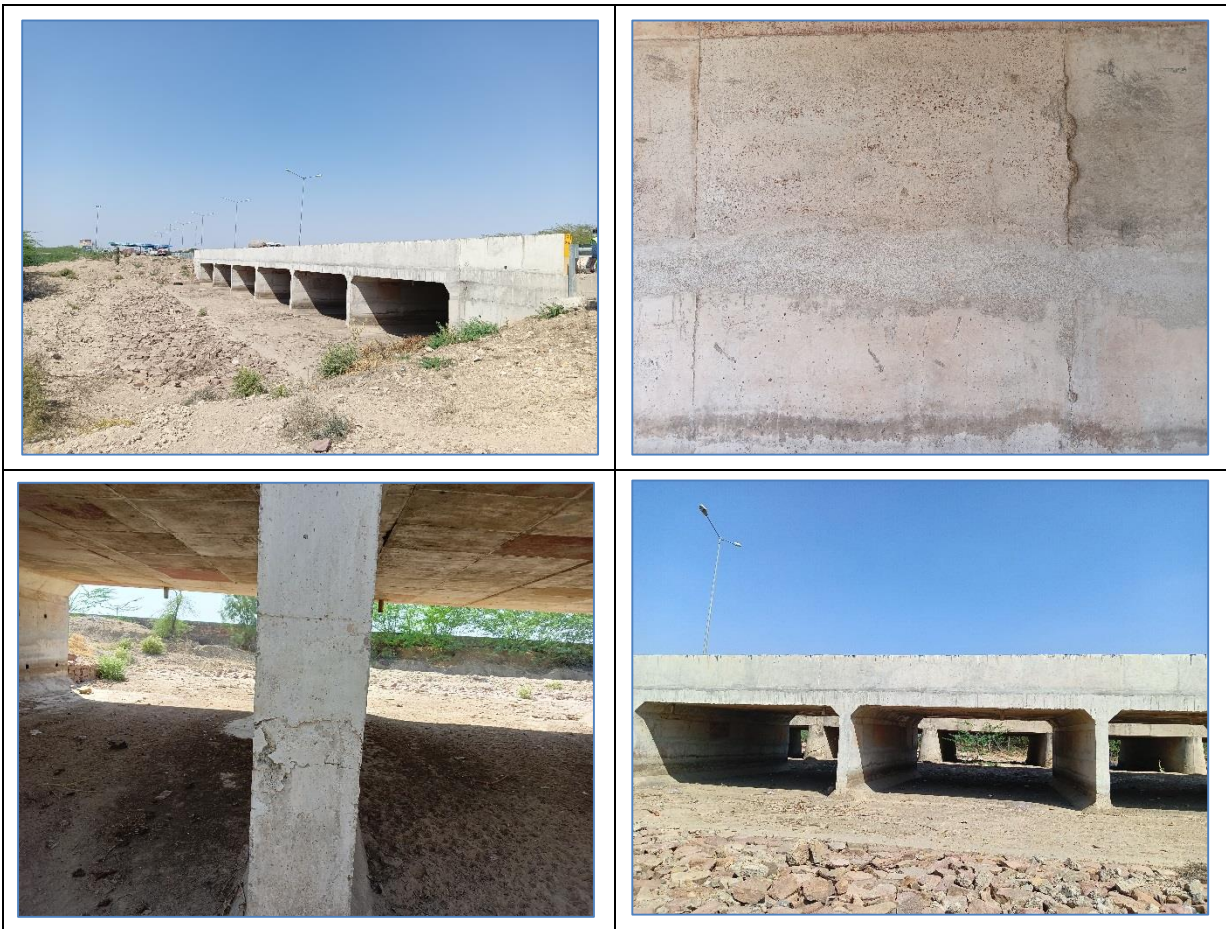
BR. NO.339+541

- Minor honey comb observed on top slab.
- Hair line cracks observed on every top slab and side walls.
