**Re: Submission of Final Report of Technical due diligence study for the project "Jodhpur Pali Expressways Pvt. Ltd".**

**Technical Due Diligence for 4 Laning of Jodhpur to Pali Section of NH 65 from Km 308 to Km 366 & includes bypass to Pali starting from Km 366 of NH-65, connecting NH-14 at Km 114 in the State of Rajasthan**

**For Virescent Infrastructure  
Investment Manager Private Limited  
(For the purpose of  
Highways Infrastructure Trust)**

# **Final Report**

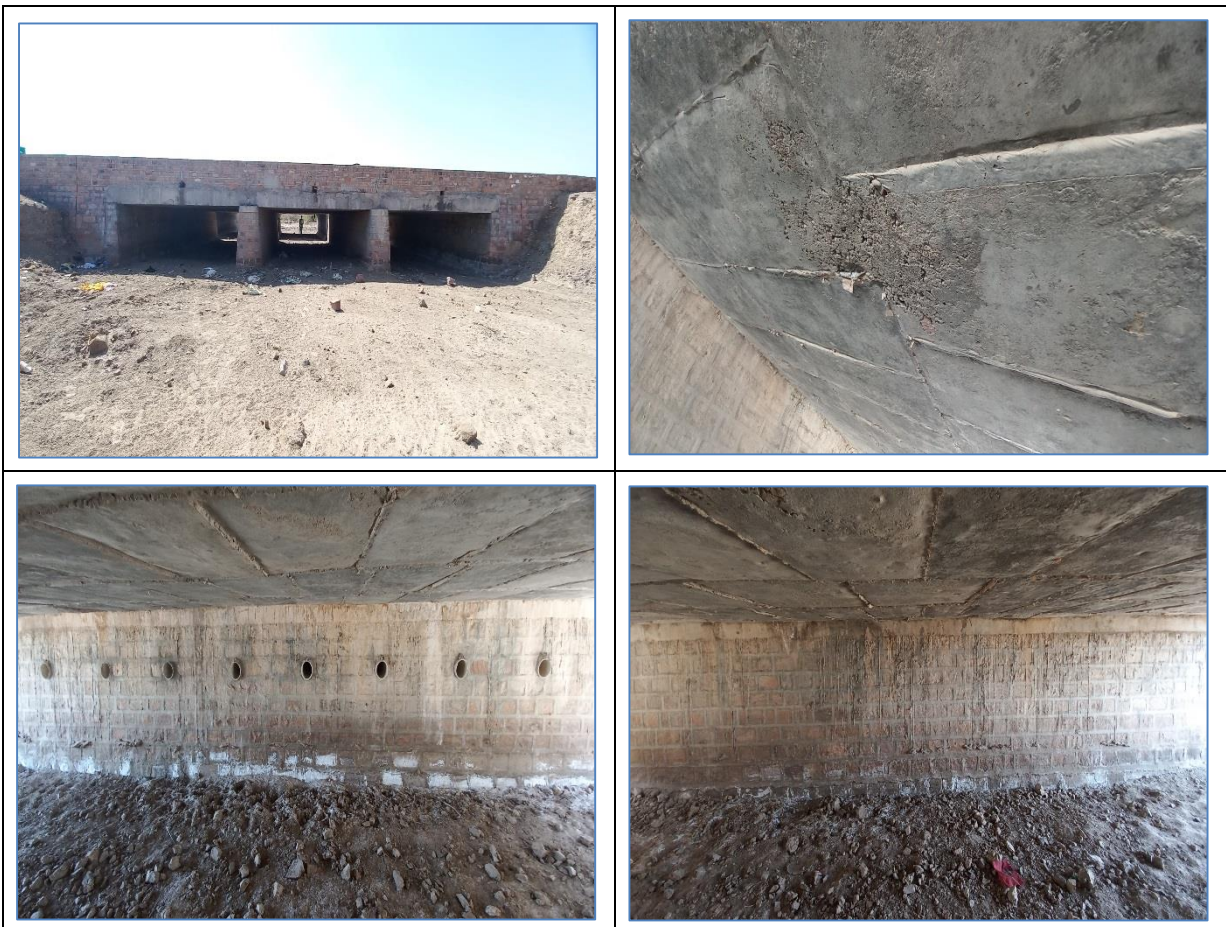
BR. NO.339+541

- Minor honey comb observed on top slab.
- Structure is in good condition.

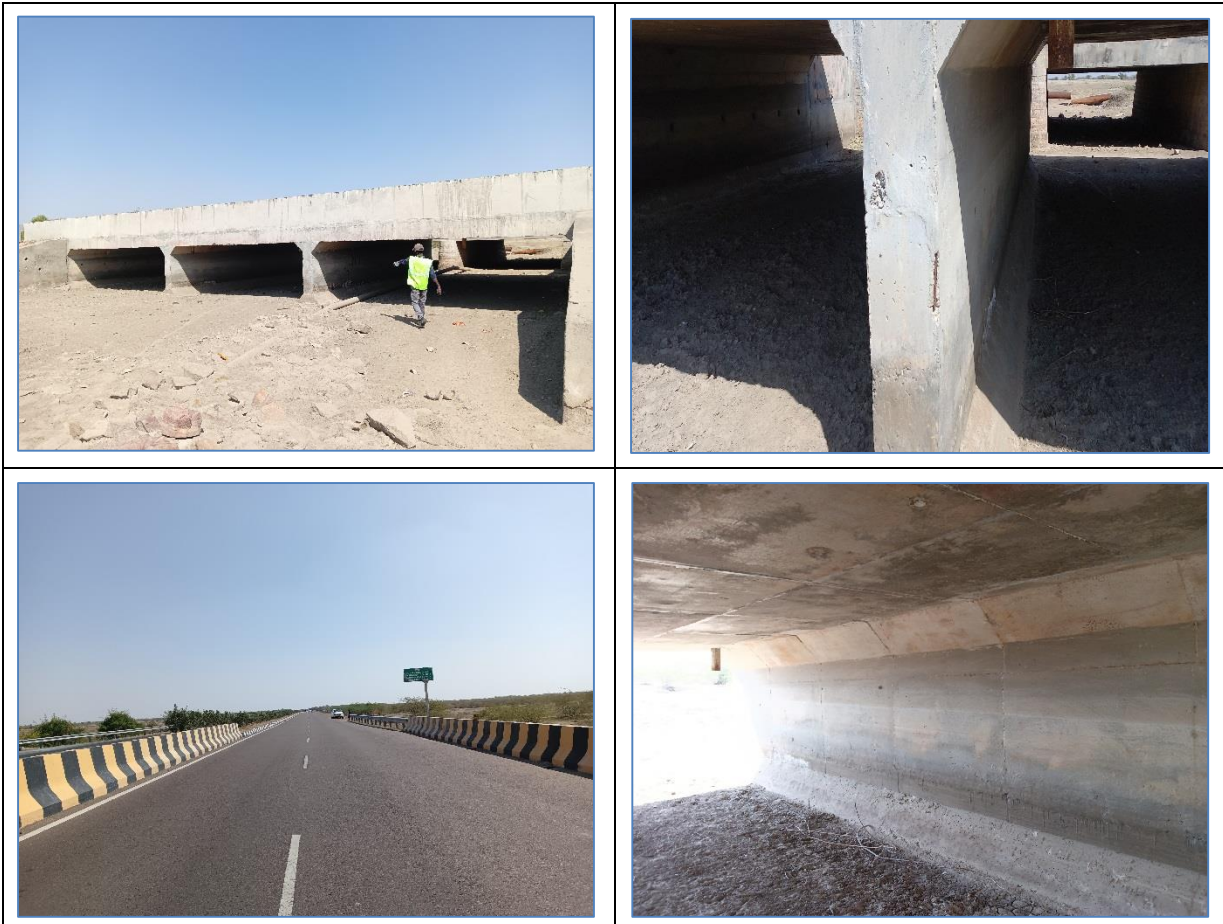
BR. NO.343+249

- Steel exposed on P1 side wall.
- Structure is in good condition.

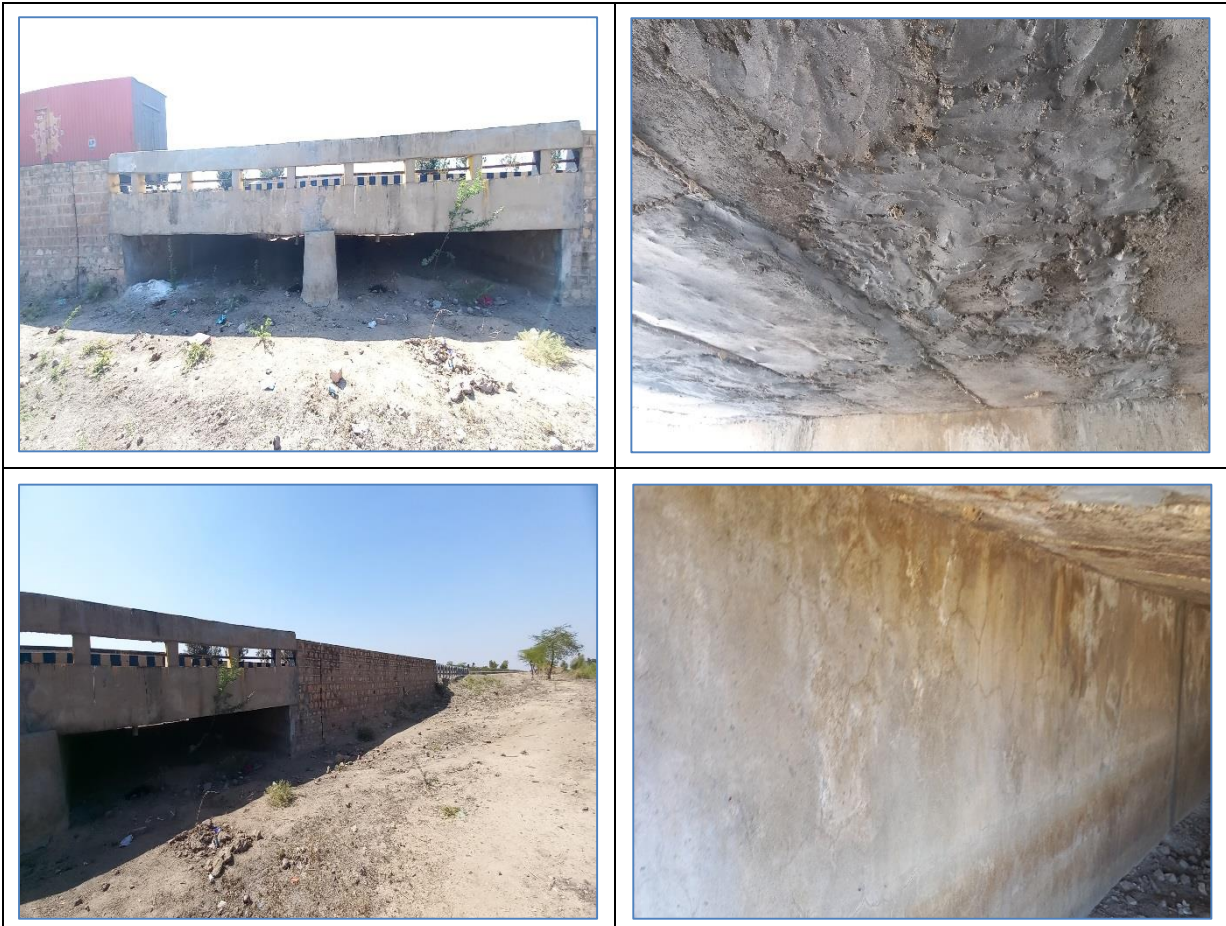
BR. NO.343+249

- Recent repair works noticed on top slab.
- Structure is in fair condition.

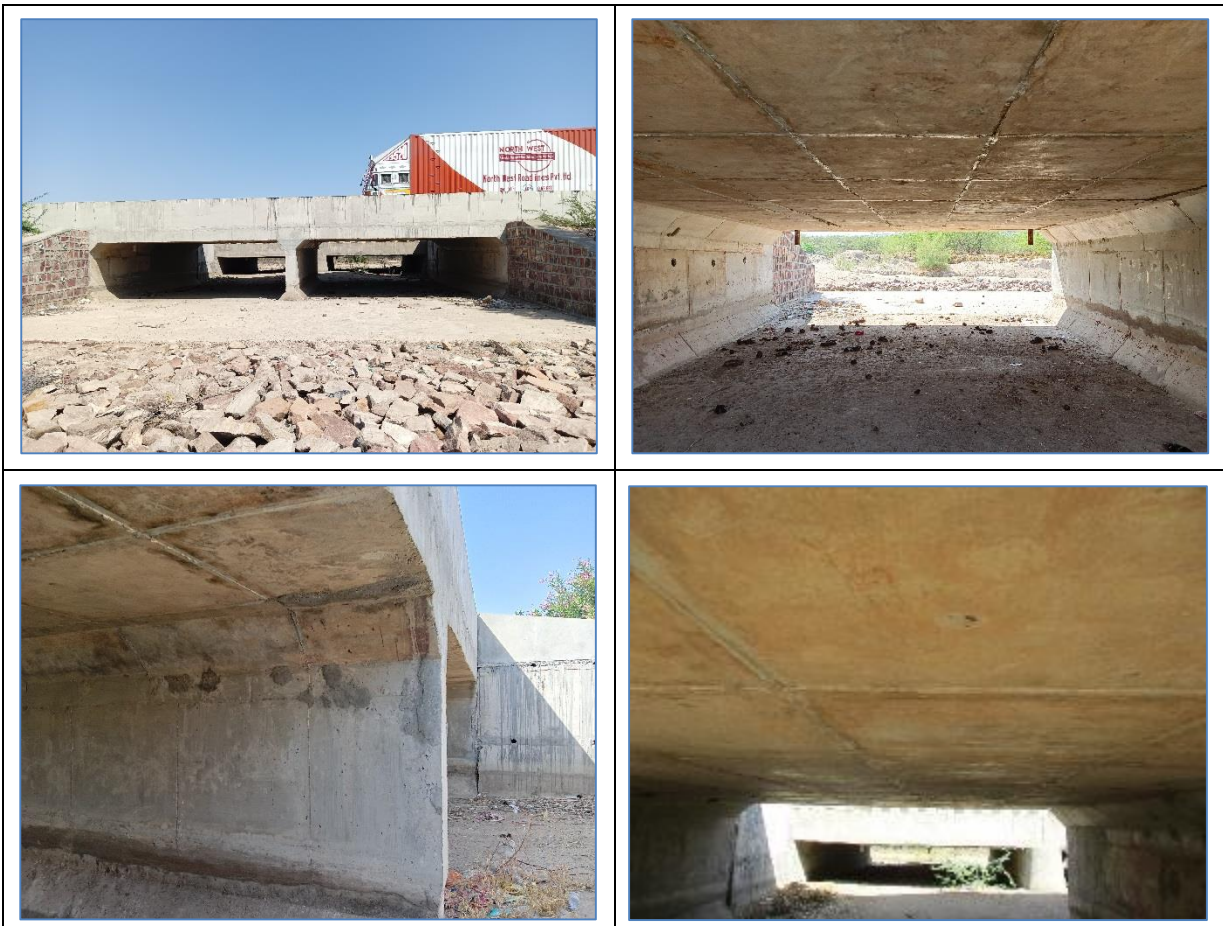
BR. NO.346+000

- Minor Cracks observed on top slab and side walls.
- Structure is in good condition.

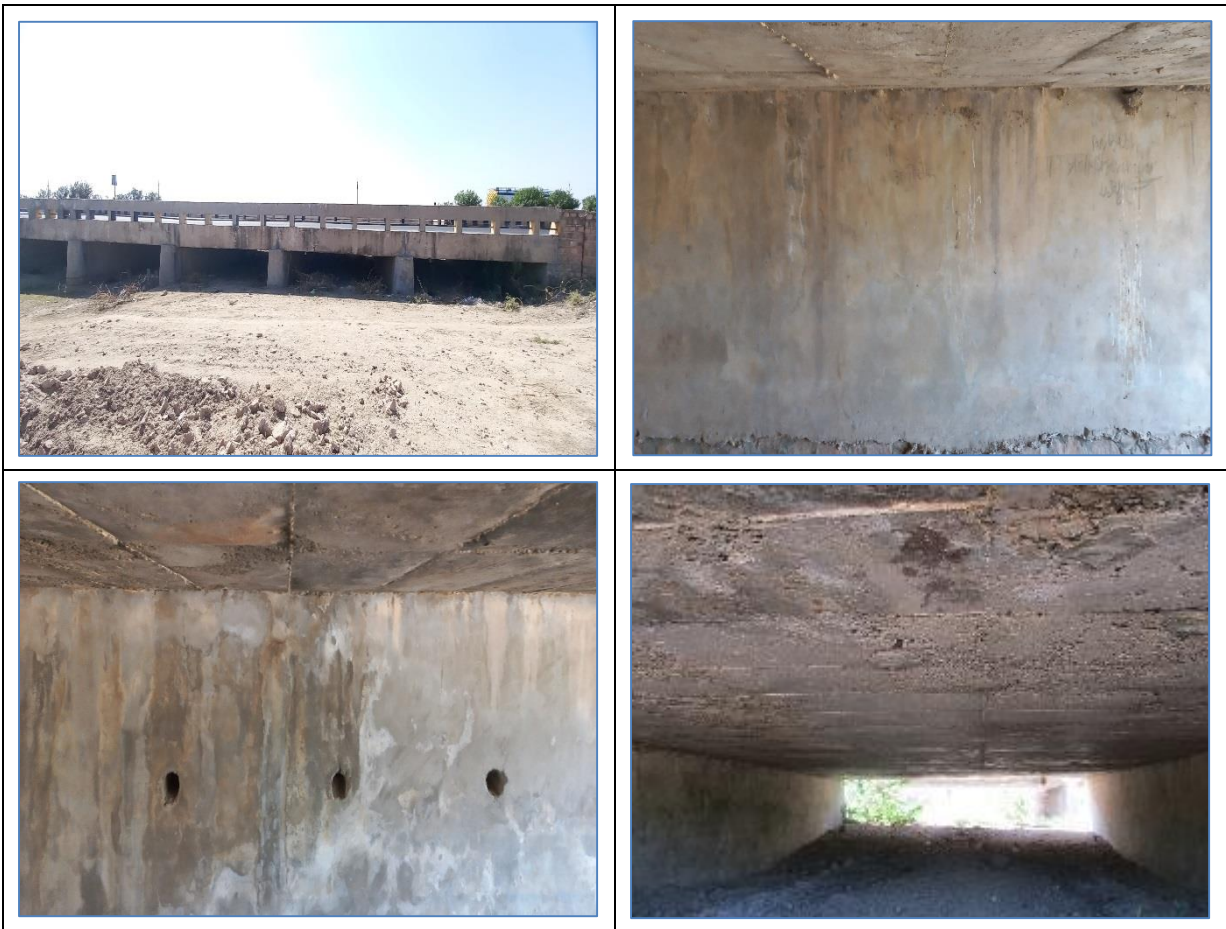
BR. NO.346+000

- Honey comb observed and Steel exposed on top slab.
- Structure condition fair.

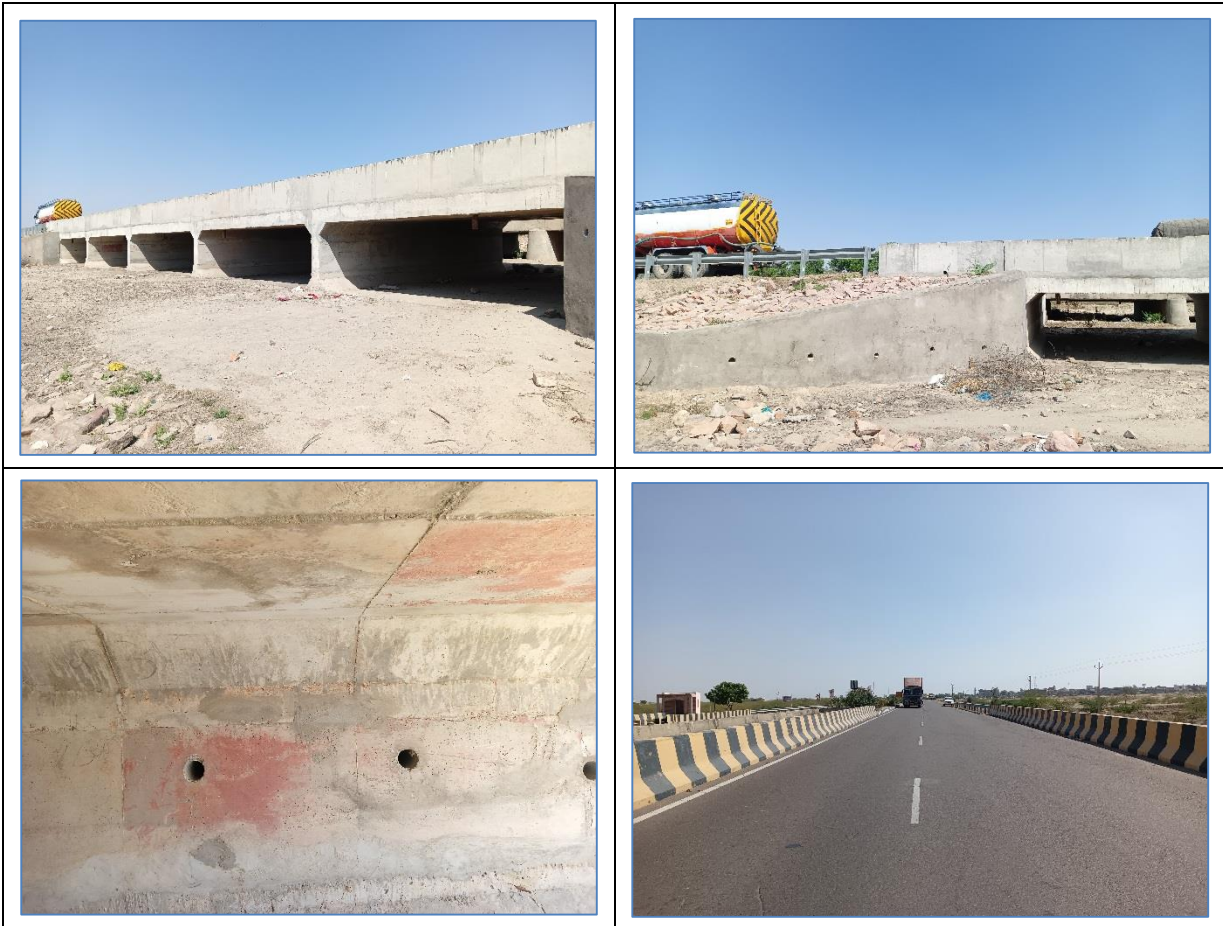
BR. NO.325+600

- Hair line cracks observed on bottom of top slab and side walls.
- Structure is in fair condition.

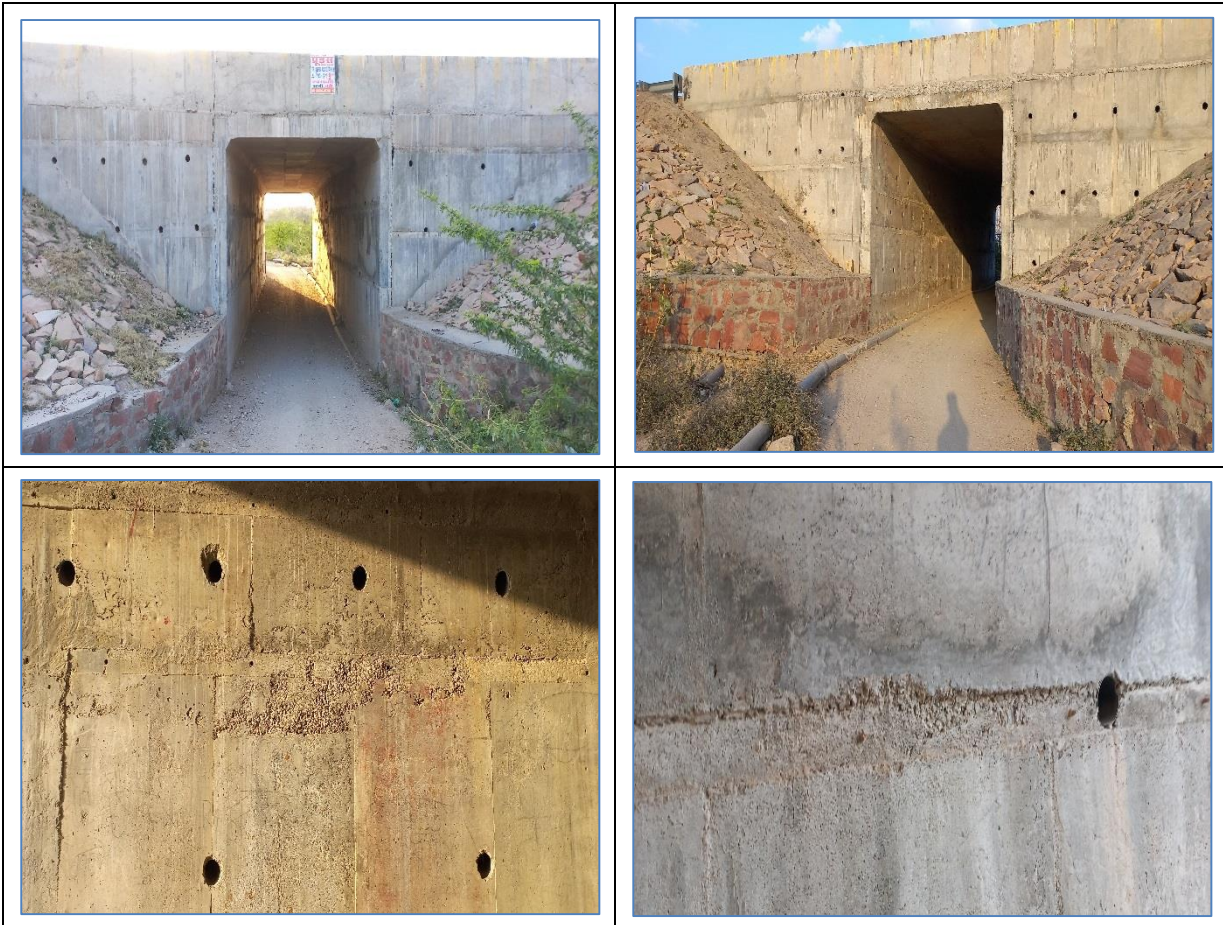
BR. NO.360+500

- Minor Honey comb observed on side walls.
- Structure is in good condition.

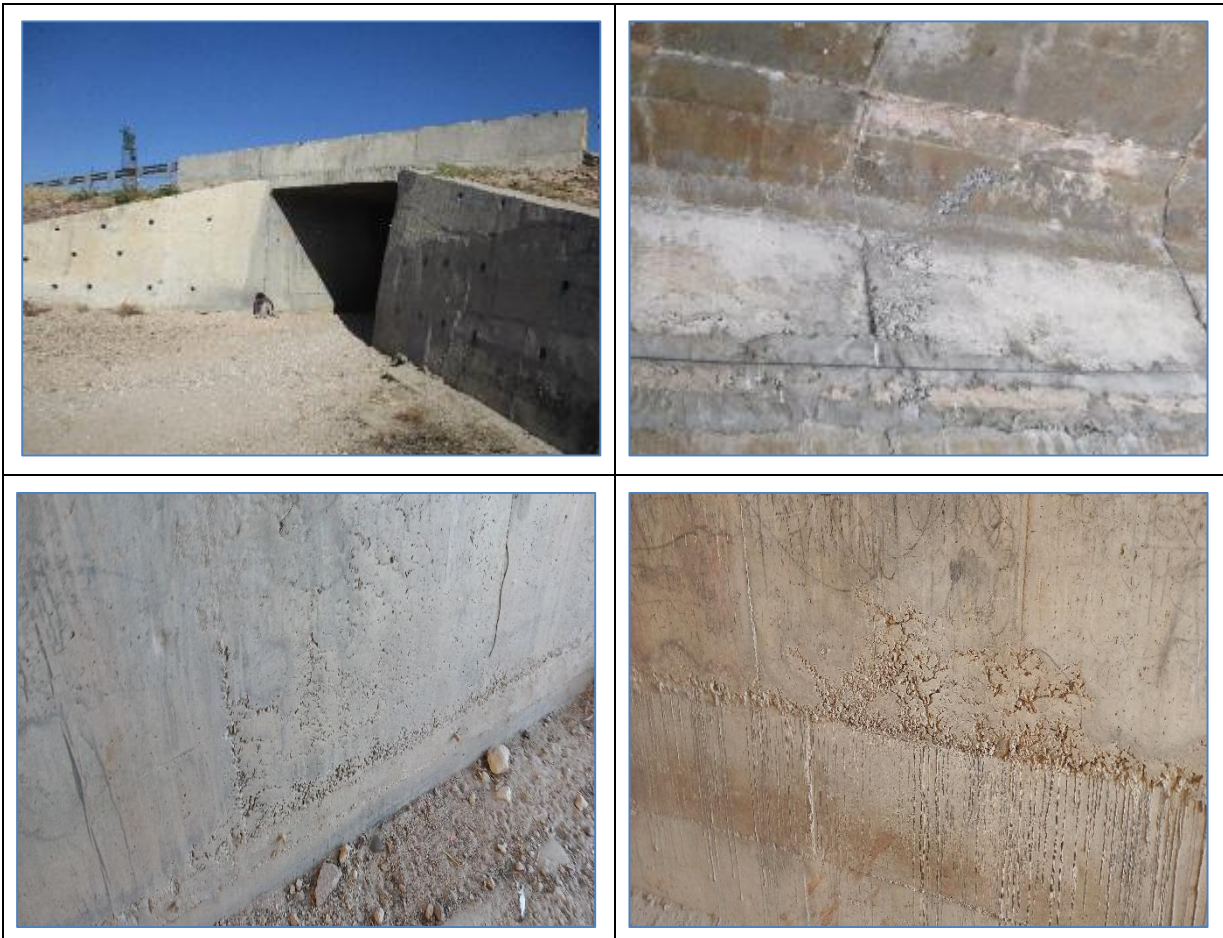
BR. NO.372+980

- Honey comb and cracks were observed on side walls.
- Structure condition good.

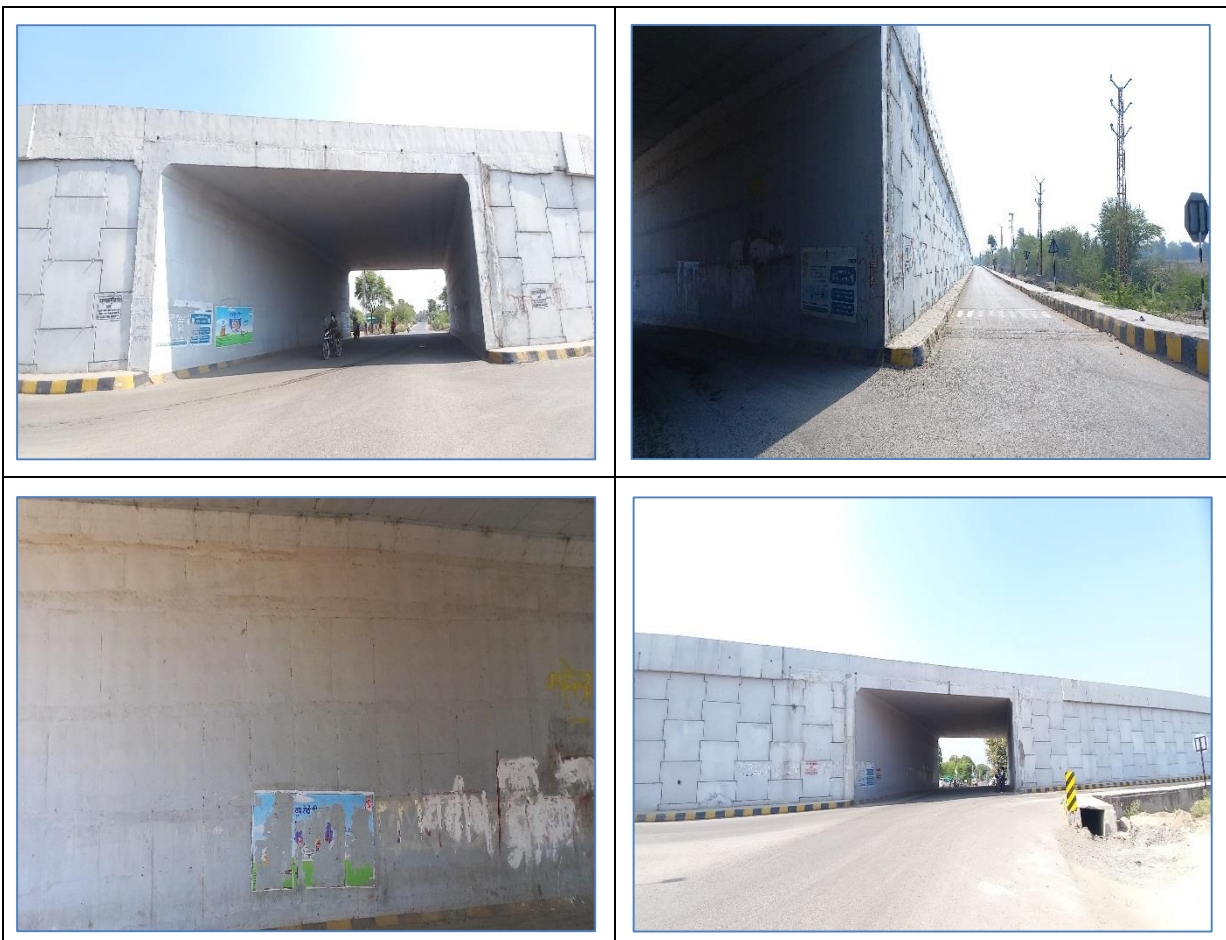
BR. NO.367+485

- Structure is in good condition.

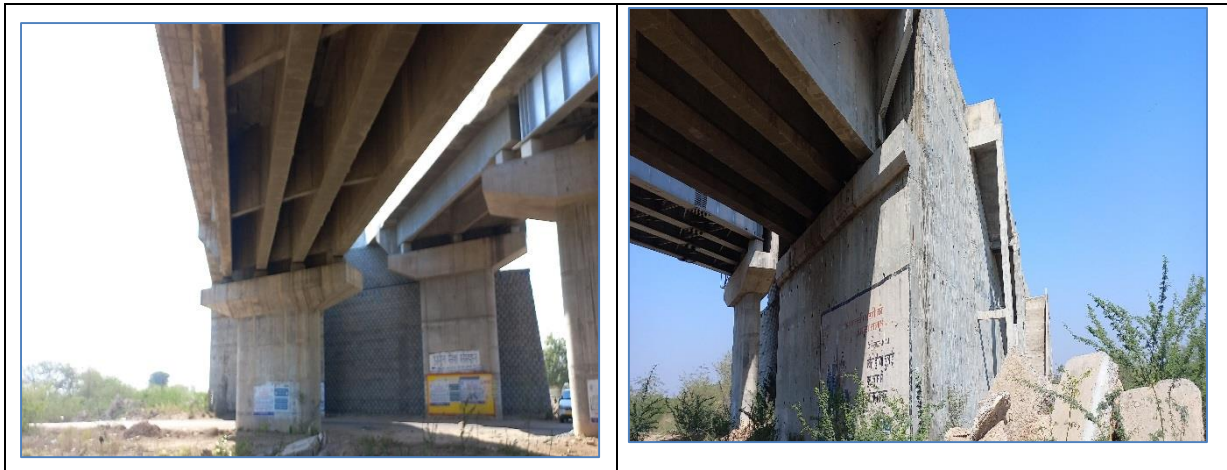
BR. NO.367+485

- Corrosion stains were observed on pier cap.
- Rubber sealant damaged in Expansion joint on A1, P1, A2 locations.

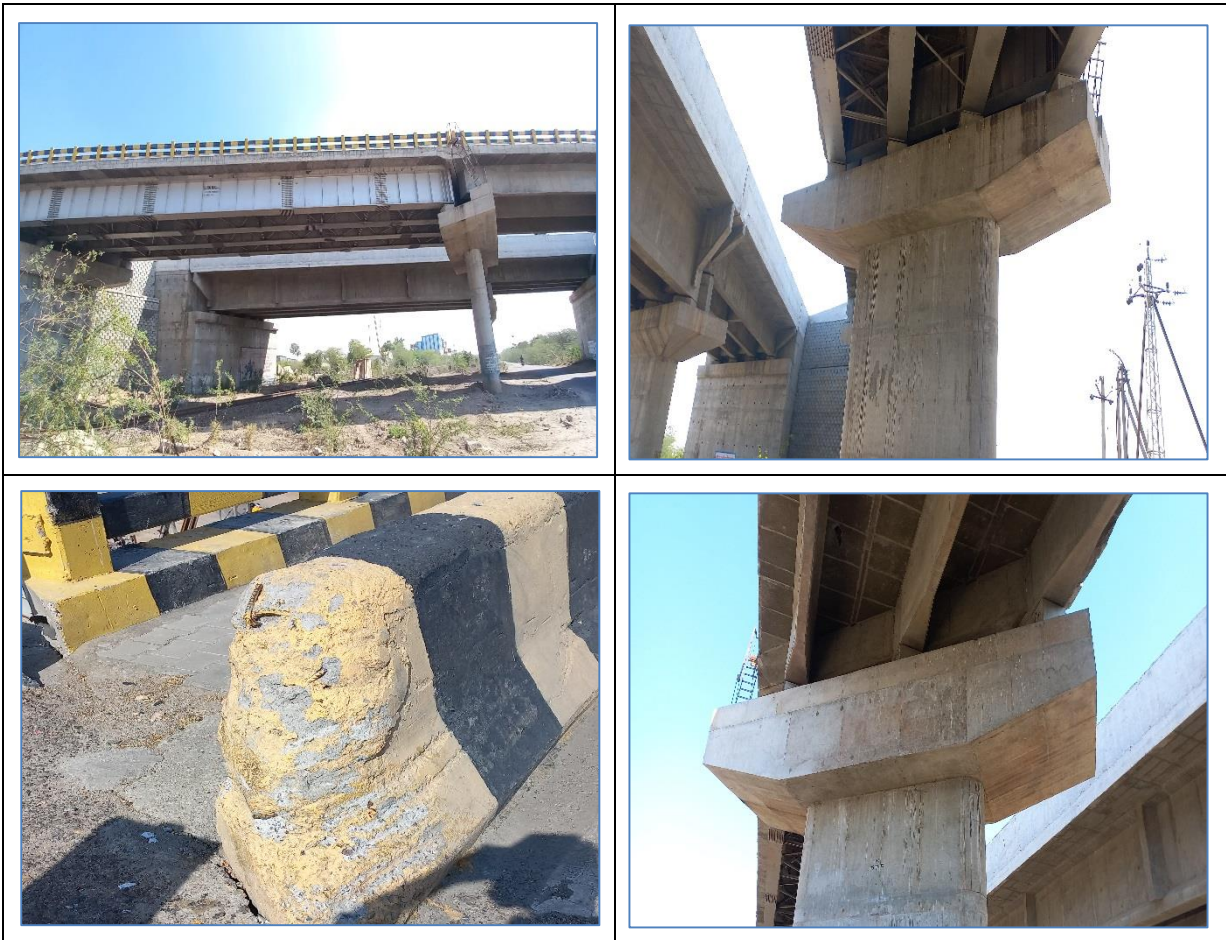
- Three RCC girders for P1 to A2 and are in good condition.
- Crash barrier damaged and also steel exposed.
