Re: Submission of Final Report of Technical due diligence study for the project "Shillong Expressways Private Limited (SEPL)".

**Technical Diligence for 2-laning of Shillong
bypass connecting NH-40 and NH-44 from
km 61/800 of NH-40 to km 34/850 on NH-
44 in the state of Meghalaya on Build,
Operate and Transfer (“BOT Annuity”) Basis.**

**For Virescent Infrastructure Investment
Manager Private Limited (For the purpose of
Highways Infrastructure Trust)**

Final Report

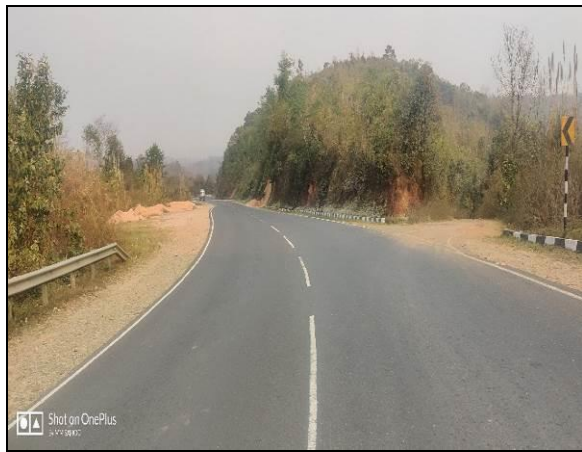
Near Km 22.000

The present condition of pavement is fair along the project road. Cracking and raveling has developed on Carriageway at some locations. These are mainly surface related distresses and the cracking appears to be top-down cracking. Crocodile cracking is noted at isolated locations. Crack sealing is also being done / in progress at some of the locations along the project corridor. The present surface condition appears slightly dry surface; because of which the cracking might have initiated at most of the locations. Crack sealing is also being done / in progress at some of the locations along the project corridor. The present surface condition appears slightly dry surface; because of which the cracking might have initiated at most of the

locations. No potholes are seen along the project. Remedial treatment at distressed locations carried out with BC material.

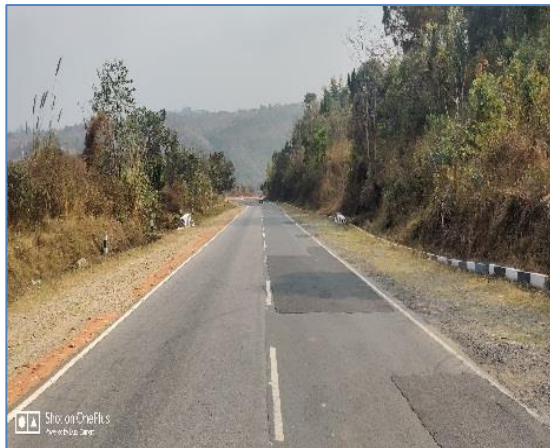
Patch work @ km 36.010

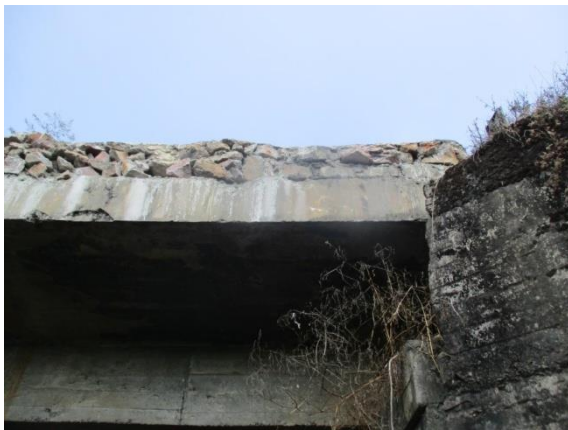
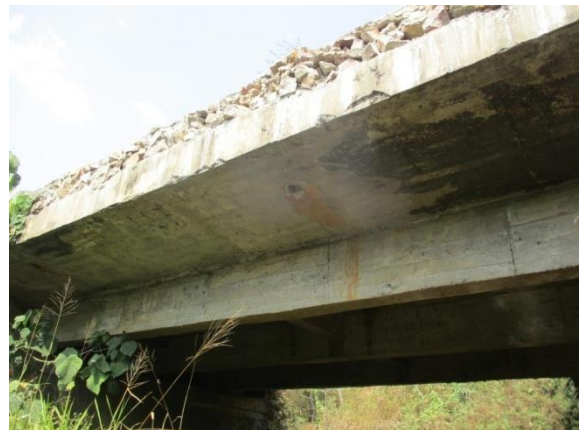
Km 7+780

- Overall structure appears to be good in good condition
- Honey combs are observed on soffit of the slab.
- In wing wall minor cracks observed at some locations.

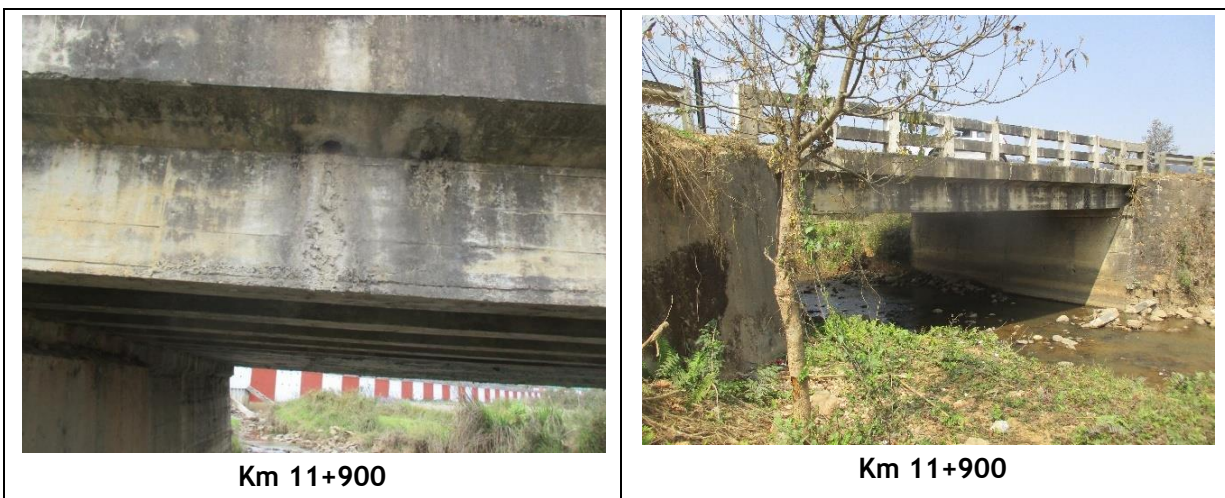
Km 11+900

- Overall structure appears to be in good condition
- Weep holes are not provided on wing walls.

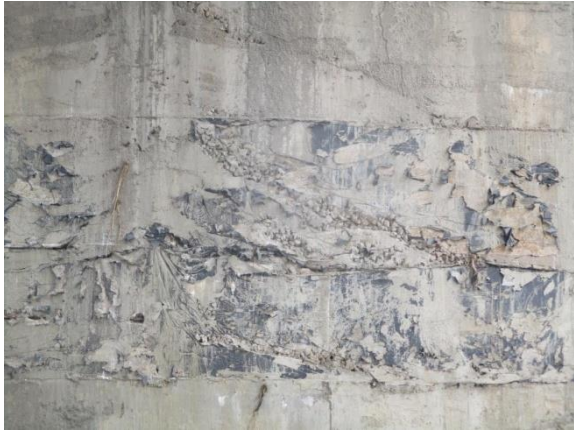
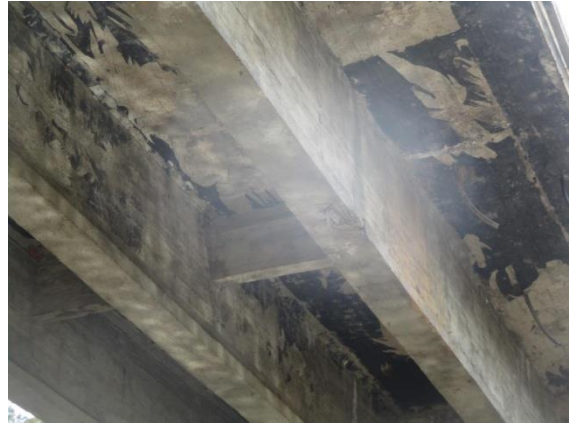
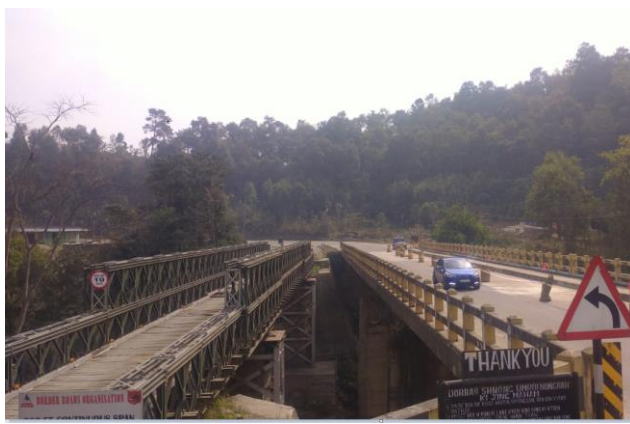
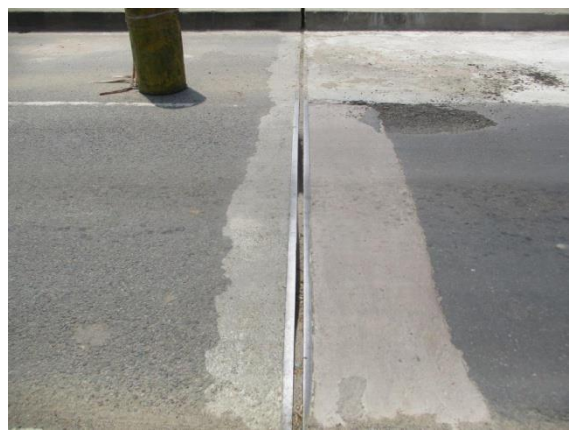
16. The project Road has 3 Major bridges and 8 Minor bridges and 1 VUP. There 240 number of Culverts exists along the project road.
17. All CD structures along the project road are having good condition except 1 Major bridge near Km 12+865 (which was constructed by PWD). Bridge at Km 12+865 is having developed Vertical Flexural and Shear cracks due to overloading of Heavy Vehicular Traffic.

4. Bailey Bridge launching was completed by the BRO and the approach road was completed by the Concessionaire under COS. Concessionaire informed that Bailey Bridge was inaugurated on 25.03.2021 in presence of Hon’ble deputy Chief Minister Meghalaya.

5. As per information by the Concessionaire, NHAI has taken up the construction of new bridge independently.

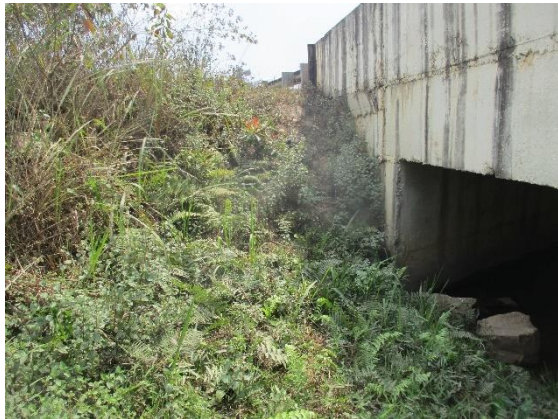
Km 15+740

- Overall Structure Condition is good
- Drainage spout down take pipe is not provided.

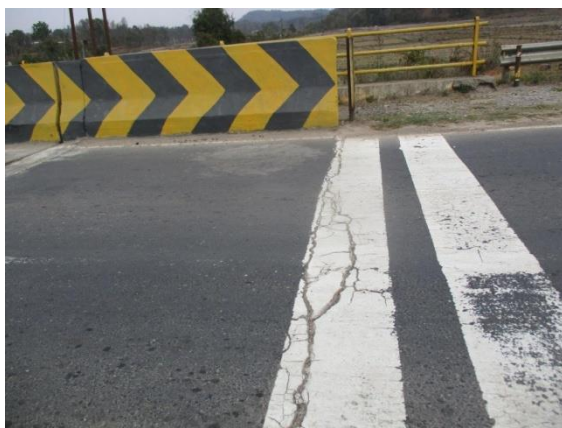
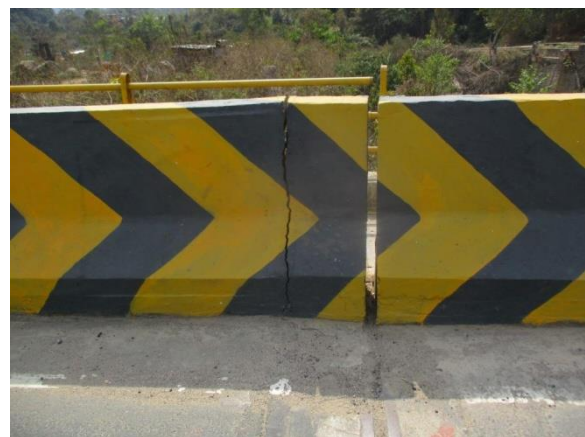
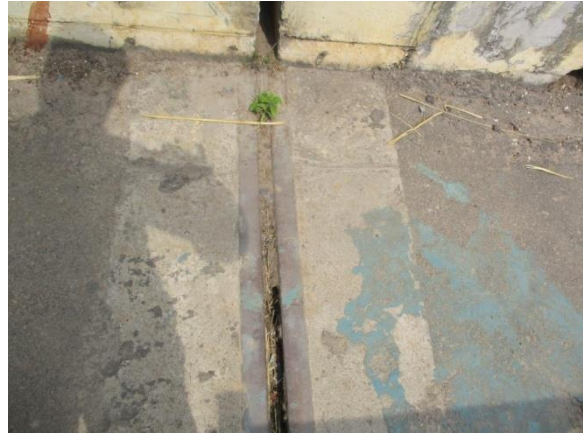
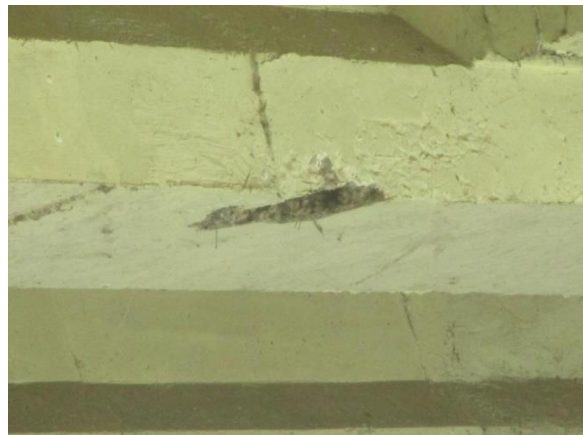
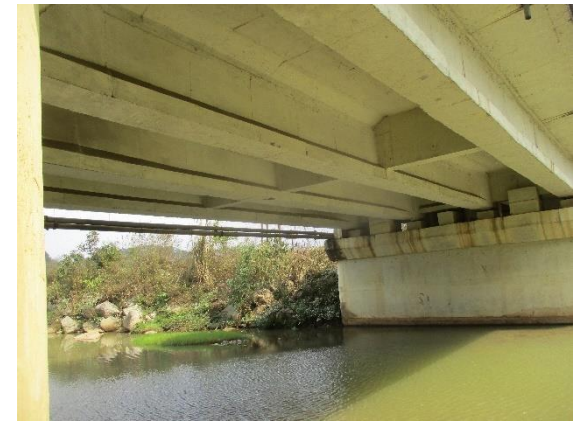
Km 19+000

- Overall Structure Condition is good
- Floor apron damaged at first span.
- Minor Cracks are observed on approach slab.
- Expansion joints rubber are damaged.
- Cracks observed on crash barrier at some locations.
- Steel pipe hand railing is damaged.
- Minor damage on second span, third girder.

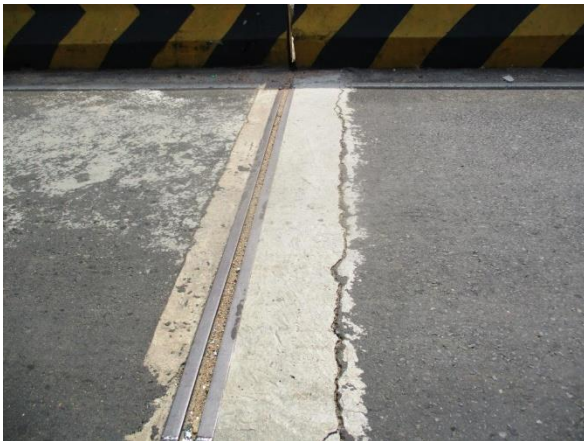
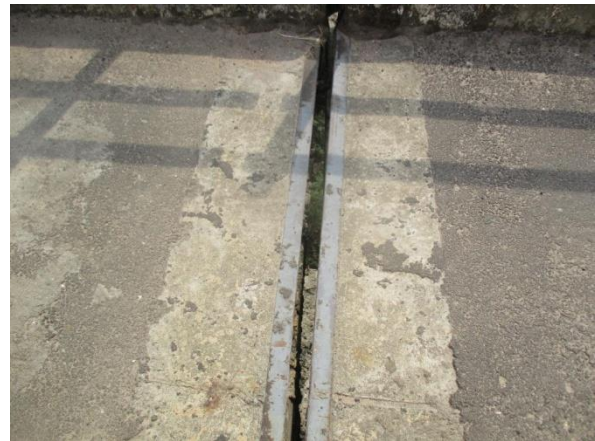
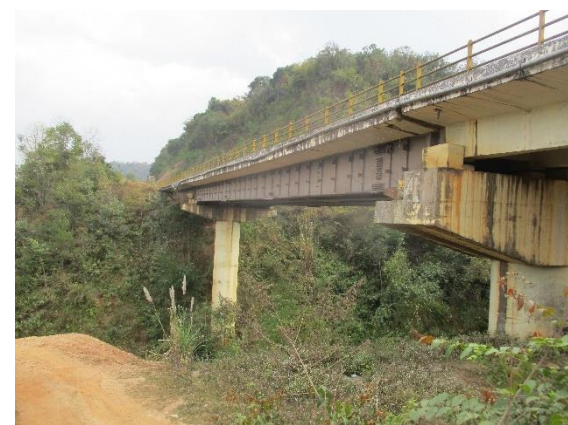
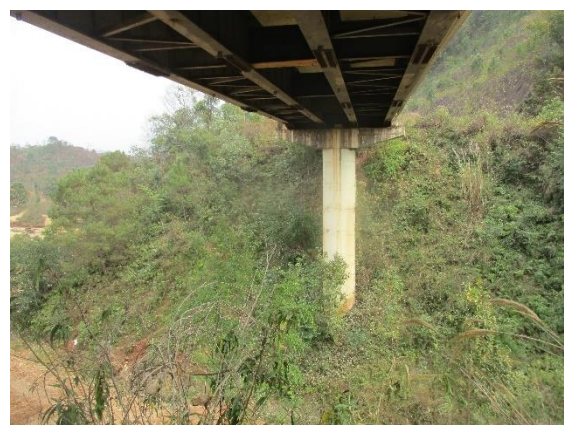
Km 22+640

- Overall Structure Condition is good
- Expansion joint rubber joints are damaged.
- Drainage spout down take pipe is not provided.
- Minor Cracks are observed on beside of the expansion joint.

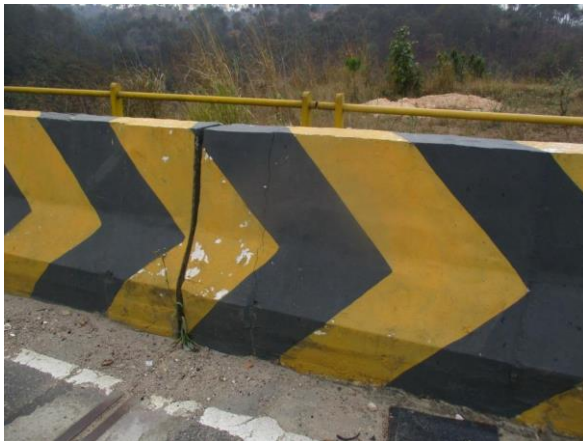
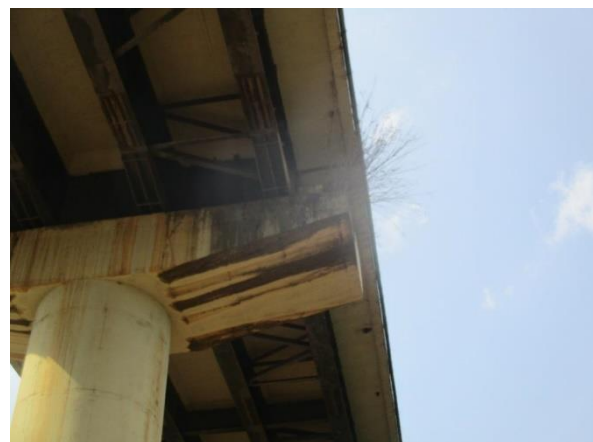
Km 31+420

- Overall Structure Condition is good
- Expansion joint rubber selling is damaged.
- Drainage spout down take pipe is not provided.
- Minor Crack observed on crash barrier at some locations.

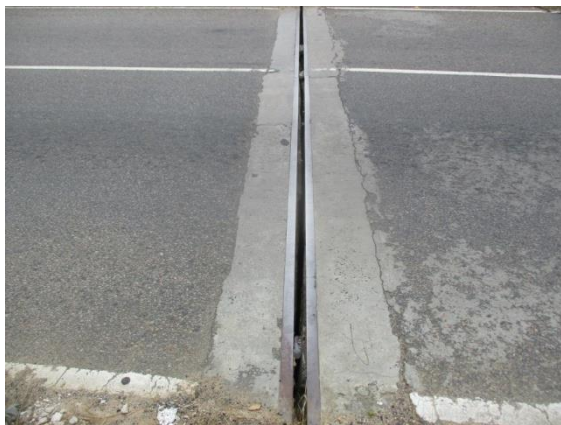
Km 32+868

- Overall Structure Condition is good
- Expansion joint rubber joints are damaged.
- Floor apron is damaged.

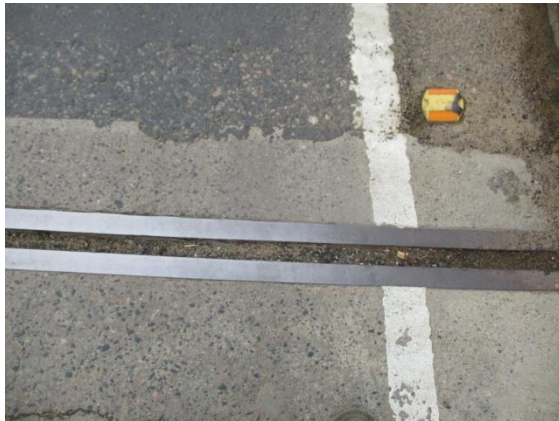
Km 37+020

- Overall Structure Condition is good
- Minor Crack observed on crash barrier wall at some locations.
- Minor Cracks observed on expansion joints sides.

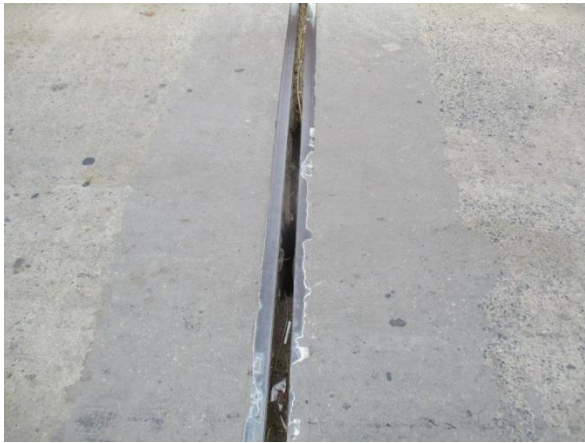
Km 37+600

- Overall Structure Condition is good
- Expansion joints rubber joints sealing is damaged.
- Minor damage on head wall at small portion

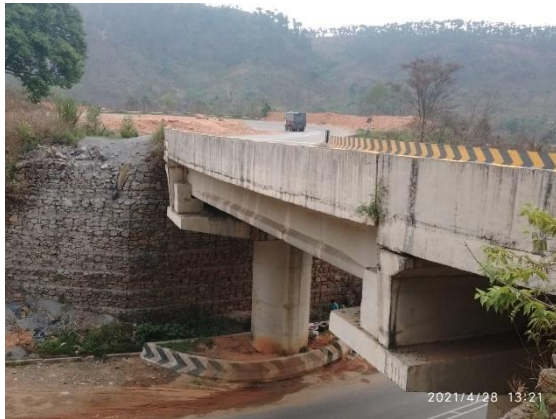
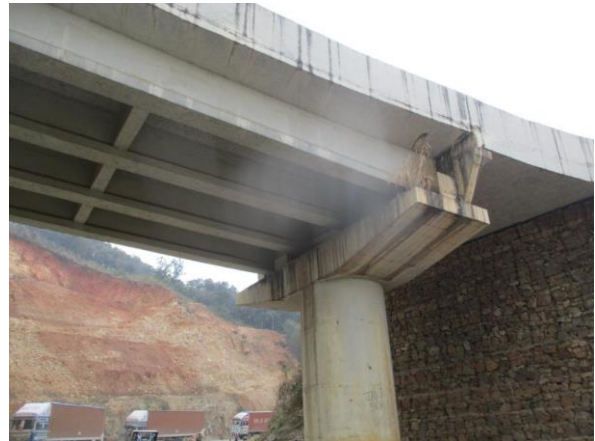
Km 38+750

- Overall Structure Condition is good
- Drainage spout down take pipes are not provided.
- Expansion joints are buried with debris
- Minor crack observed on RCC crash barrier at some locations

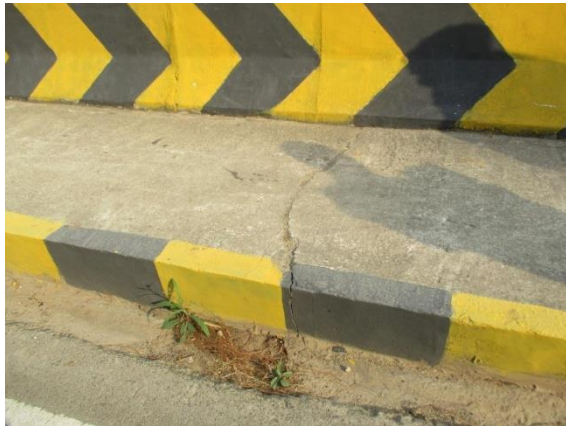
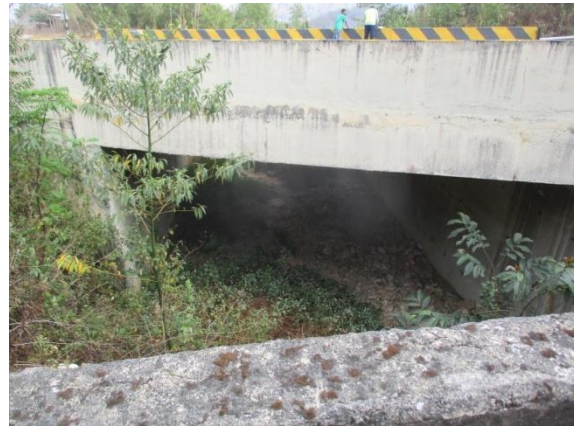
Km 42+400

- Overall Structure Condition is good
- Drainage spout down take pipes are not provided
- Minor Crack observed on footpath location at 1 location.
