Re: Submission of Final Report of Technical due diligence study for the project "Ulundurpet Expressways Pvt. Ltd (UEPL)".

**Technical Due Diligence for Tindivanam
to Ulundurpet section of NH-45 from km
121.000 to km 193.900 of Length
72.900 kms in the State of Tamil Nadu.**

**For Virescent Infrastructure Investment
Manager Private Limited (For the purpose of
Highways Infrastructure Trust)**

Final Report

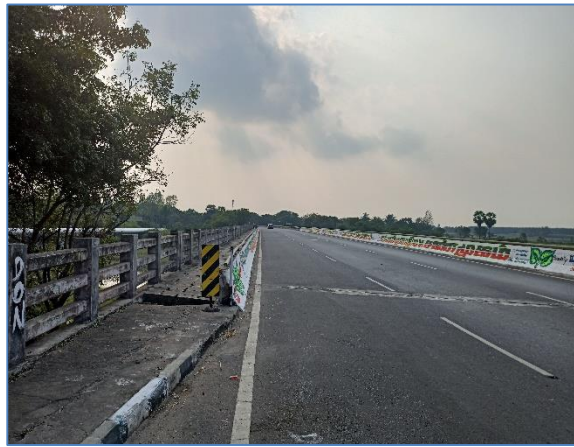
139+138 MJB (LHS)

- Cleaning required for Expansion Joints
- Bridges are constructed with Split Carriageway.
- RHS seems to be old and LHS seems to be New.
- Repairs done earlier on BHS.

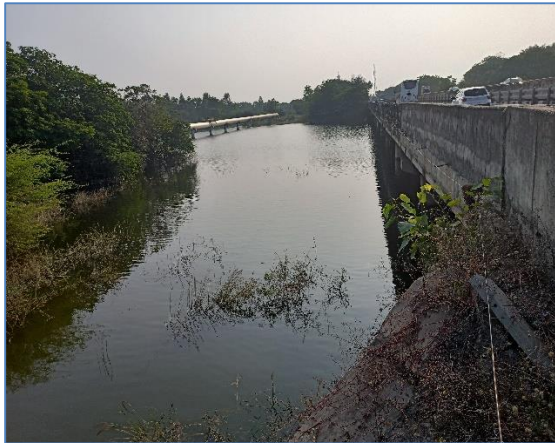
141+362 MJB (LHS)

- RHS seems to be New and LHS Seems to be old.
- Fair condition.

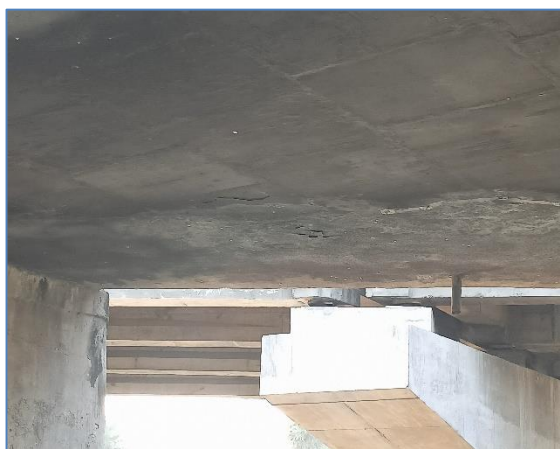
149+933 MJB (LHS)

- Leaching observed on entire deck of bridge on LHS and fog seal to be applied over wearing coat as a remedy.
- LHS seems to be old and RHS seems to be New.
- Concrete spalling observed on Pier P5 on LHS.
- Partial delamination of the concrete observed in span 1,2 &3.

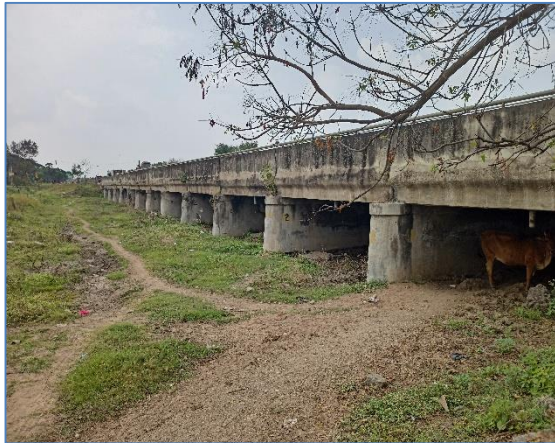
158+193 MJB (LHS)

- Foot path damaged in RHS
- LHS seems to be old and RHS Seems to be New
- Fair condition.

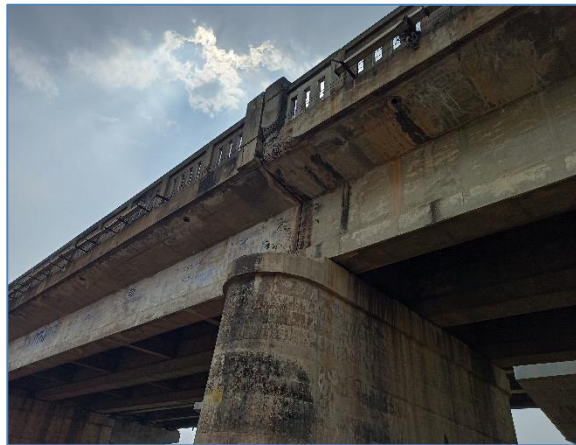
171+728 MJB (LHS)

- Corrosion Strains are observed in RHS
- Concrete spalling and reinforcement exposure observed on Hand railing - LHS
- Reinforcement exposed at slab and piers (P4 - P9 & P13 -P21) on LHS and Slab reinforcement exposed in span -1 on RHS.
- Spalling of concrete observed in girders of span-1 on LHS.
- Spalling observed at dirt wall junction on RHS.

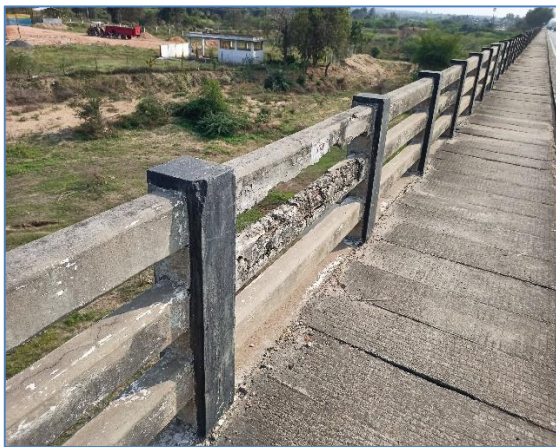
186+614 MJB (LHS)

- Corrosion Strains Are Observed in the Girder Soffit Level at RHS
- Reinforcement exposed in pier cap (P4) on LHS.
- Reinforcement exposure and minor cracks observed at girder resting portions at P5 & P9 locations.
- Foot path damaged.
- Cracks and spalling observed on Hand railing on LHS.

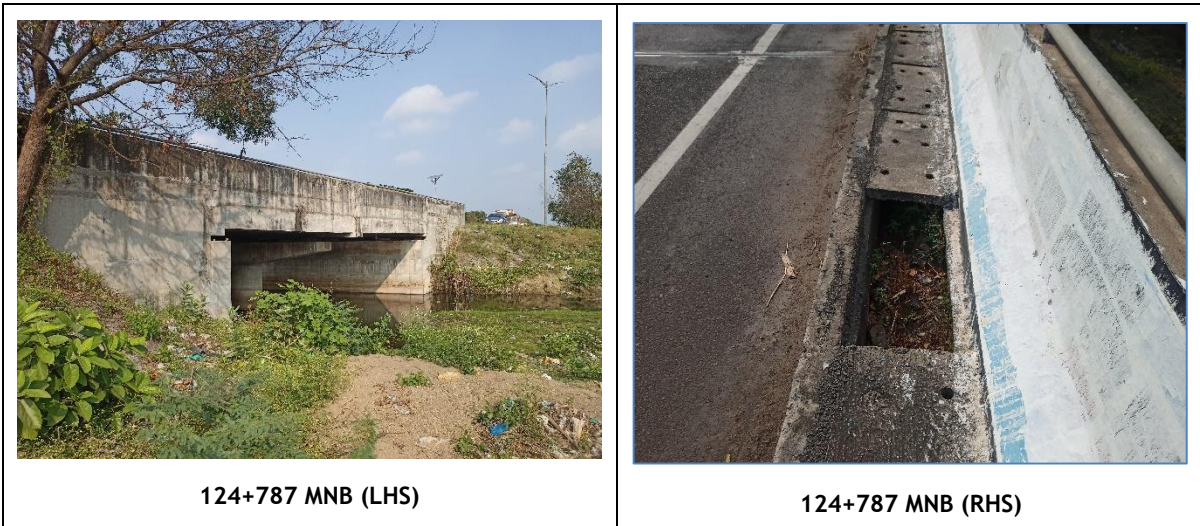
124+787 MNB (LHS)

- By Visual observation Condition is good.
- Footpath slab damaged on RHS.

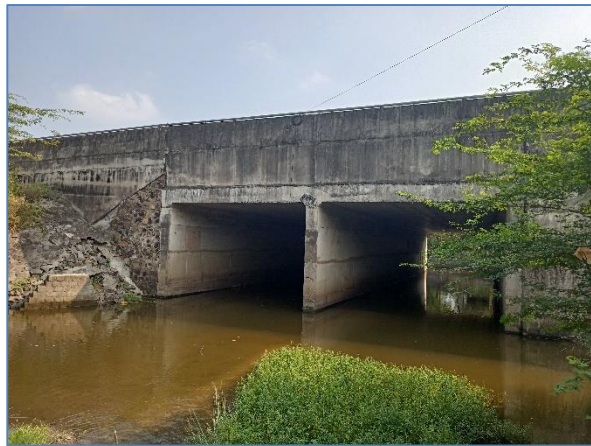
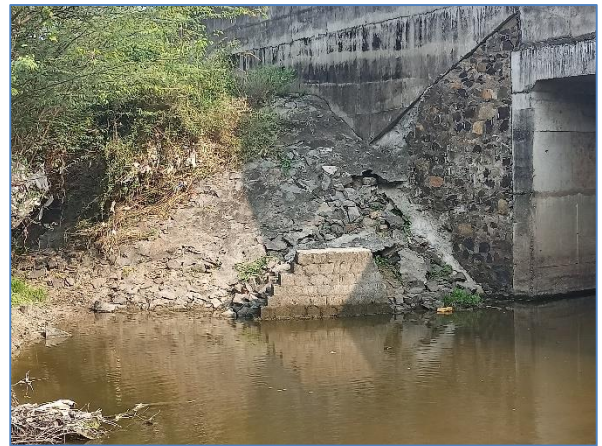
125+725 MNB (LHS)

- Quadrant pitching damaged on RHS.
- By Visual Observation Structure seems to be Good Condition

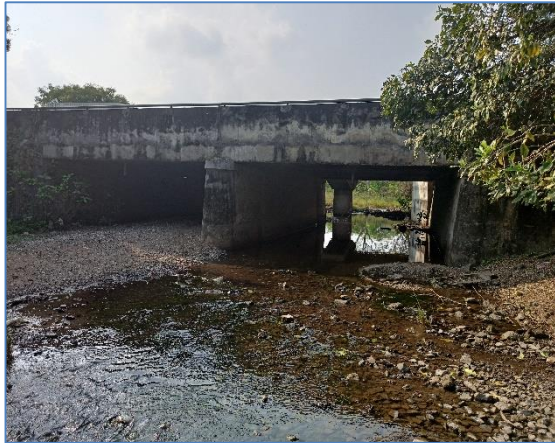
127+510 MNB (LHS)

- LHS seems to be old and RHS Seems to New.
- Quadrant pitching damaged on RHS.

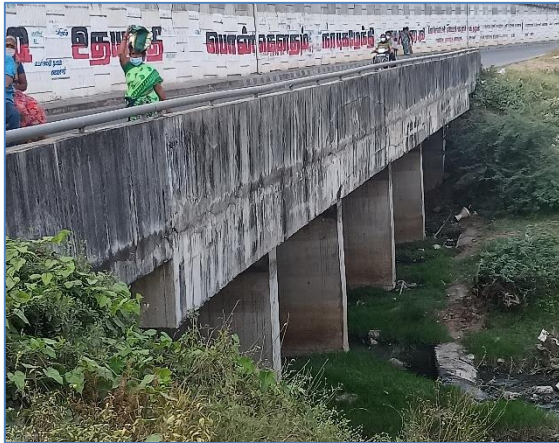
151+083 MNB (LHS)

- Honey comb observed at the top slab.
- Repair works done and It appears that it is in good condition.

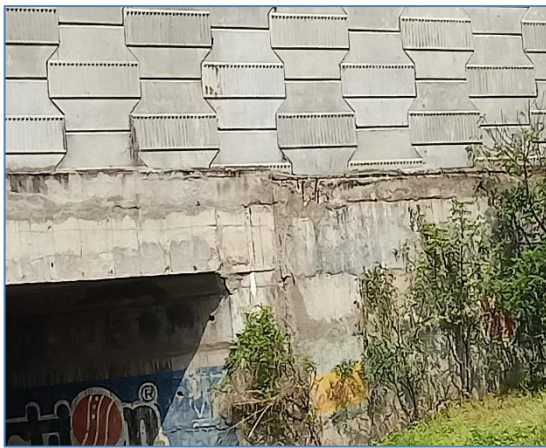
157+725 MNB (LHS)

- It comes under approach of ROB
- Retaining wall reinforcement exposed on LHS.
- Reinforcement exposed at 3rd intermediate wall.

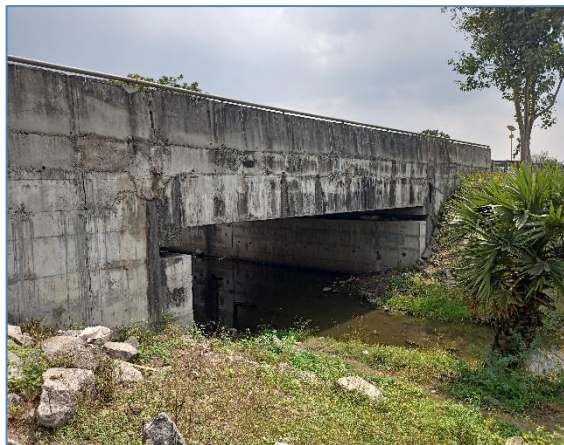
164+235 MNB (LHS)

- Expansion joint concrete damaged at EJ-1 location on RHS.
- Reinforcement exposed in median for small portion where Median is open to sky.
- Small portion of Stone pitching damaged on RHS.

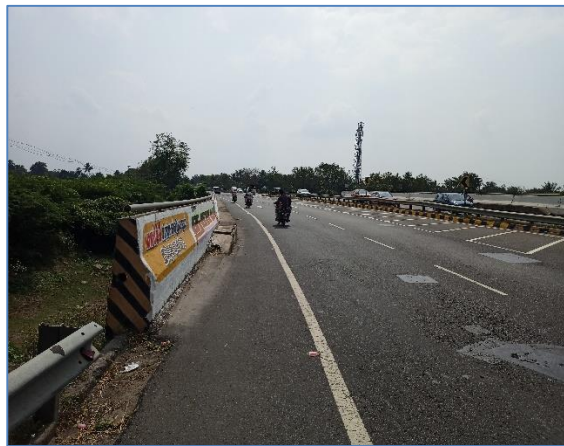
170+950 MNB (LHS)

- Overall condition good.
- Cleaning of Drainage Spouts is required.

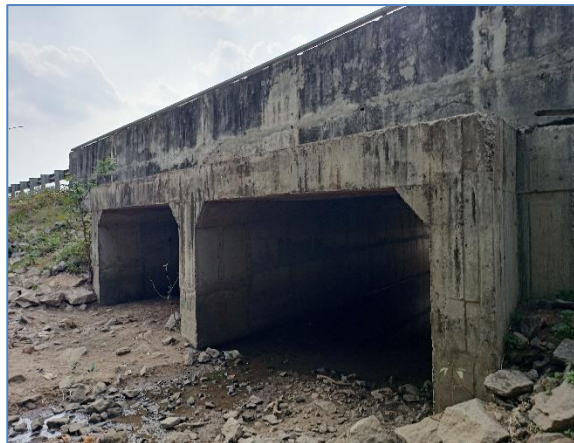
175+280 MNB (LHS)

- Reinforcement is exposed in pier at RHS.
- Reinforcement exposed at the joints in abutment.

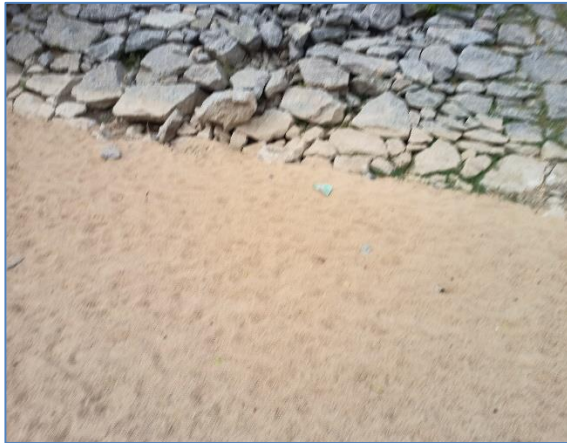
176+120 MNB (LHS)

- Portion of the Quadrant pitching damaged on LHS.
- Structure is good in condition.

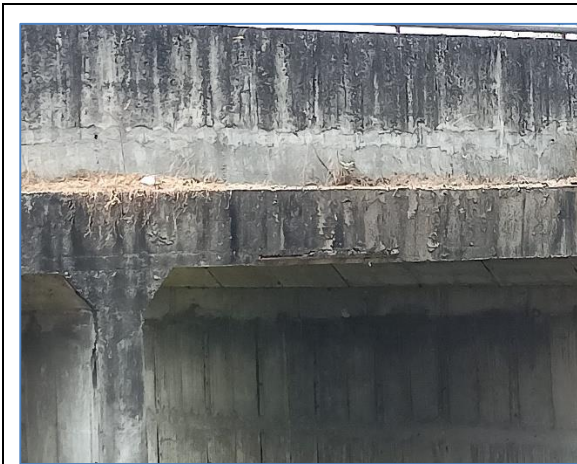
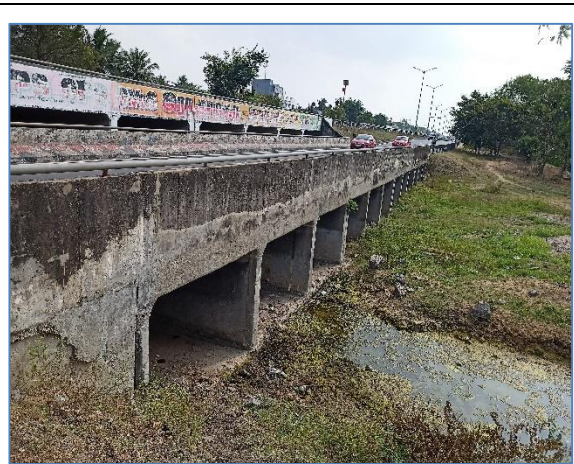
176+165 MNB (LHS)

- Cleaning of Drainage spouts is required.
- Reinforcement exposed on top slab on LHS.

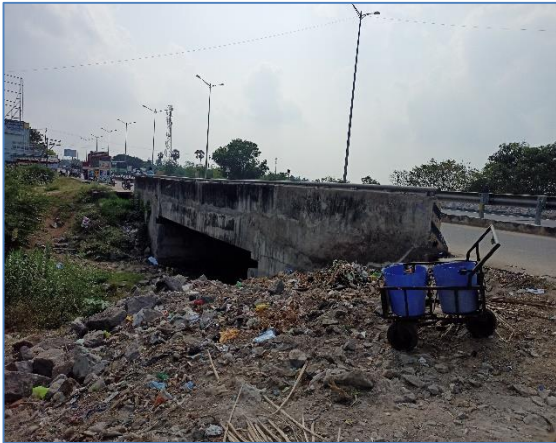
176+415 MNB (LHS)

- Stone pitching damaged on LHS.
- Reinforcement exposed at face of the slab on LHS.

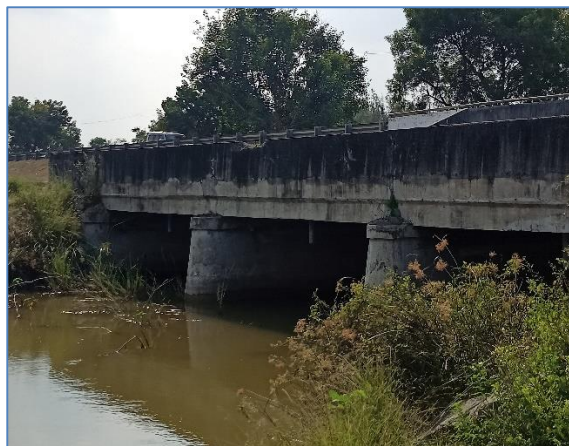
184+054 MNB (LHS)

- repair works done already done, the Condition of Bridge is Good.

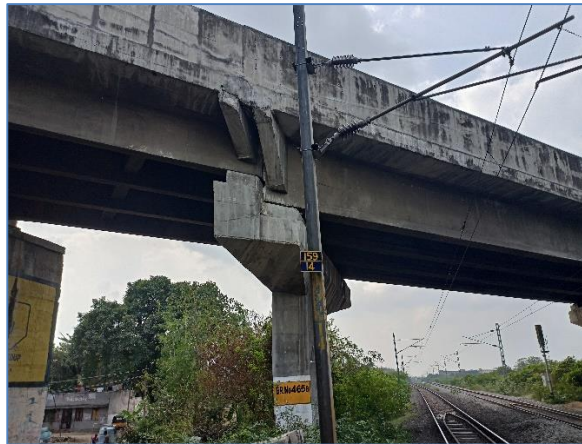
157+433 ROB (LHS)

- ROB on RHS is old ROB and it is under railway maintenance. Concessionaire paying the maintenance fee. ROB on LHS is constructed and maintained by Concessionaire
- Minor damage in Mid span end girder resting portion is noticed.
- Reinforcement Exposed near the Cantilever Portion of 1 m² and Abutment for 0.5 m² - RHS
- Wing wall damaged on RHS.
- Cleaning of Expansion joints is required

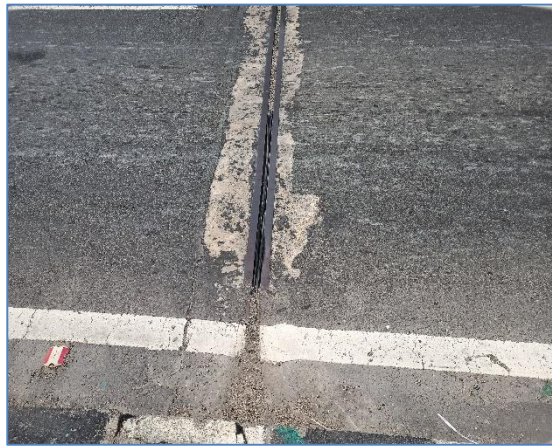
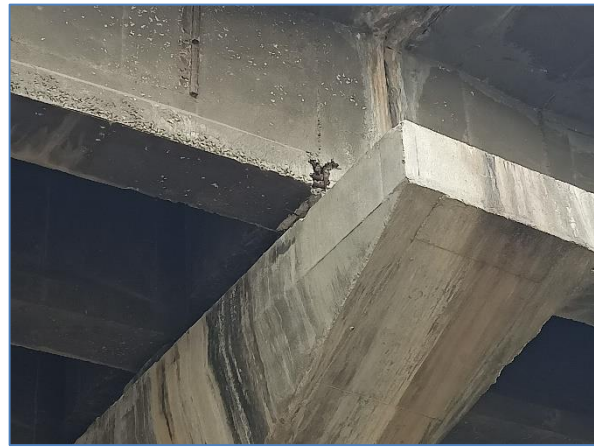
163+220 ROB (LHS)

- Cleaning of Expansion Joints is required.
- Leakage through expansion joints observed.
- Reinforcement exposed in pier cap on RHS for small length.
- Rubber sealant damaged at EJ-5 on LHS.
- Spalling and reinforcement exposure observed on soffit of the slab at P3 location on LHS.

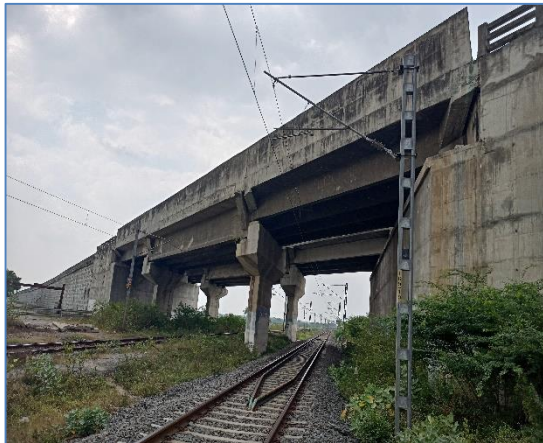
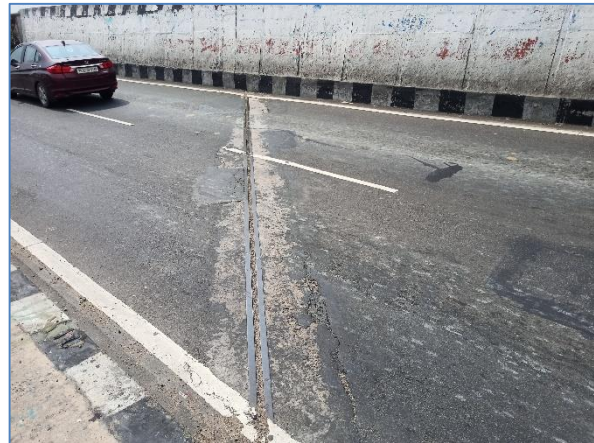
167+660 ROB (LHS)

- Cleaning of Drainage spout and Expansion Joints is required.

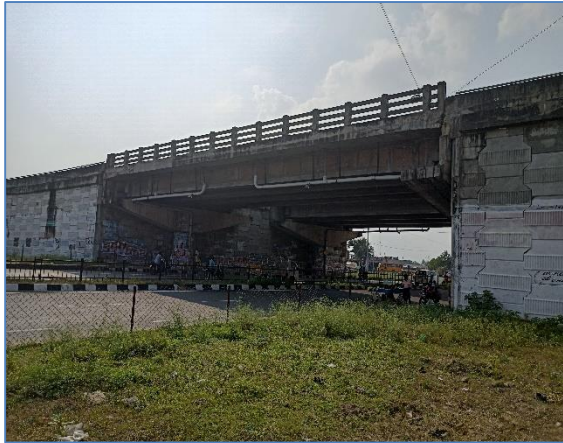
123+883 GRADE SEPERATOR (LHS)

- Approach of Grade Separator is in Curvilinear.
- By Visual observation seems to New.
- Fair condition.

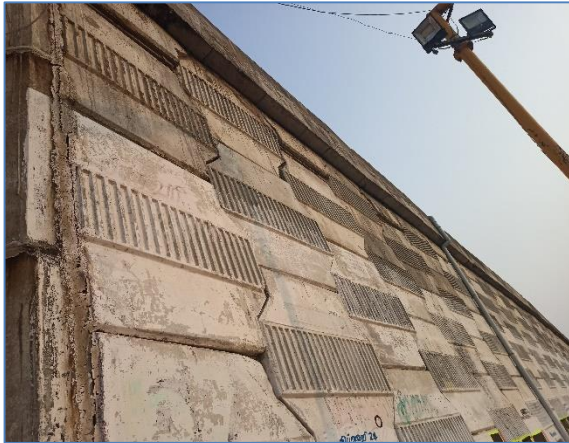
151+140 VUP (LHS)

- Approach of VUP is in Curvilinear.
- By Visual observation seems to New.
- Cleaning of Expansion joint and Drainage Spout are required
- Dirt wall and crash barrier junction portion slightly damaged.
- Mild bulging in RE panels is noticed and it is understood from Concessionaire that this is there since construction and was monitored closely from then onwards and there is no further deterioration observed.
