**Re: Submission of Final Report of Technical due diligence study for the project "Godhra Expressway Private Limited (GEPL)".**

**Technical Diligence for 4 Laning of  
Godhra-Gujarat/ Madhya Pradesh  
border Section of NH-59 from km  
129.300 to km 215.900 in the State of  
Gujarat**

**For Virescent Infrastructure Investment  
Manager Private Limited (For the purpose of  
Highways Infrastructure Trust)**

**FINAL REPORT**

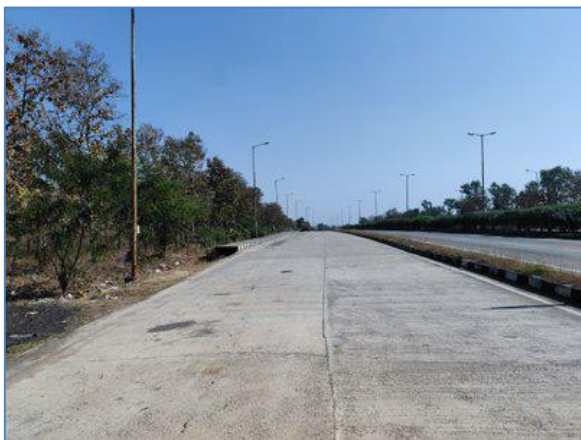
Truck Lay bye on LHS km 134.400

The Project Road has six Truck lay byes, two each at km 134.400, km 157.800 & km 190.500. These truck lay byes have been provided with rigid Pavement and the condition appears to be good. Few photos depicting the truck lay bye portion are presented below:

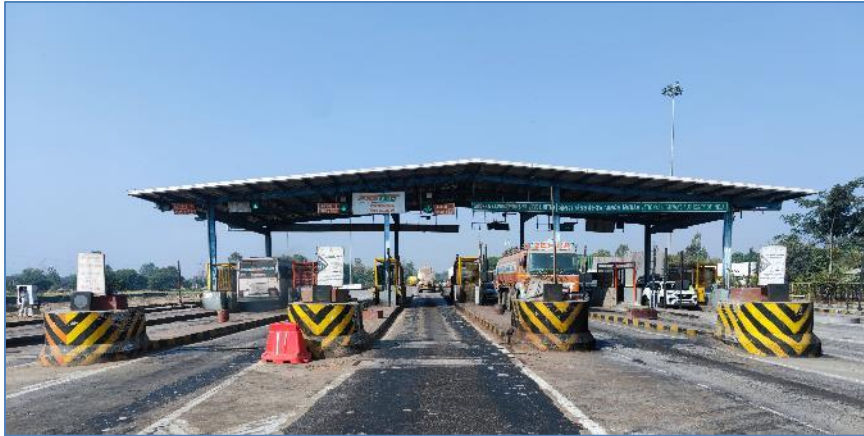
Toll Plaza near km 146.150

The Project Road has one Toll Plaza at km 146.150. Rigid pavement exists in the toll plaza as well as in tapering portions. The condition of toll plaza appears to be good. There are three normal lanes and one extra wide lane in each direction. One more extra lane is observed for 2-wheeler & 3-wheeler on both sides. 4 numbers of High mast lighting has been provided at Toll plaza location and on the approach to Toll plaza, double arm lighting has been provided on median.

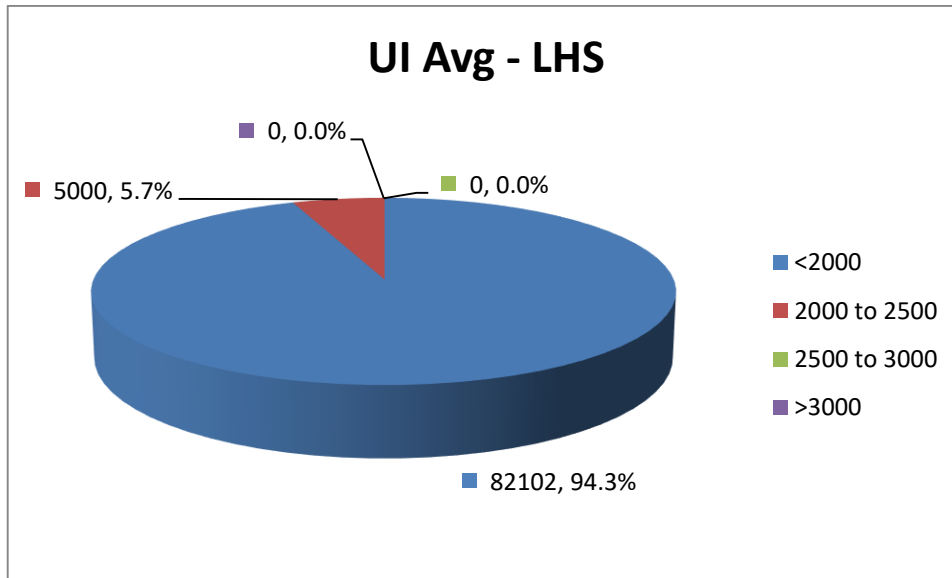
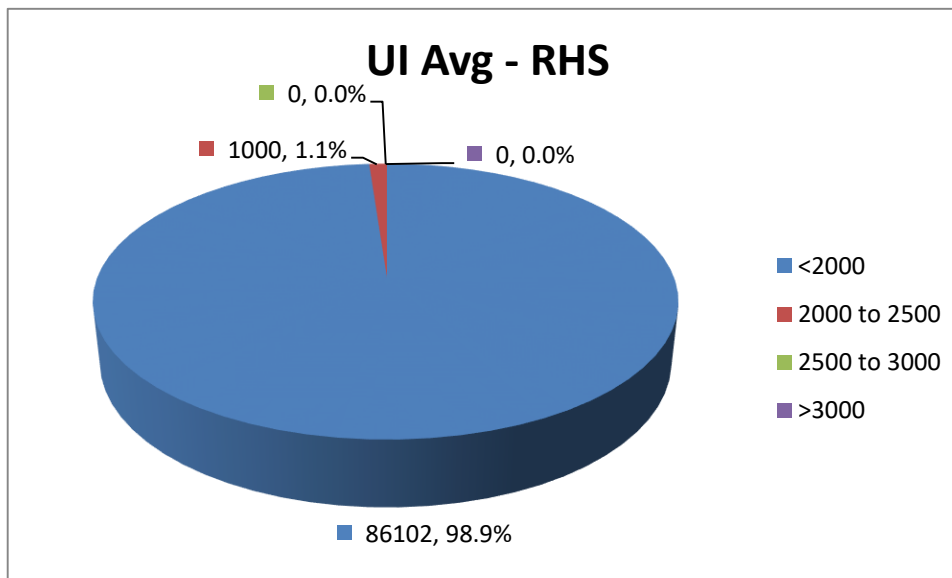
It can be seen from the above pie charts, that about 94.3% & 98.9% length of the Project Road has good riding quality (UI<2000 mm/km) in LHS carriageway and RHS carriageway respectively.

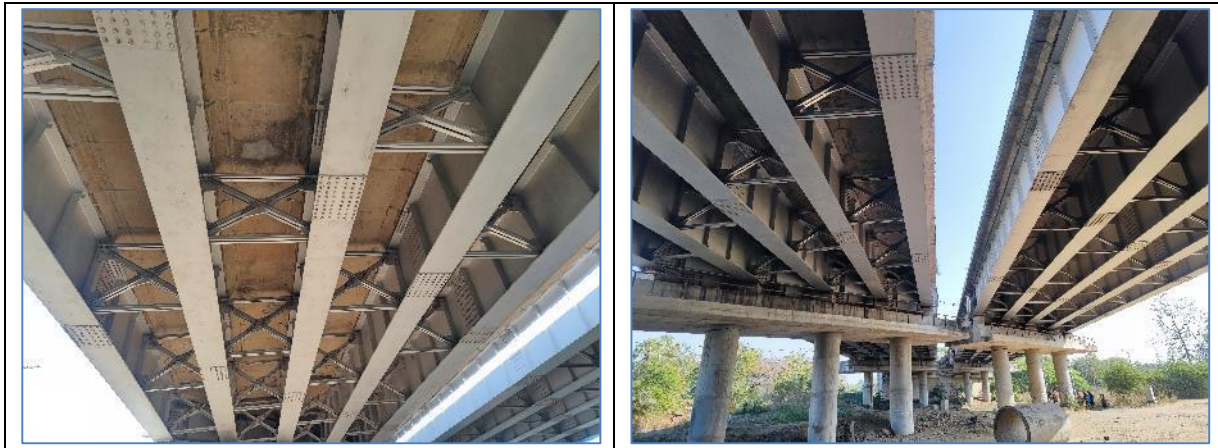
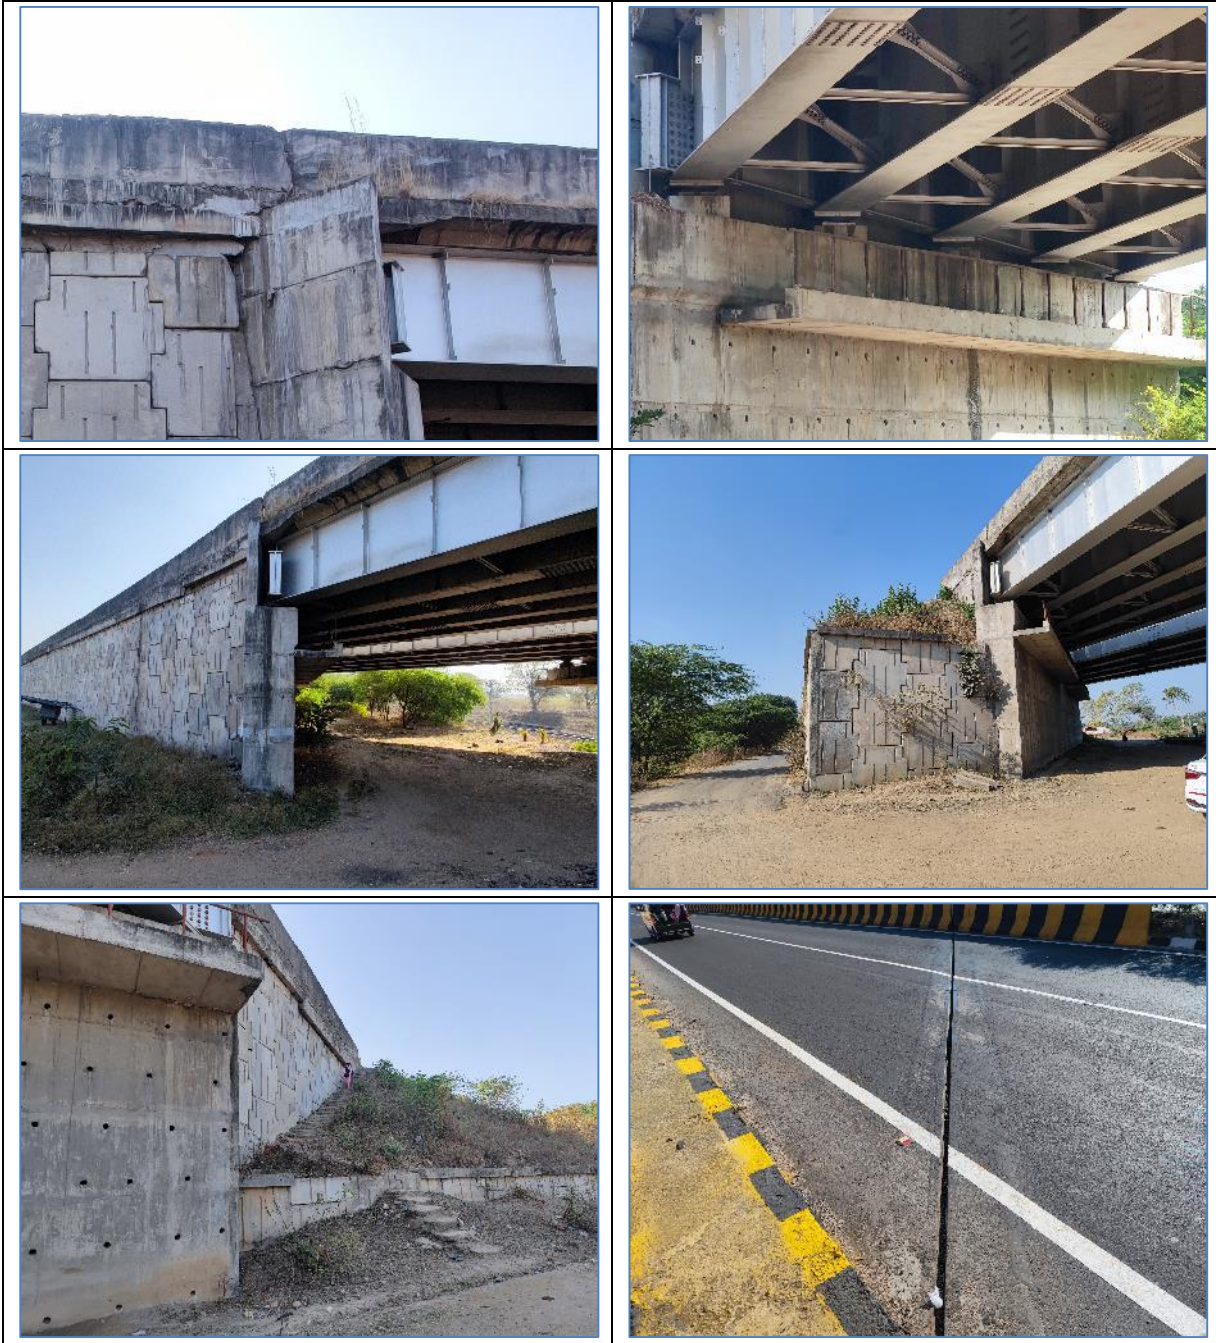
- The structure is in skew of nearly 30 degrees.
- RCC crash barrier is provided is in good condition.
- Stone pitching is provided on abutment location quadrant slopes is in good condition.

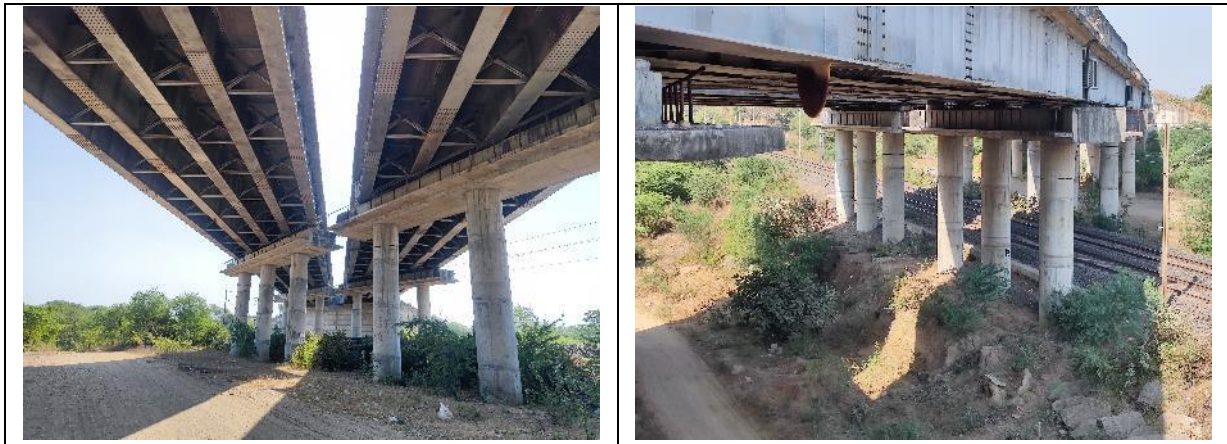
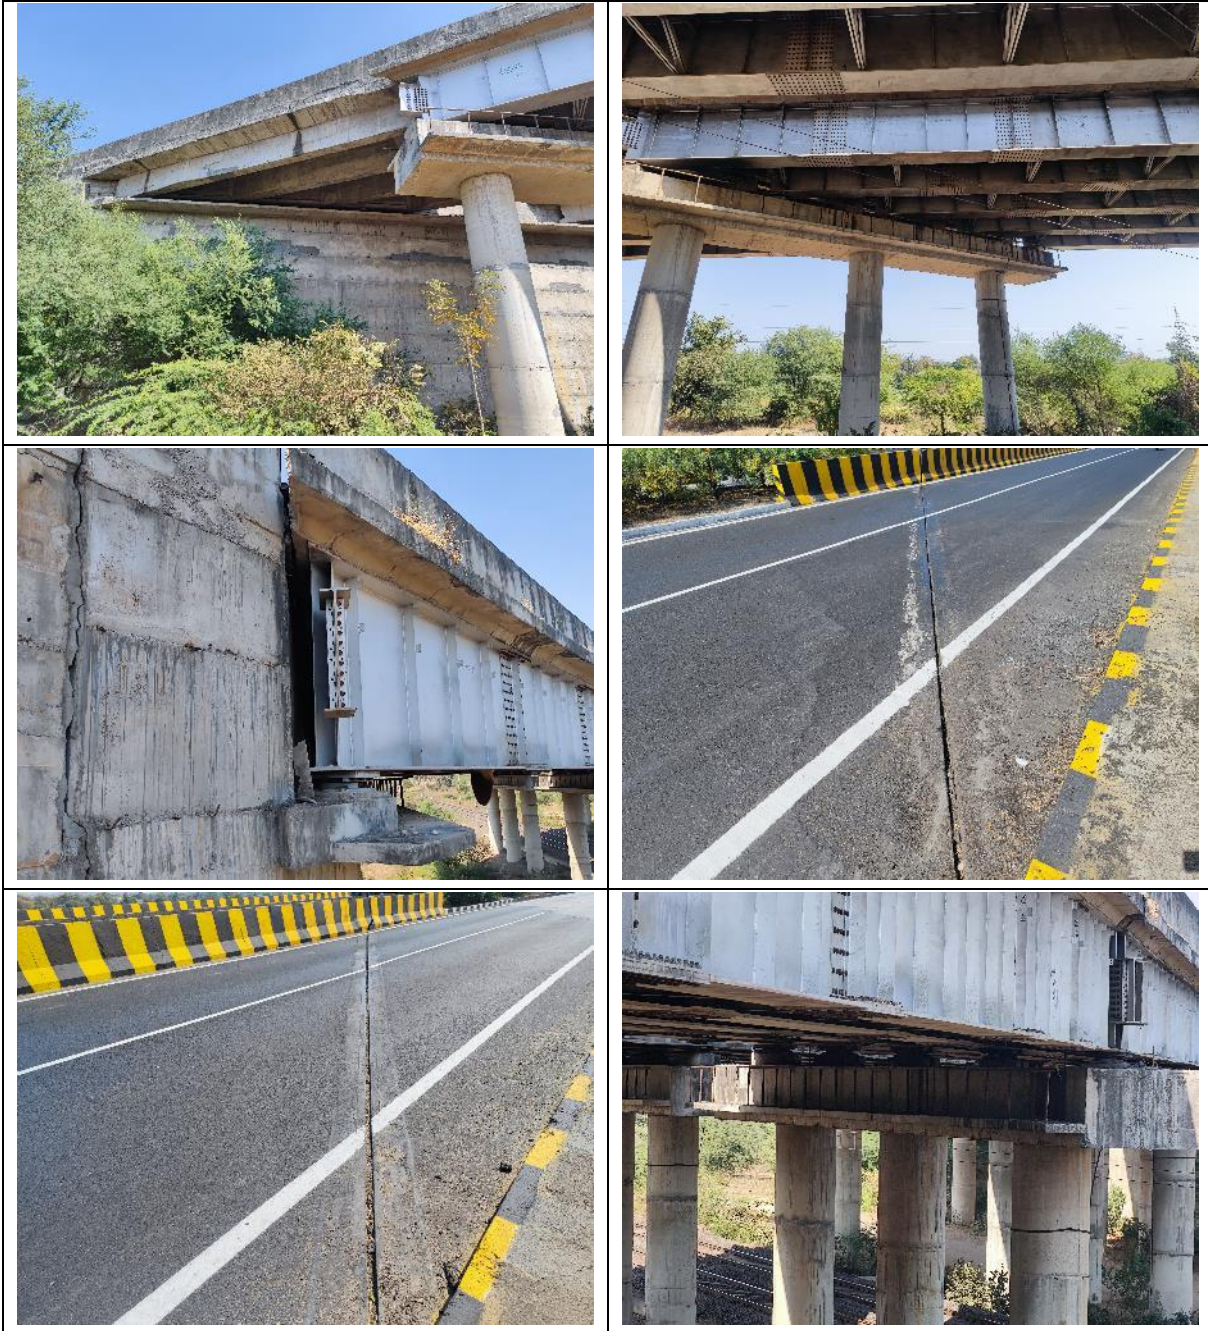
**BR. NO. 144+827 (ROB)**

- The bridge is in skew of nearly 35 degrees.
- Corrosion stains observed on pier cap and bottom of girders at BHS.
- RCC crash barrier is provided is in good condition.
- Fly wings provided on abutment location quadrant slopes are in good condition.

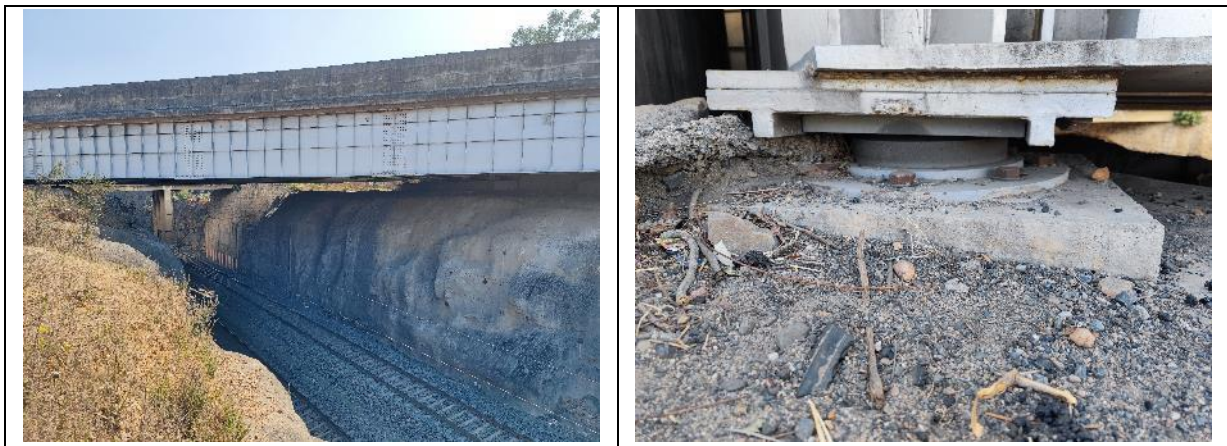
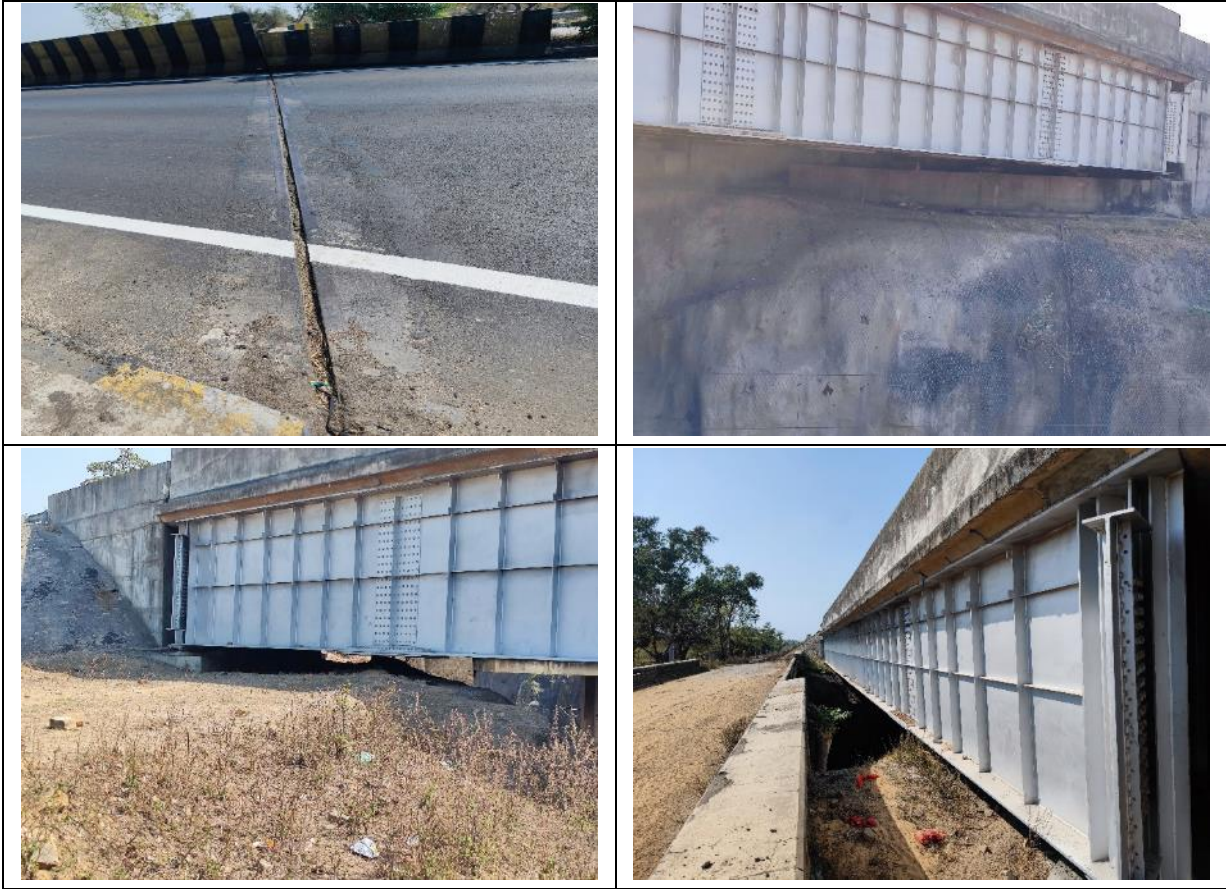
**BR. NO. 167+324 (ROB)**

- The bridge is in skew of nearly 20 degrees.
- Abutments are in good condition.
- Steel Girders are in good condition.
- Stone pitching is provided on abutment location quadrant slopes is in good condition

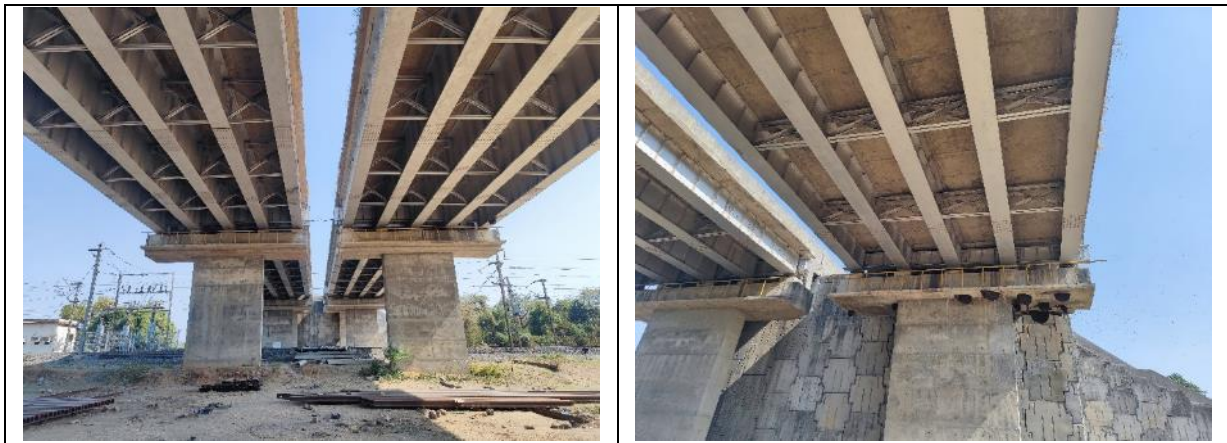
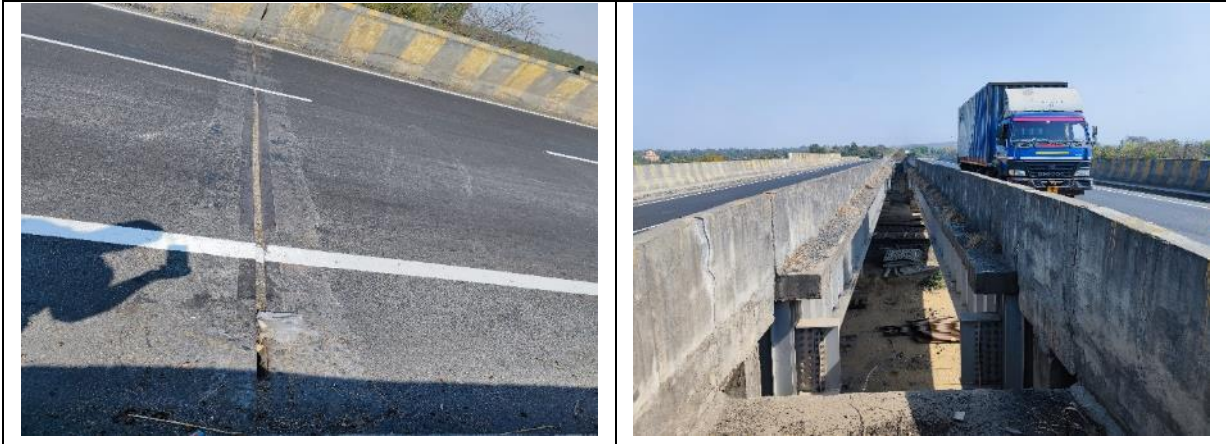
**BR. NO. 171+300 (ROB)**

- As per Schedule 2 ROB's at chainage specific ch:- 171+320 & 171+430 but As per site observations we found only one ROB at ch:- 171+320 with spans deviation.
- Abutments and piers are in good condition.
- Top slab is in good condition.
- RCC crash barrier is provided is in good condition.
- Wing wall provided on abutment location quadrant slopes is in good condition
- Sealant damaged in Expansion joint at some locations.

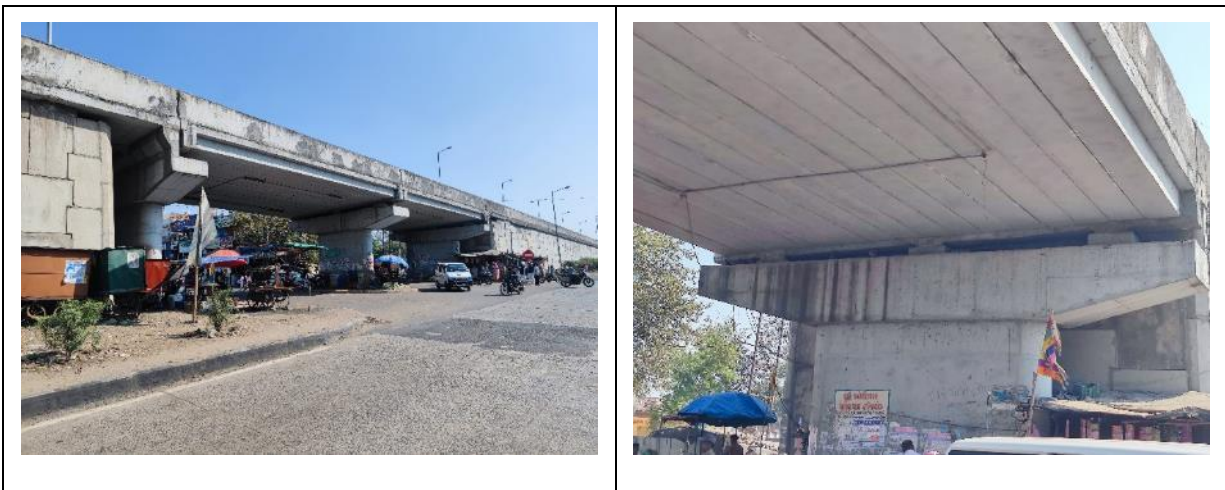
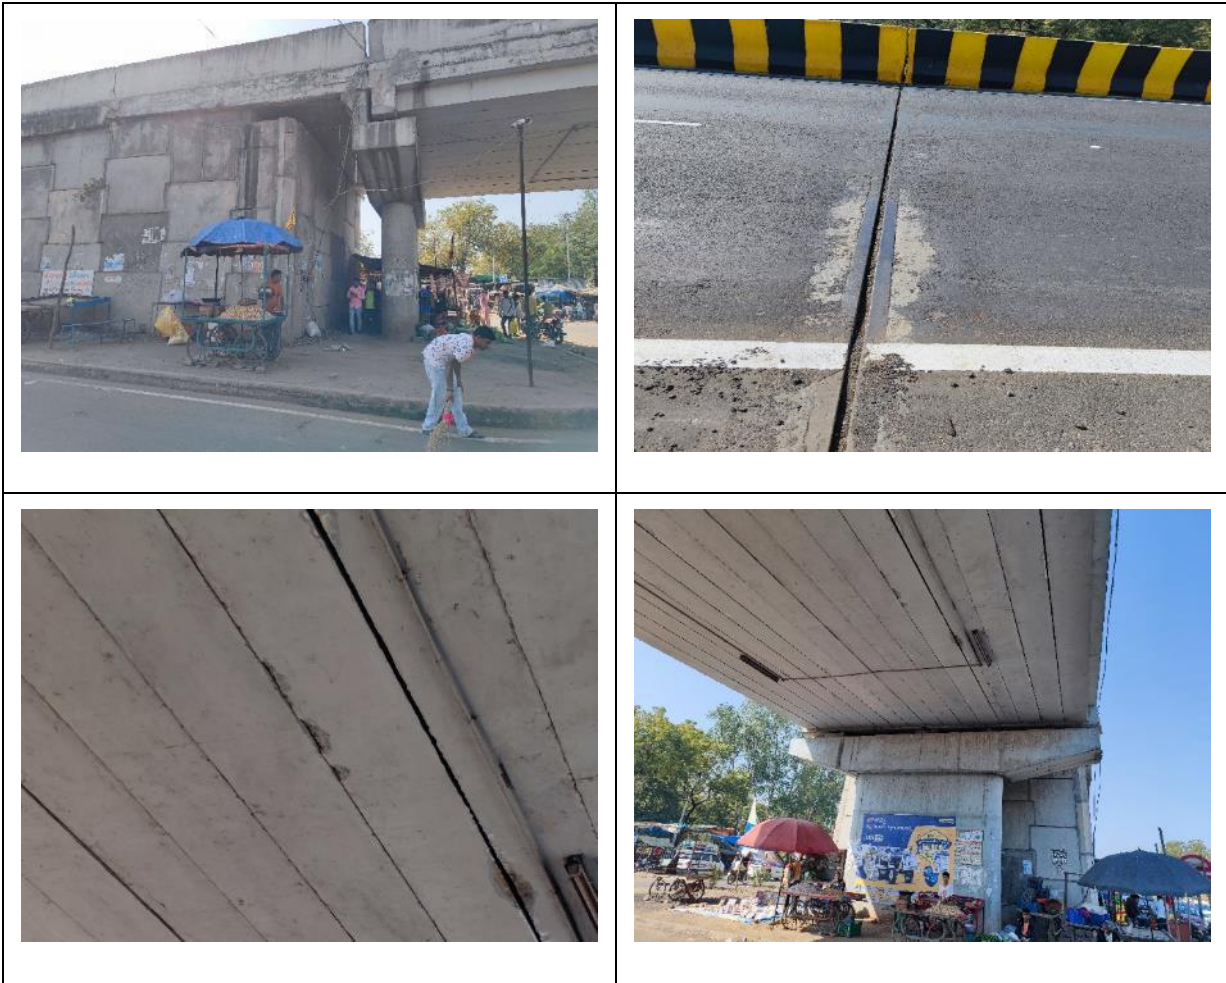
**BR. NO. 141+526 (Flyover)**

- RE walls and side walls are in good condition.
- Damp spots observed on bottom of RCC Precast Panels.
- RCC crash barrier is provided is in good condition.

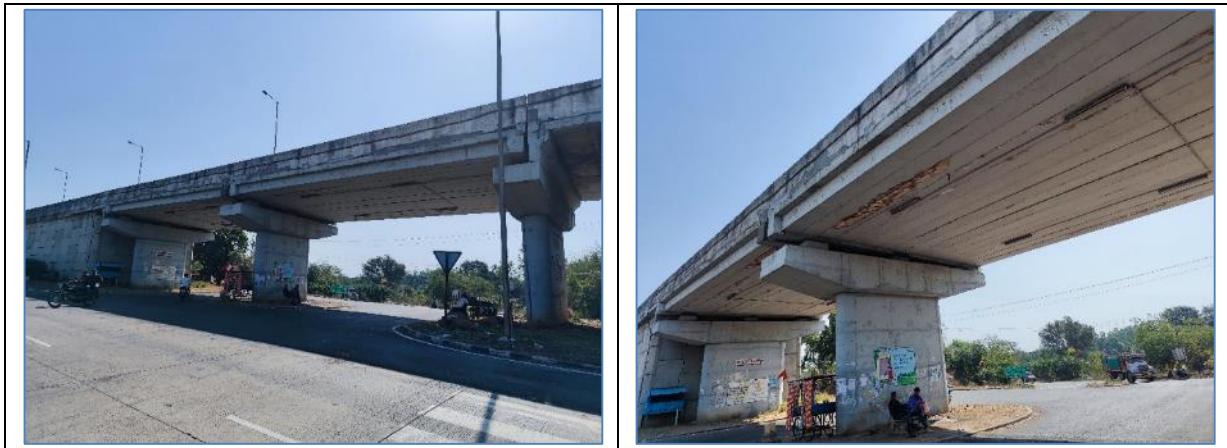
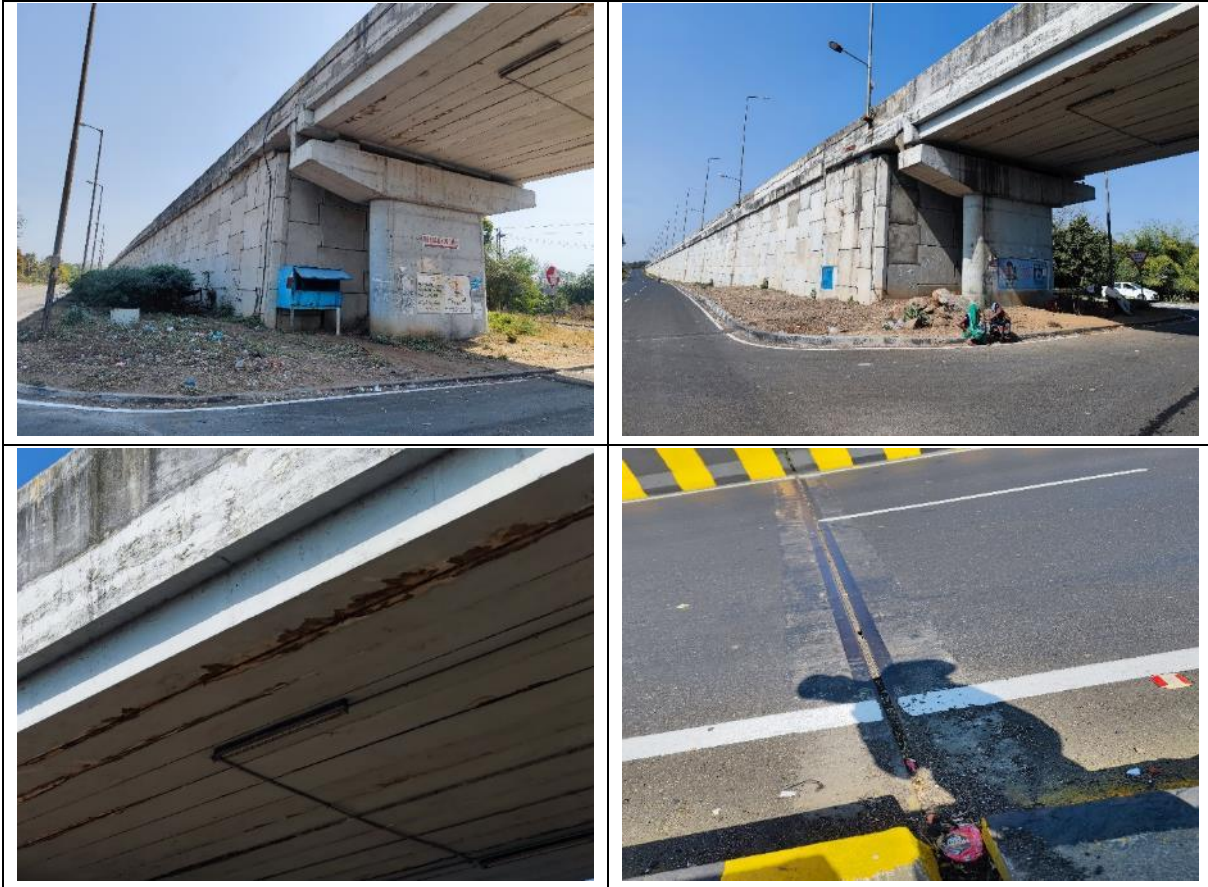
**BR. NO. 147+445 (Flyover)**

- RE walls and side walls are in good condition.
- Damp spots observed on bottom of RCC Precast Panels.
- Minor Honey combing observed on diaphragm.
- Strip seal damaged in Expansion joint at some locations.
- RCC crash barrier is provided is in good condition.

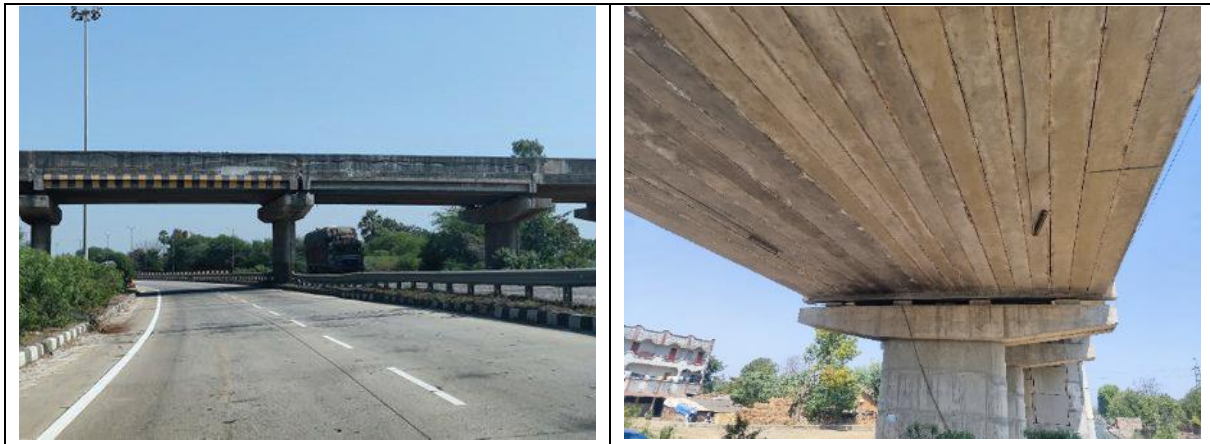
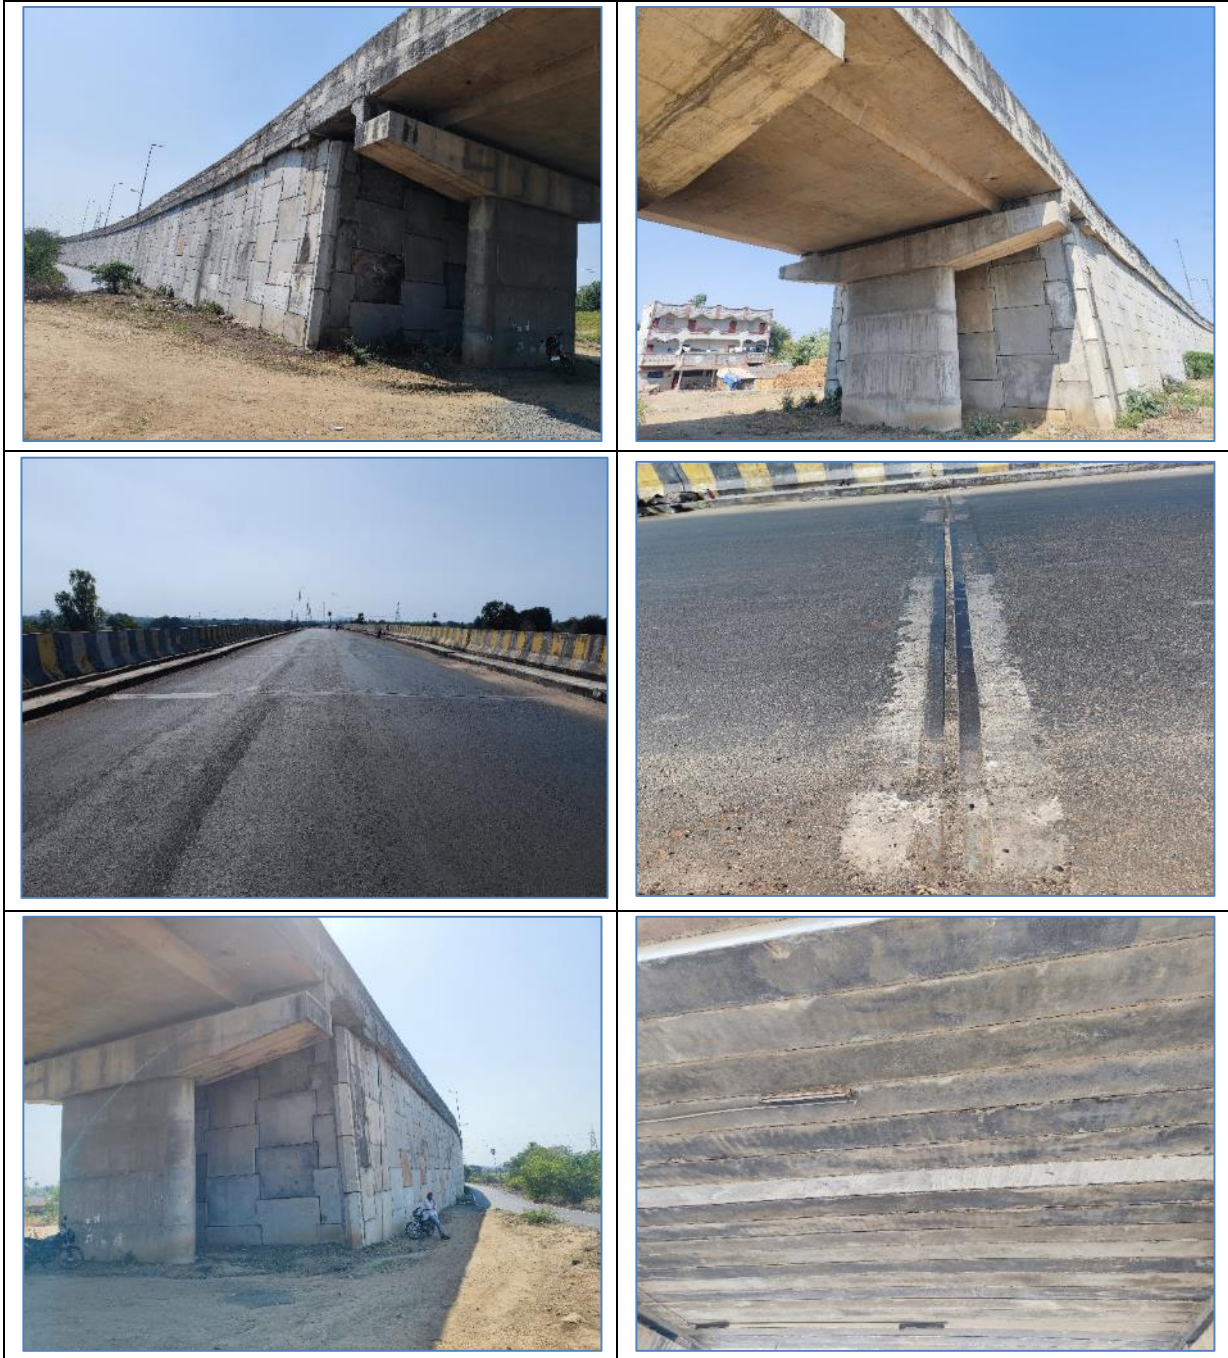
**BR. NO. 153+966 (Overpass)**

- RE walls are in good condition.
- Pedestal and panel damaged at some locations observed at LHS & RHS.
- Damp spots observed on bottom of RCC Precast Panels.
- Honey combing observed on dirt wall, diaphragm and pier cap.
- RCC crash barrier is provided is in good condition.

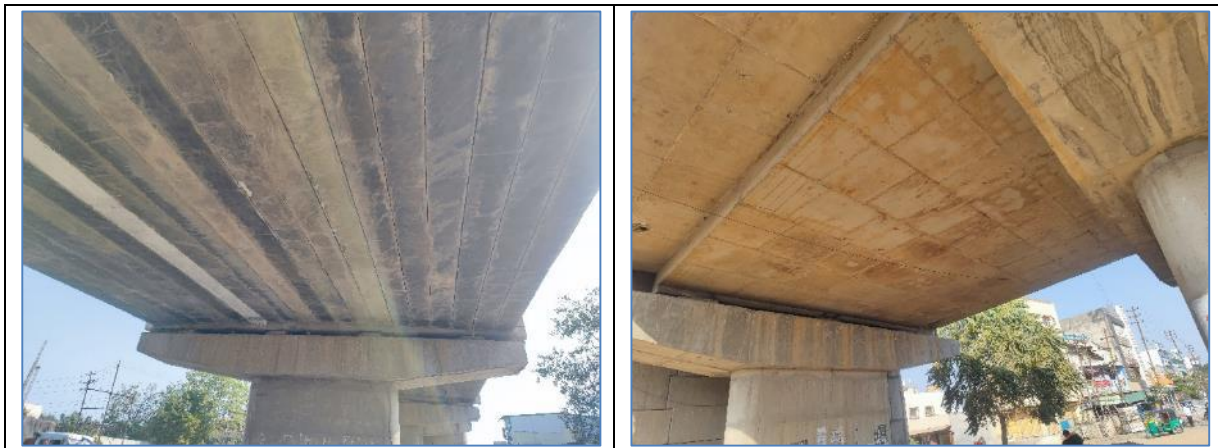
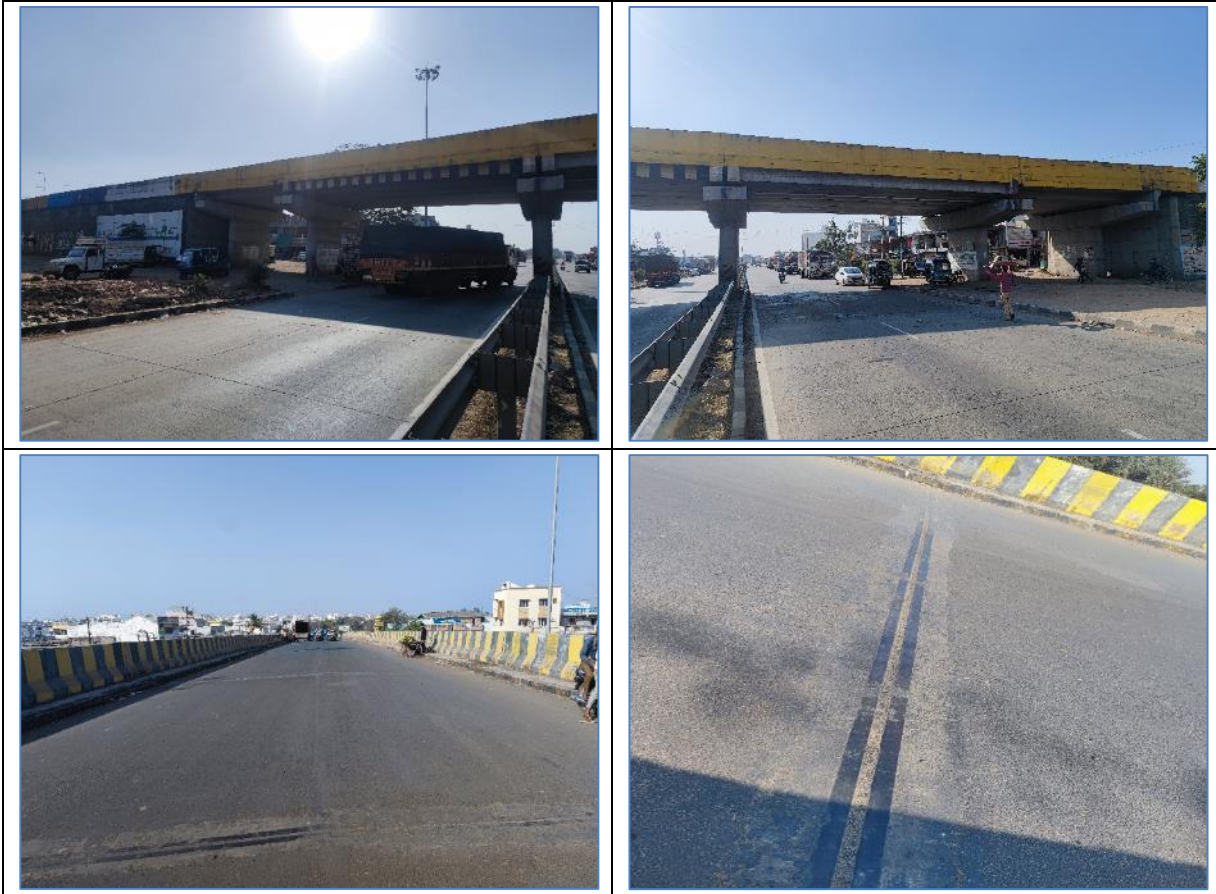
**BR. NO. 194+098 (Overpass)**

- RE walls are in fair condition.
- Minor Honey combing on median pier
- RCC Solid Girders are in good condition and minor damp spots are observed in RCC Precast Panels.
- RCC crash barrier is provided is in good condition.

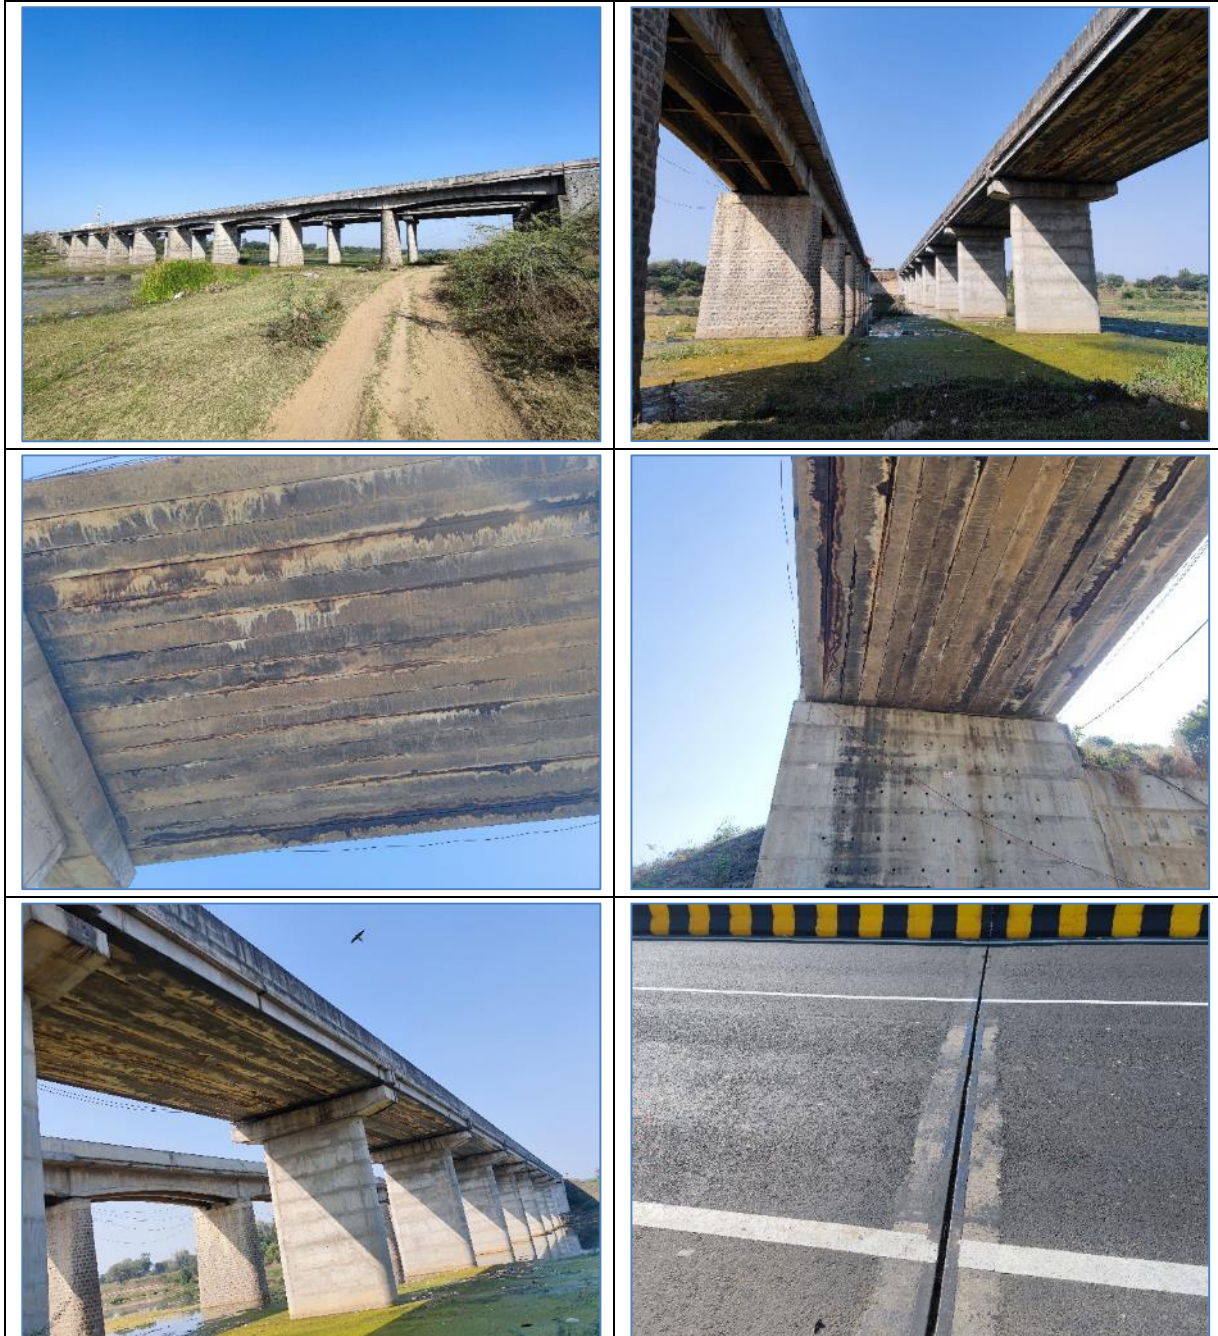
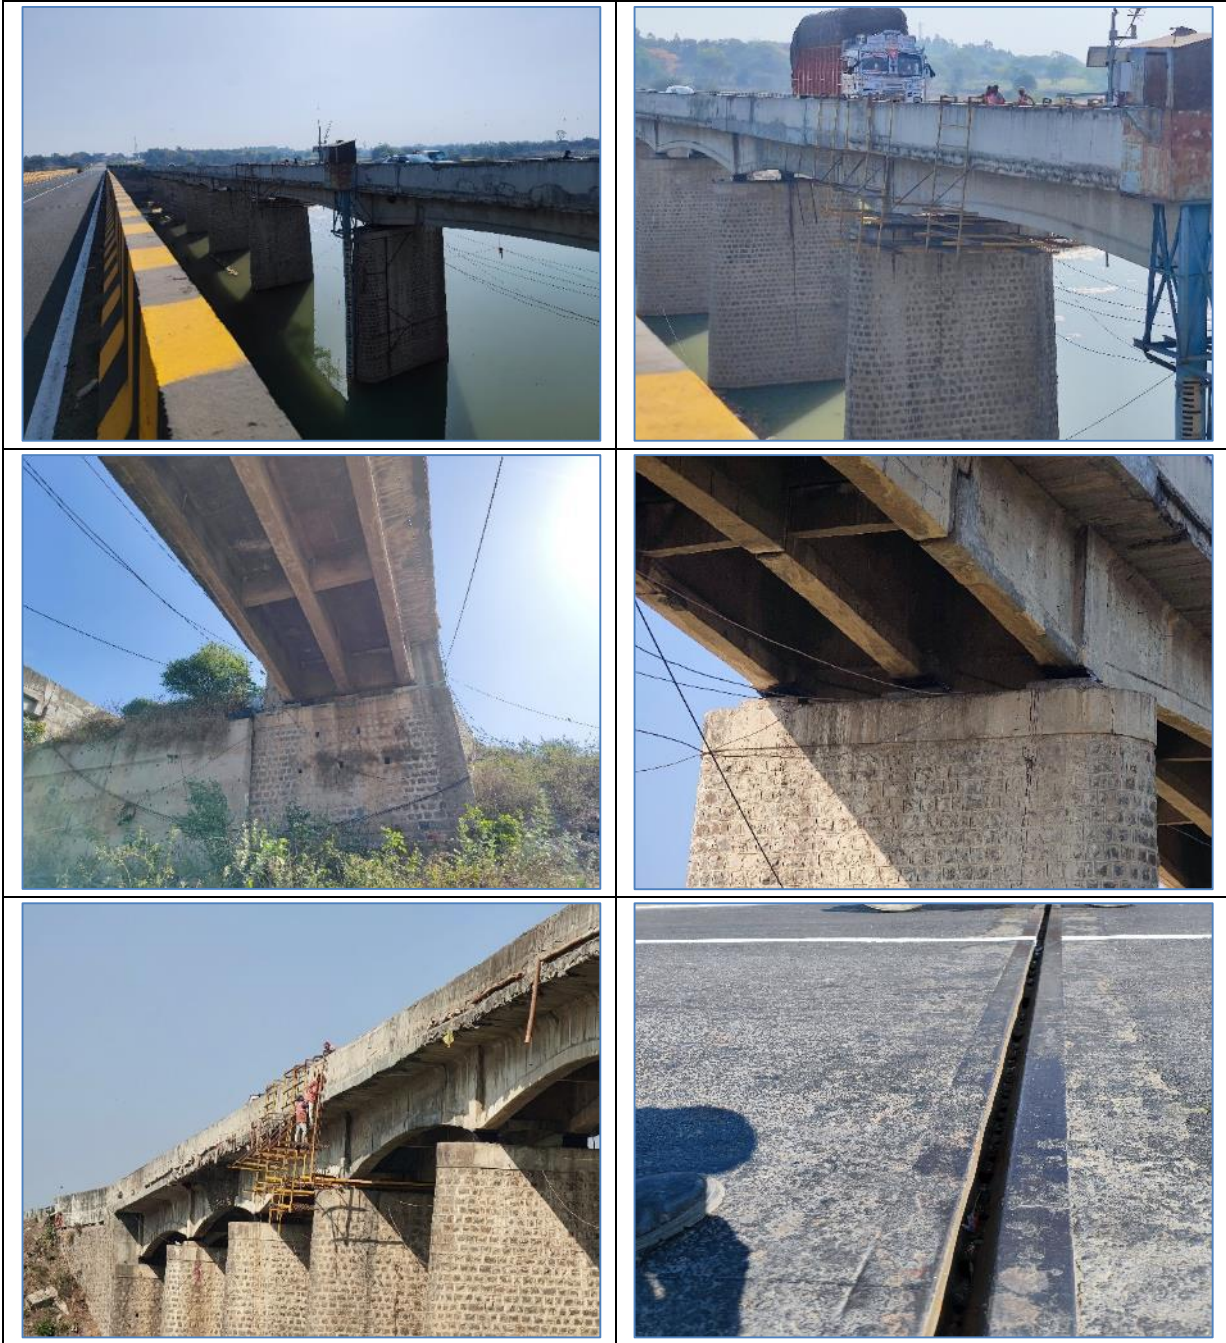
**MJB @ 140+331 (BALANCED CANTILEVER BRIDGE)**

- Reinforcement steel exposed in top slab and Girders at few locations. (Repair Work is in Progress)
- Honey combing observed on diaphragm. (Repair Work is in Progress)
- Retaining wall is in good condition.
- Side walls are in fair condition.
- Sealant damaged at some locations in Expansion joint. (Repair Work is in Progress)
- Stone pitching is provided on abutment location is in good condition.

In the absence of seismic arresters and high degradation levels shown, the performance of the bridge during seismic event is to be ascertained by appropriate inspection and testing activity.

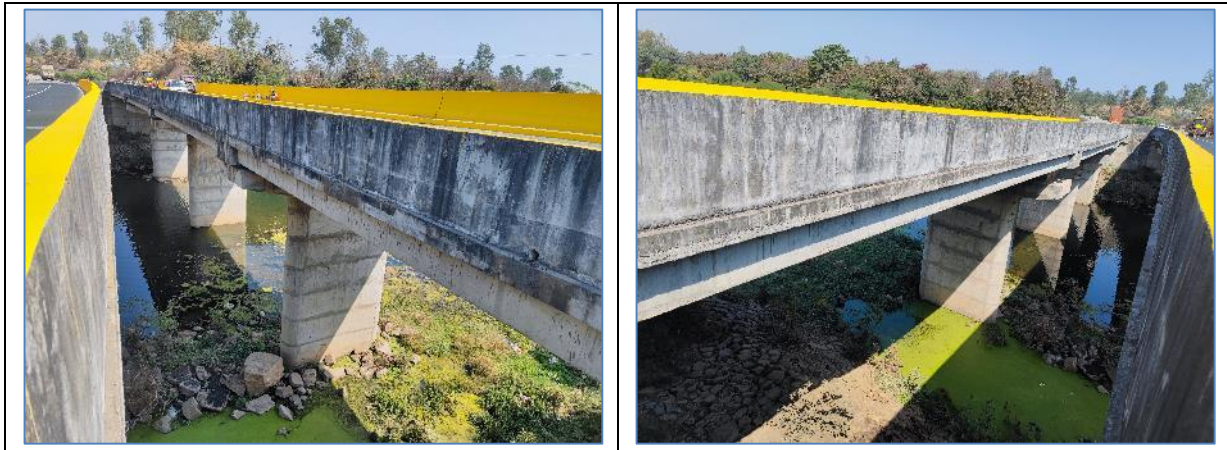
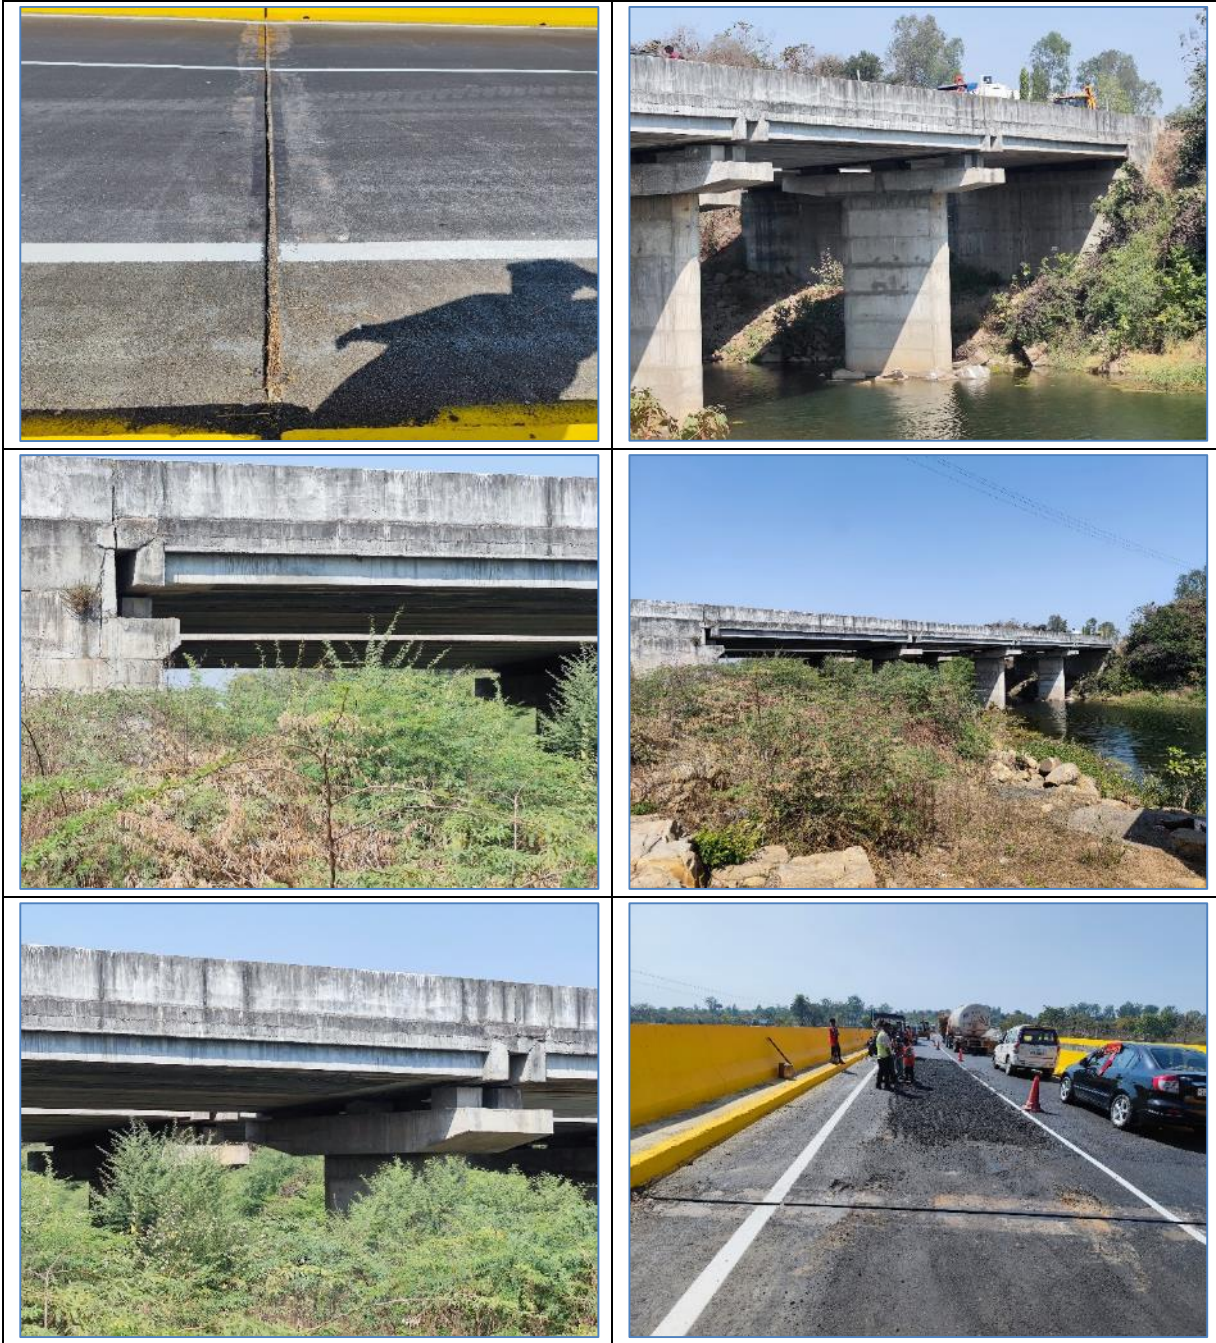
**BR. NO. 163+970 (MJB)**

- RCC precast panels are in good condition.
- RCC crash barrier is provided is in good condition.
- Minor Honey combing observed on RCC precast panels.
- Stone pitching is provided on abutment location quadrant slopes is in good condition.
- Minor Damp spots observed on bottom of RCC Precast Panels at BHS.
