**Re: Submission of Final Report of Technical due diligence study for the project "Godhra Expressway Private Limited (GEPL)".**

**Technical Diligence for 4 Laning of  
Godhra-Gujarat/ Madhya Pradesh  
border Section of NH-59 from km  
129.300 to km 215.900 in the State of  
Gujarat**

**For Virescent Infrastructure Investment  
Manager Private Limited (For the purpose of  
Highways Infrastructure Trust)**

**FINAL REPORT**

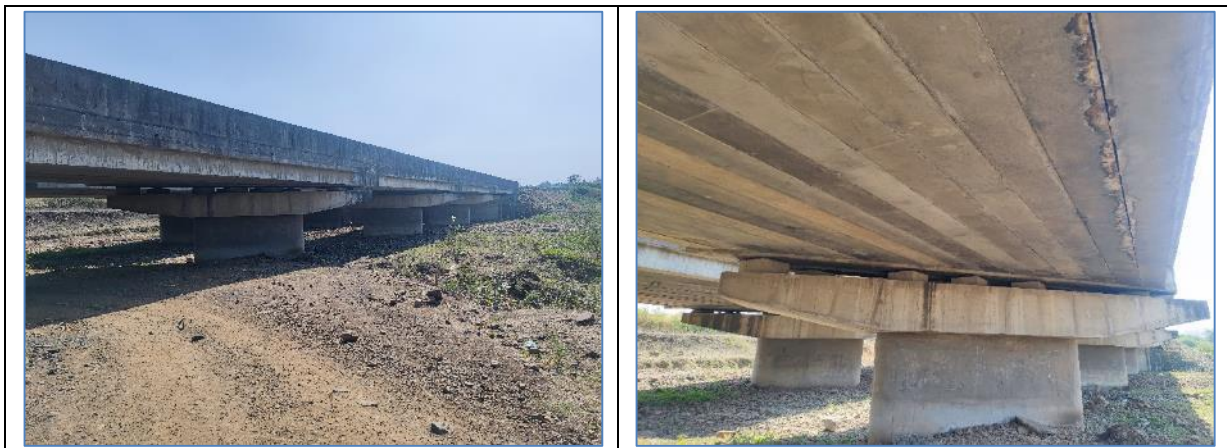
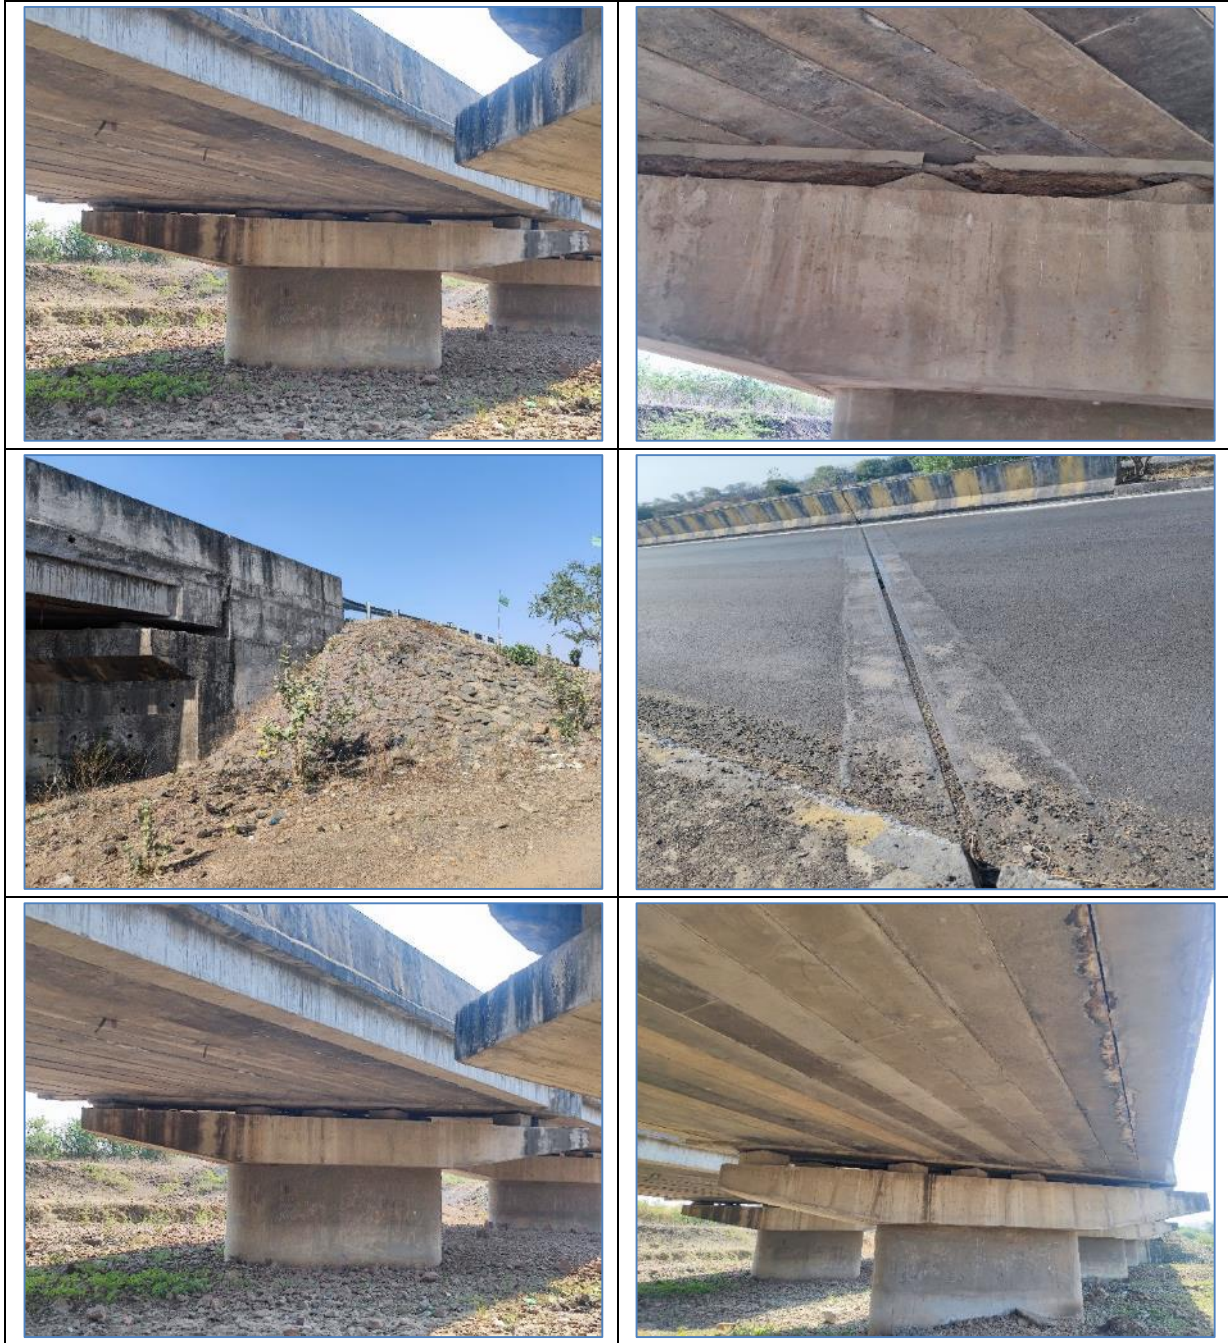
**BR. NO. 179+547 (MJB)**

- As per site Major Bridge, in schedule mentioned as Minor Bridge.
- This Bridge is in skew of nearly 15 degrees.
- Damp spots observed on bottom of RCC Precast Panels at BHS.
- Panels damage and Honey combing observed on bottom of RCC Precast Panels at some locations on RHS.
- Corrosion stains observed on bottom of RCC Precast Panels at RHS.
- Steel Exposed on bottom of RCC Precast Panels at RHS.
- RCC crash barrier is provided is in good condition.
- Stone pitching is provided on abutment location quadrant slopes is in good condition.
- Rubber sealant is damaged in some expansion joint location.

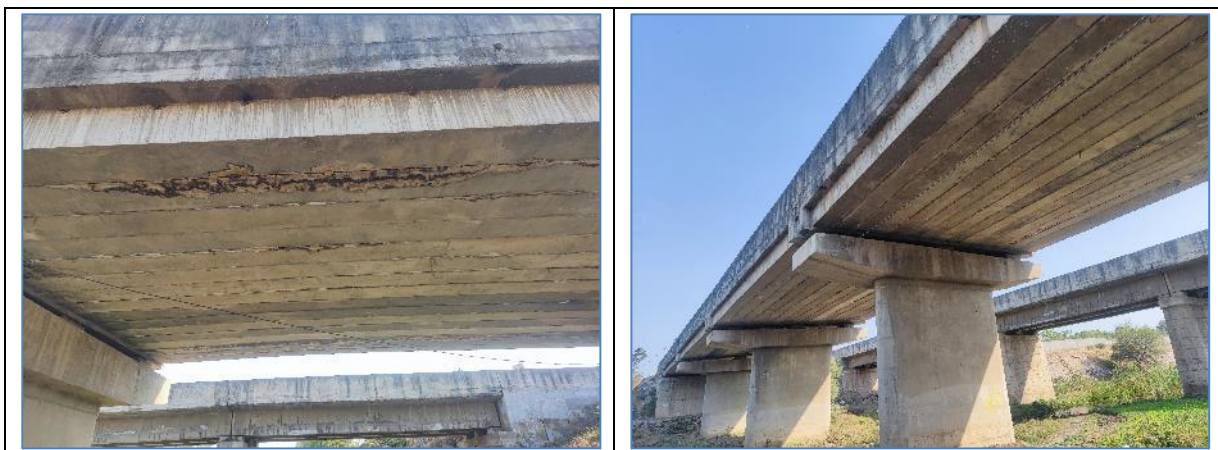
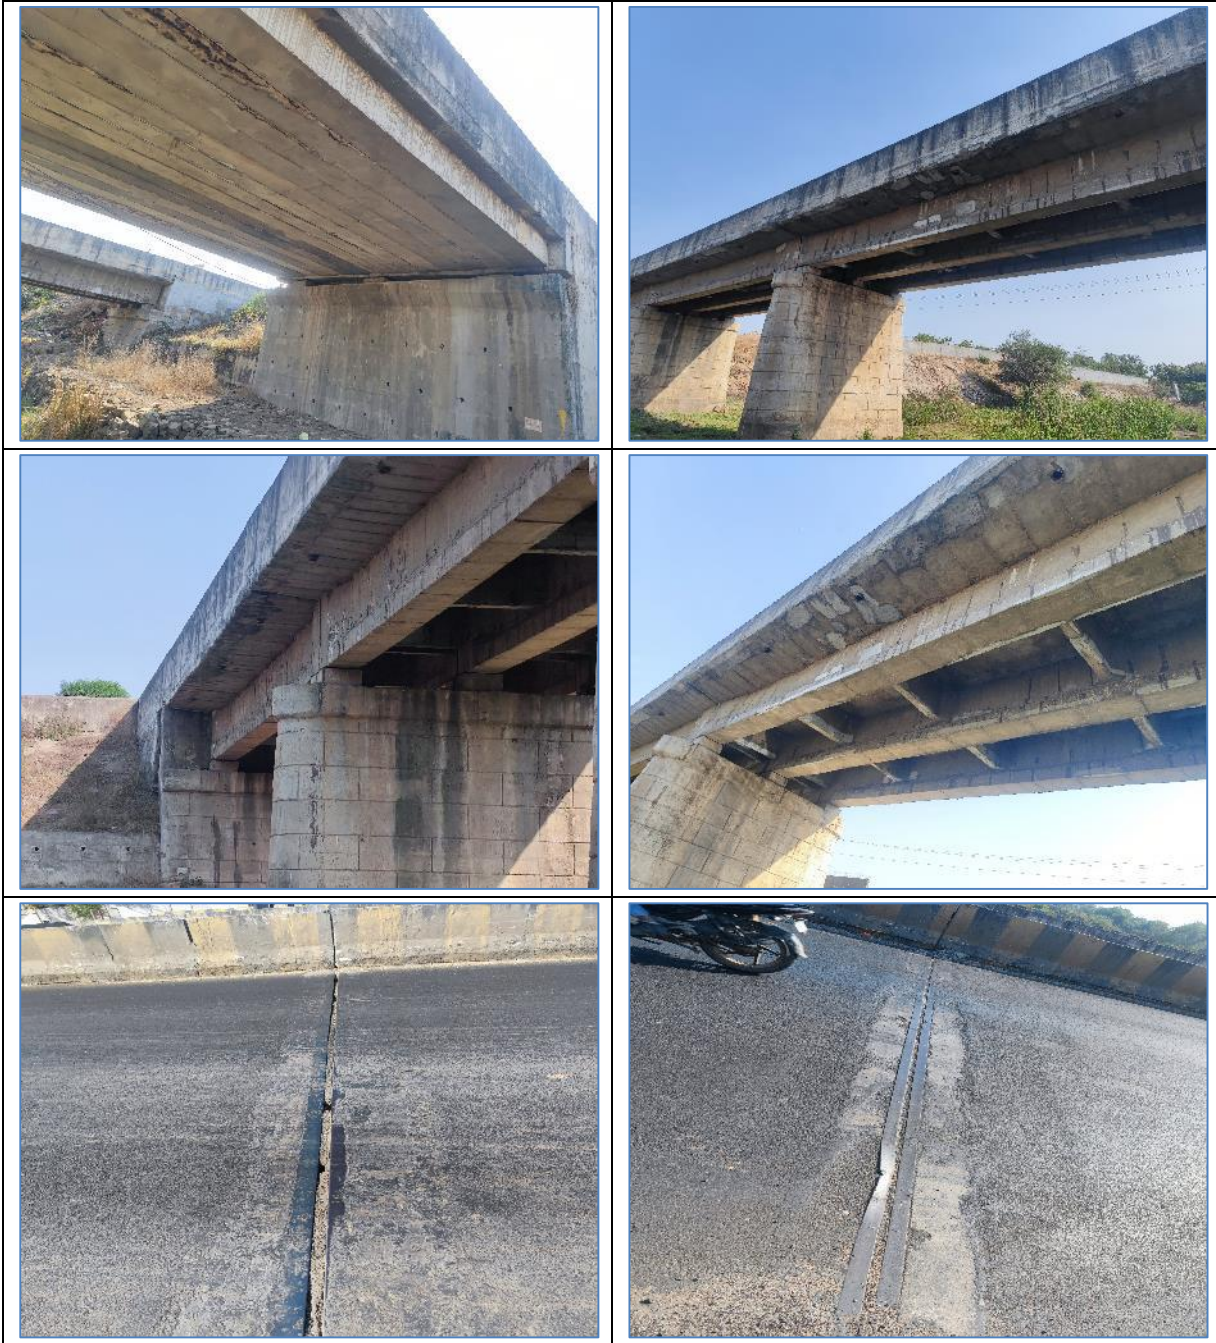
**BR. NO. 192+186 (MJB)**

- Damp spots observed on bottom of RCC Precast Panels.
- Rubber sealant is damaged in some expansion joint location.
- RCC crash barrier is in good condition except minor Reinforcement exposed.

- Structure is in fair condition.
- Rubber sealant is damaged in some expansion joint location.

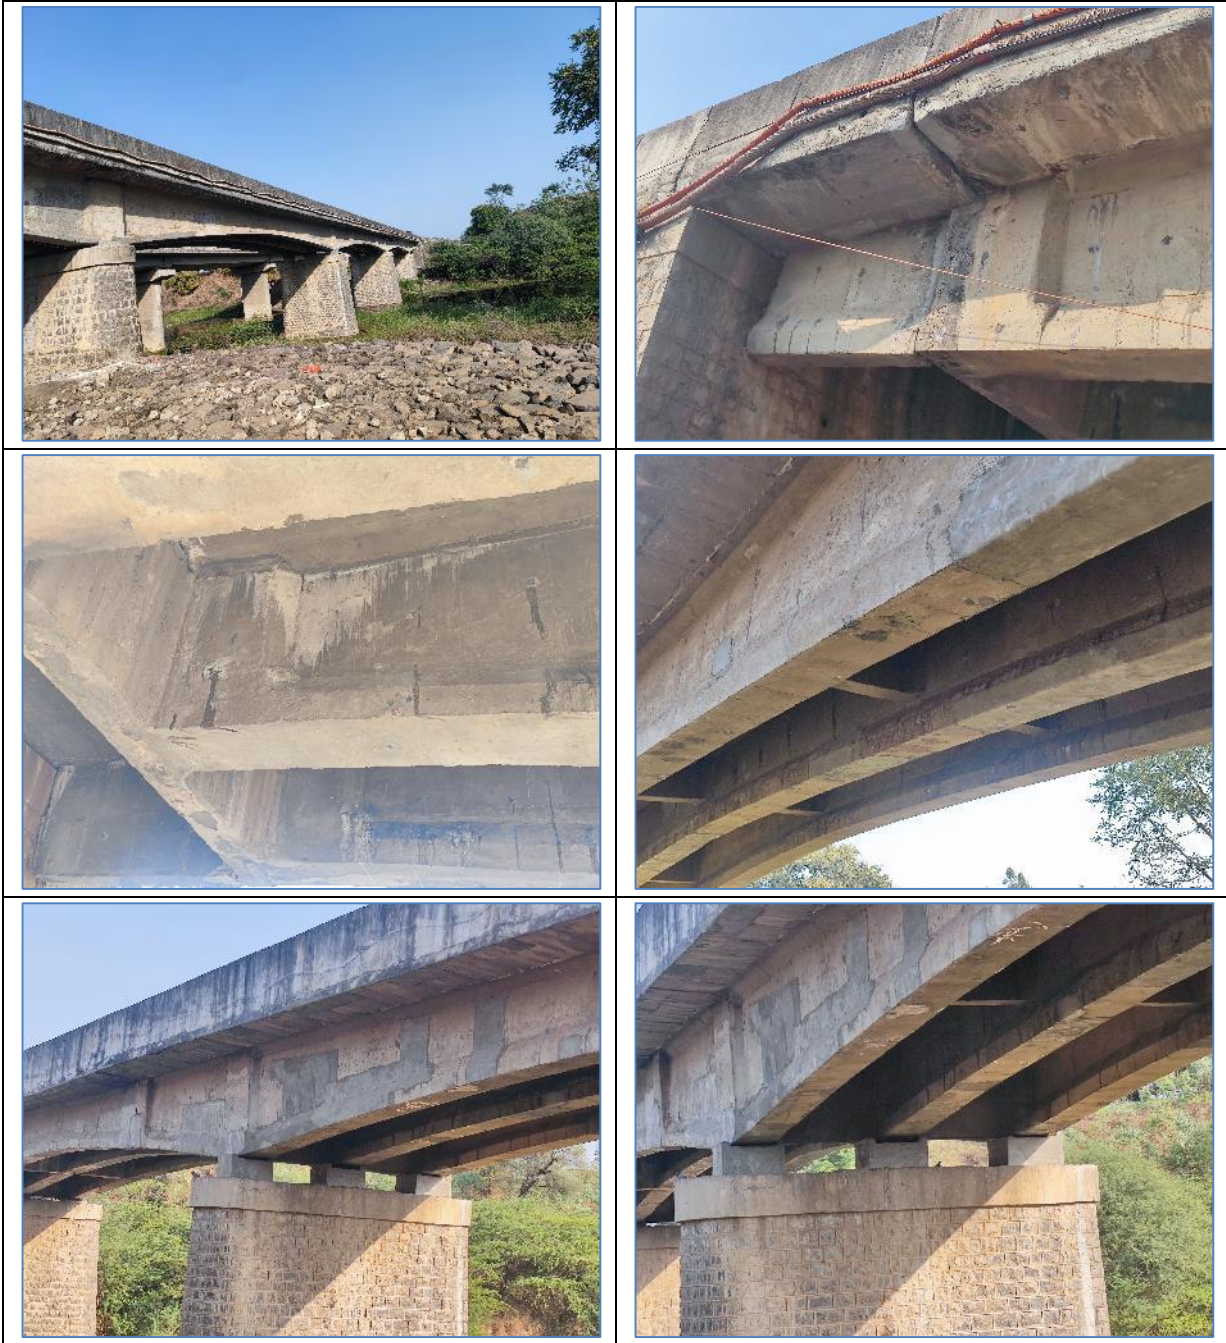
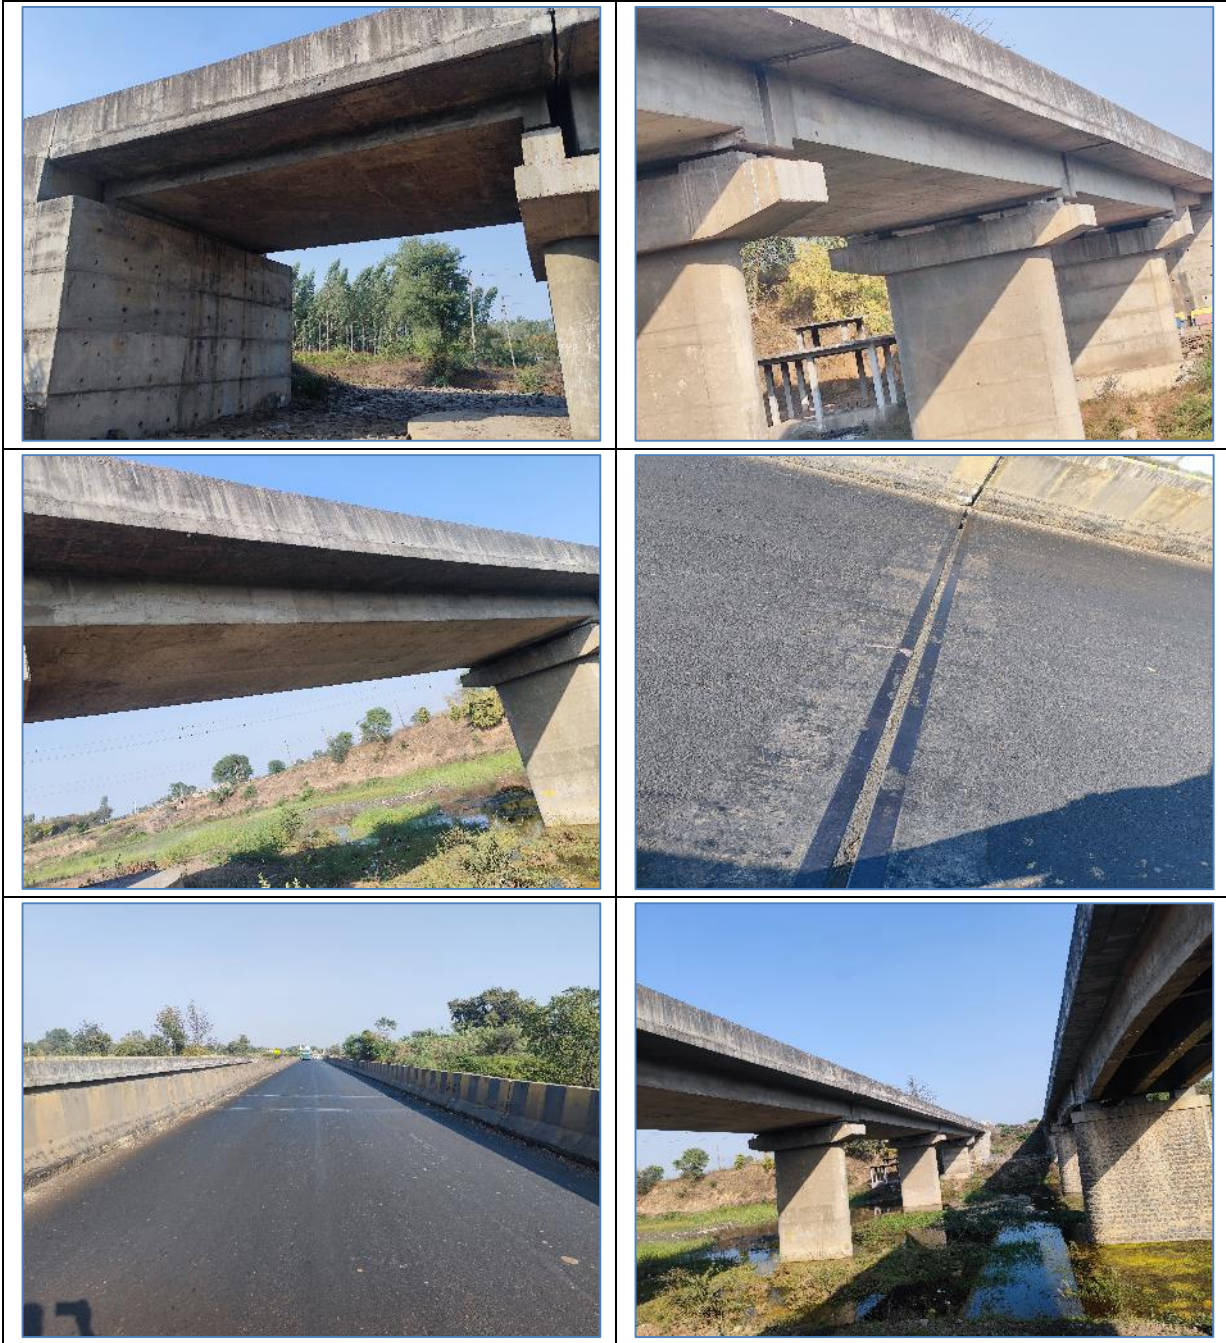
**BR. NO. 197+933 (MJB)**

- Honey combing observed on top slab.
- Rubber Sealant is damaged in some expansion joint locations.
- RCC crash barrier provided is in good condition.

- Structure is in fair condition
- Rubber Sealant is damaged in some expansion joint locations.

- Concrete quality - Good
- Carbonation depth - 0 to 20mm
- Probability of Corrosion risk 10%

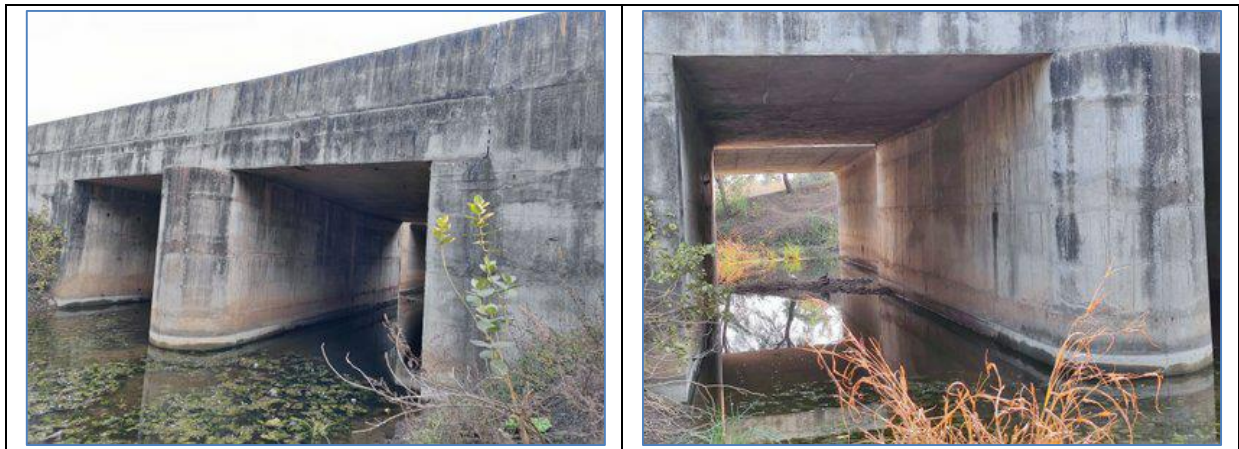
- Side walls are in good condition.
- Solid slab is in good condition.
- RCC crash barrier is provided is in good condition.

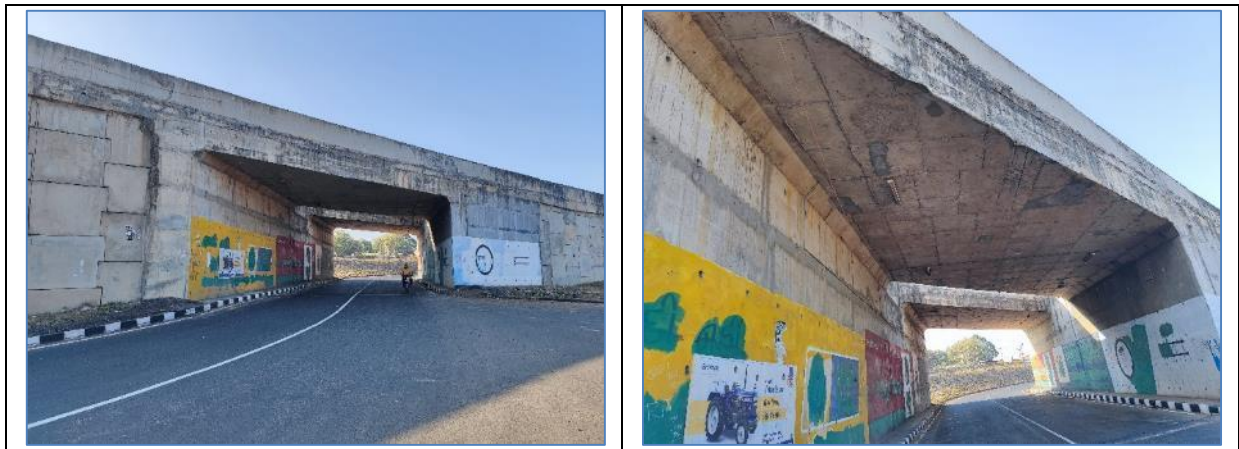
**BR. NO. 128+317 (VUP)**

- The span is observed as 1 x 15.0 m in skew.
- The structure is in skew of nearly 20 degrees.
- RE walls are in good condition.
- RCC crash barrier is provided is in good condition.

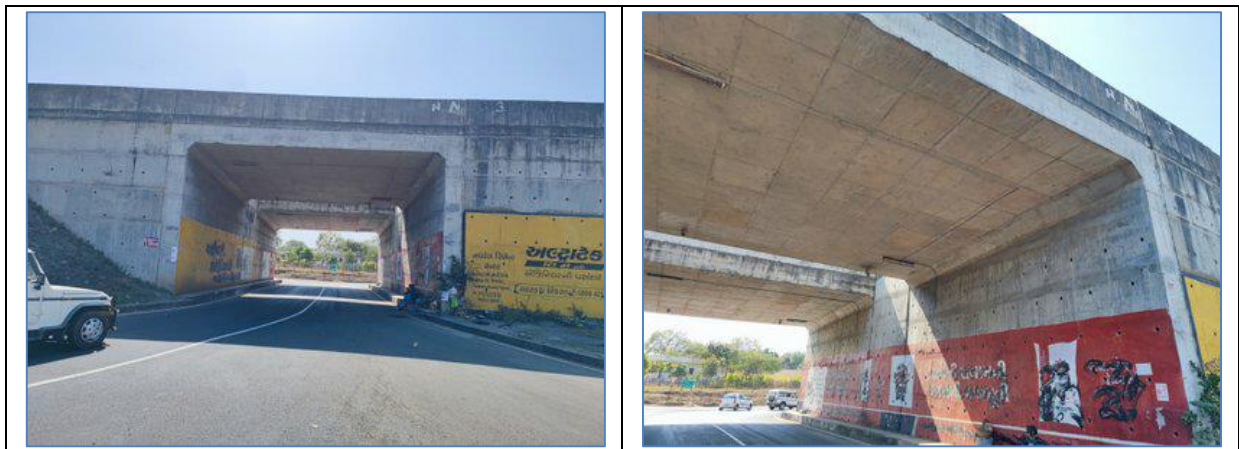
**BR. NO. 152+026 (VUP)**

- Side walls are in good condition.
- The structure is box type with raft foundation and is in good condition.
- RE walls are in good condition.
- RCC crash barrier is provided is in good condition.
- Stone pitching is provided on abutment location quadrant slopes in good condition.

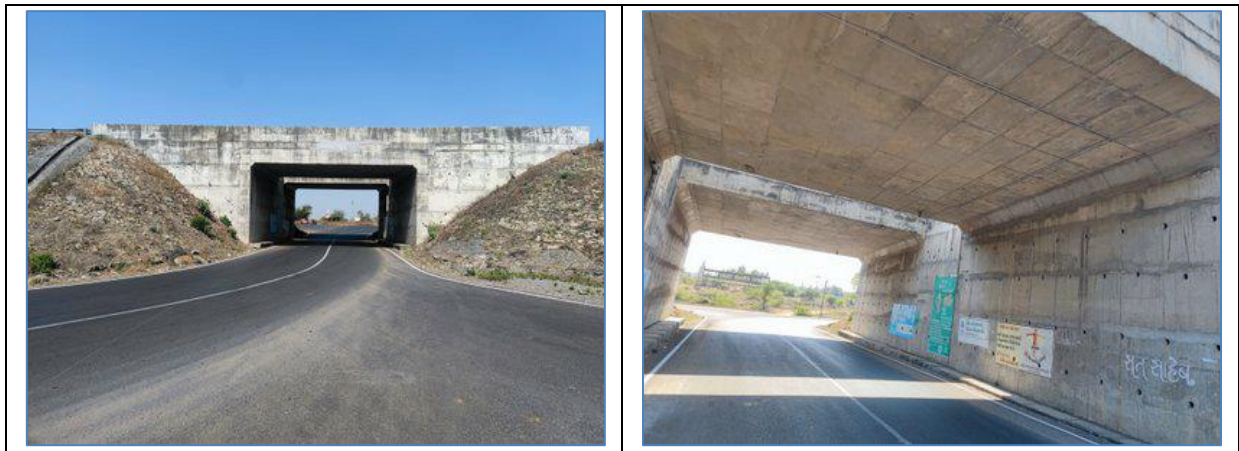
**BR. NO. 160+930 (VUP)**

- The structure is box type with raft foundation and is in good condition.
- Side walls are in good condition.
- RE walls are in fair condition.
- RCC crash barrier is provided is in good condition.
- Stone pitching is provided on abutment location quadrant slopes in good condition.

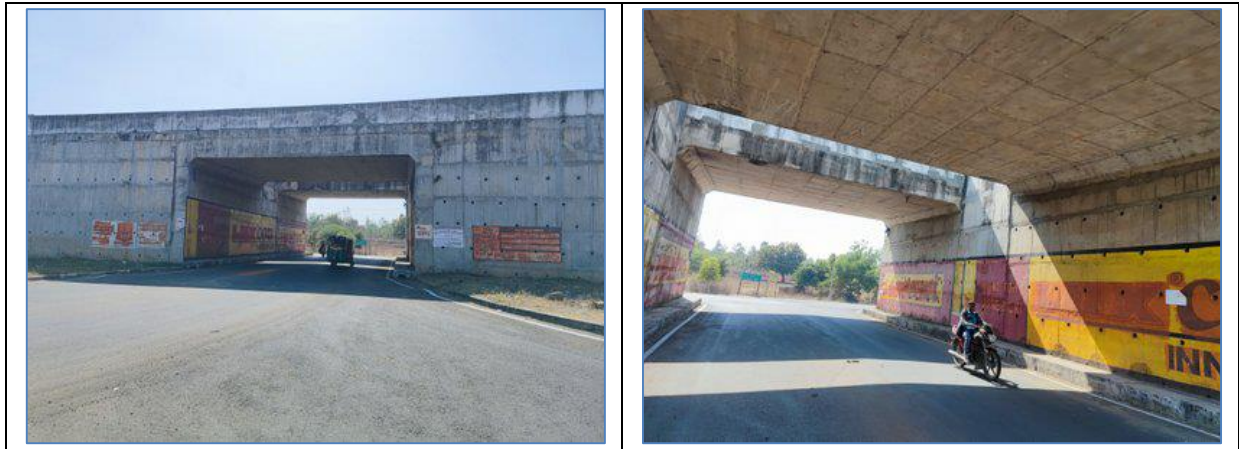
**BR. NO. 162+914 (VUP)**

- Side walls are in fair condition.
- The structure is box type with raft foundation.
- RE walls are in good condition.
- RCC crash barrier is provided is in good condition.
- Stone pitching is provided on abutment location quadrant slopes in good condition.

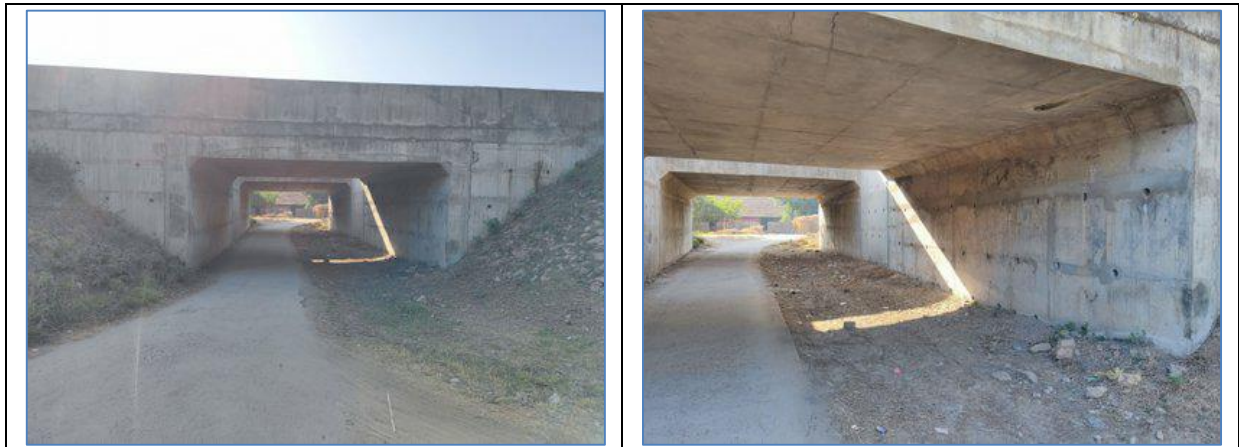
**BR. NO. 131+321 (PUP)**

- Side walls are in good condition.
- Top slab is in good condition.
- RCC crash barrier is provided is in good condition.
- Stone pitching is provided on abutment location quadrant slopes is good.

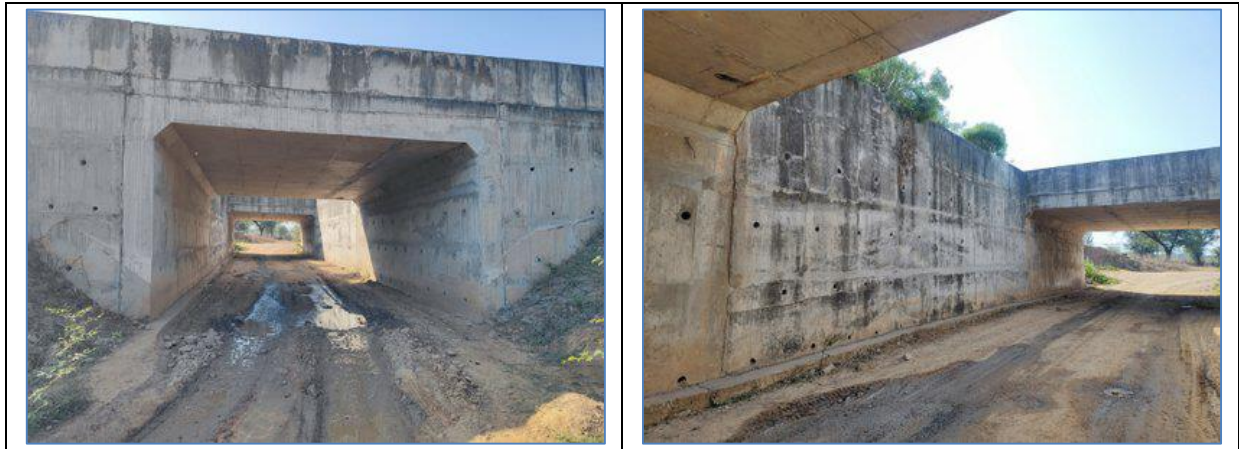
**BR. NO. 140+396 (PUP)**

- Side walls are in good condition.
- RCC crash barrier is provided is in good condition.
- Stone pitching is provided on abutment location quadrant slopes is in good condition

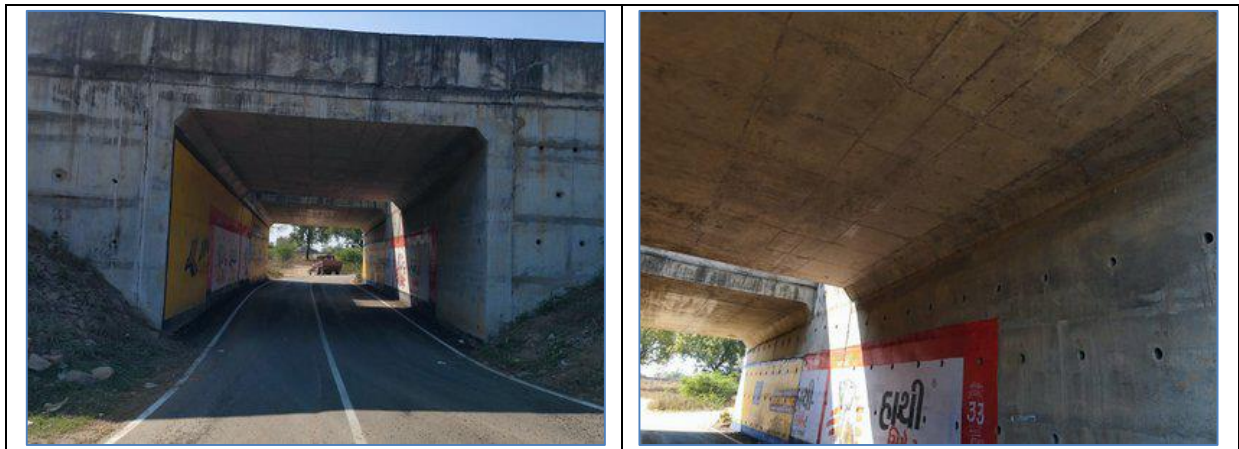
**BR. NO. 144+251 (PUP)**

- Side walls are in good condition.
- RCC crash barrier is provided is in good condition.
- Stone pitching is provided on abutment location quadrant slopes is in good condition

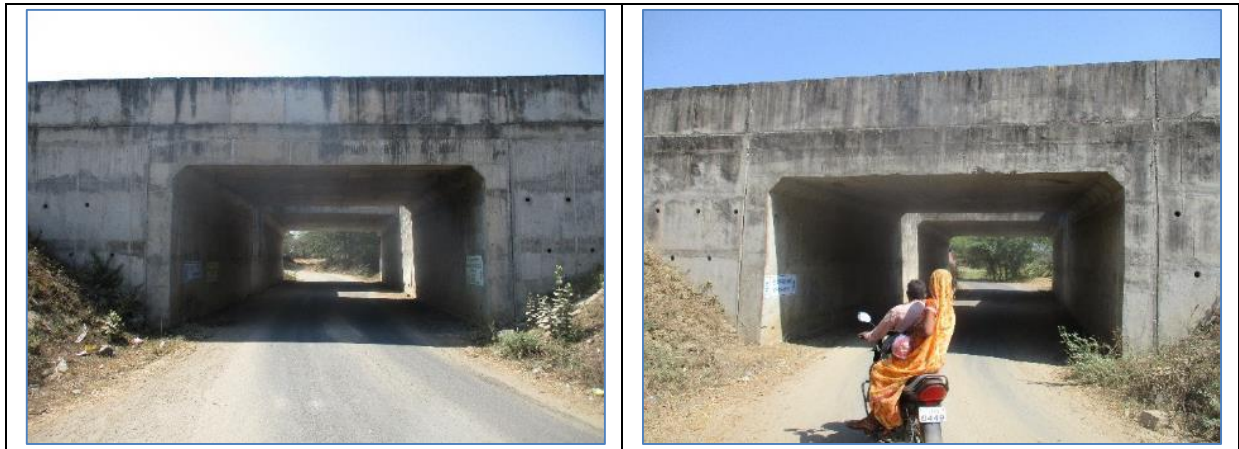
**BR. NO. 155+241 (PUP)**

- Side walls are in good condition.
- RCC crash barrier is provided is in fair condition.
- Stone pitching is provided on abutment location quadrant slopes in fair condition.

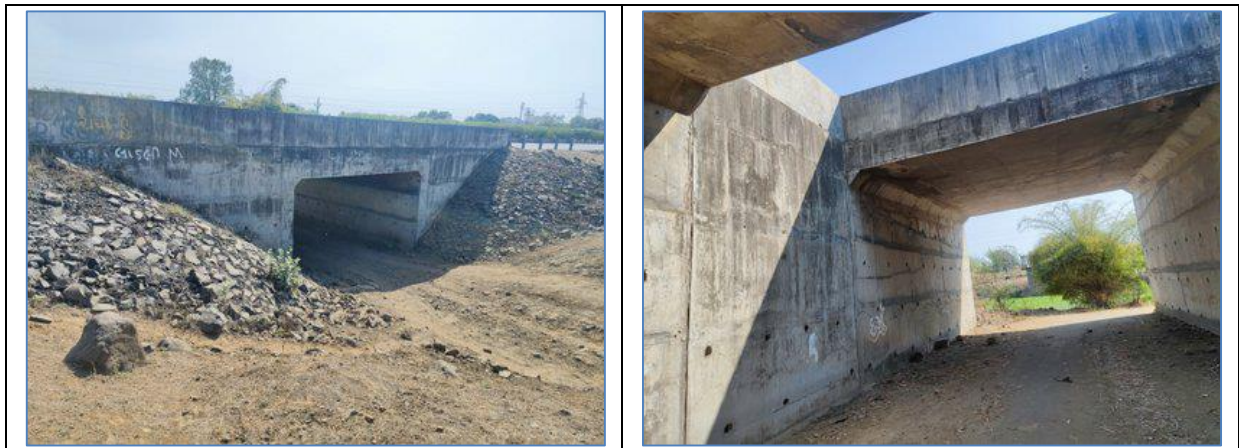
- Side walls are in good condition.
- RCC crash barrier is provided is in good condition.
- Stone pitching is provided on abutment location quadrant slopes is mostly good

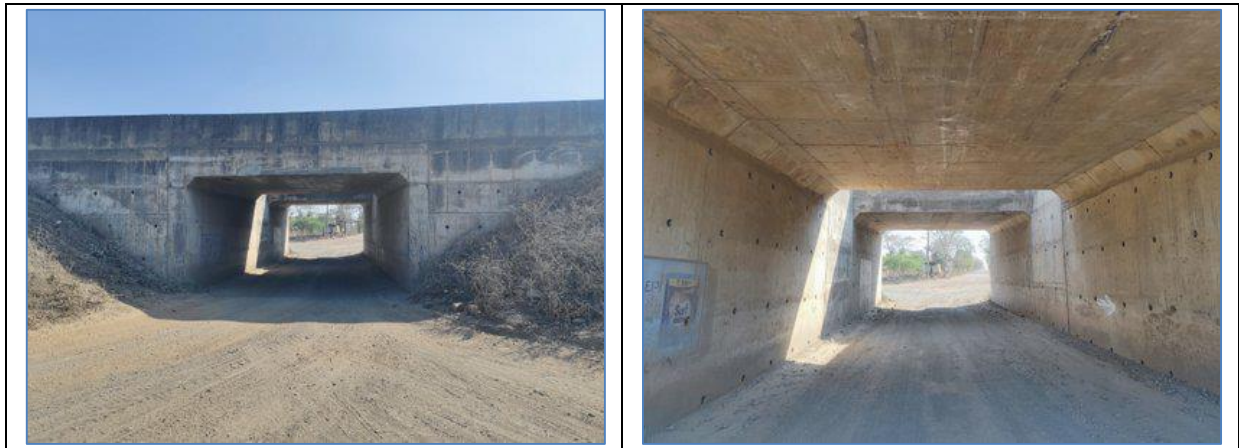
- RCC crash barrier is provided is in good condition.
- Stone pitching is provided on abutment location quadrant slopes is good.

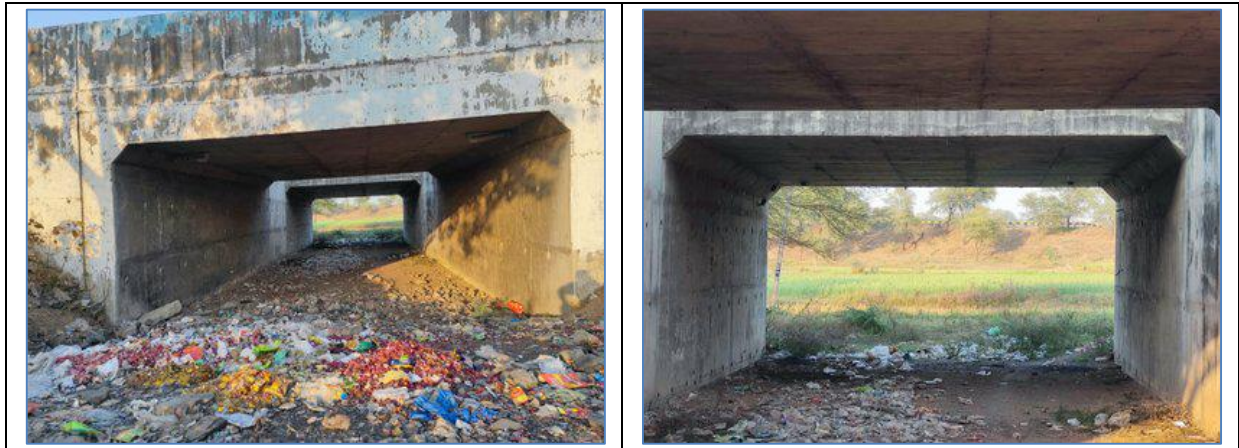
**BR. NO. 199+099 (PUP)**

- Side walls are in good condition.
- RCC crash barrier is provided is in good condition.
- Stone pitching provided on abutment location quadrant slope is fair.

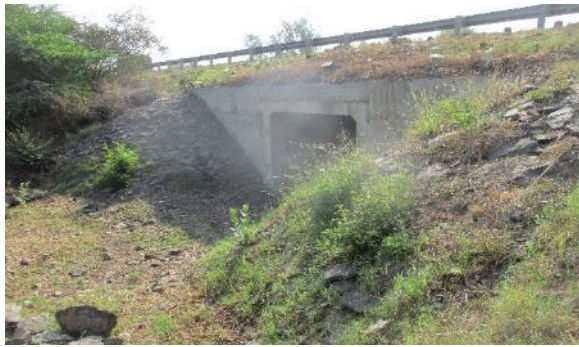
Km 130+820

| S. No | Type as per CA | Type as per site | Proposed chainage | Proposed chainage as per site | Proposed Span arrangement (No. x Length) (m) | Span as per site (No. x Length) (m) | Existing deck width as per site | Skew angle | Vertical Clearance (m) | Slab Thickness (m) | Remarks |
|---|---|---|---|---|--|---|---|---|---|---|---|
| 3 | RCC Slab | BOX CULVERT | 131+009 | 130+820 | 1 x 7 | 1 x 3 x 2.5 | 32.5 | - | 2.5 | 0.3 | Structure is in good condition. |

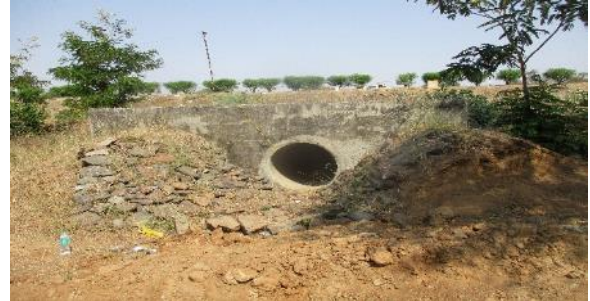
Km 142+800

| S. No | Type as per CA | Type as per site | Proposed chainage | Proposed chainage as per site | Proposed Span arrangement (No. x Length) (m) | Span as per site (No. x Length) (m) | Existing deck width as per site | Skew angle | Vertical Clearance (m) | Slab Thickness (m) | Remarks |
|---|---|---|---|---|--|---|---|---|---|---|---|
| 14 | PIPE | PIPE CULVERT | 143+002 | 142+800 | 1 x 0.9 | 1 x 0.9 | 39.5 | - | - | - | Structure is in good condition. |
