**Re: Submission of Final Report of Technical due diligence study for the project "Jodhpur Pali Expressways Pvt. Ltd".**

**Technical Due Diligence for 4 Laning of Jodhpur to Pali Section of NH 65 from Km 308 to Km 366 & includes bypass to Pali starting from Km 366 of NH-65, connecting NH-14 at Km 114 in the State of Rajasthan**

**For Virescent Infrastructure  
Investment Manager Private Limited  
(For the purpose of  
Highways Infrastructure Trust)**

# **Final Report**

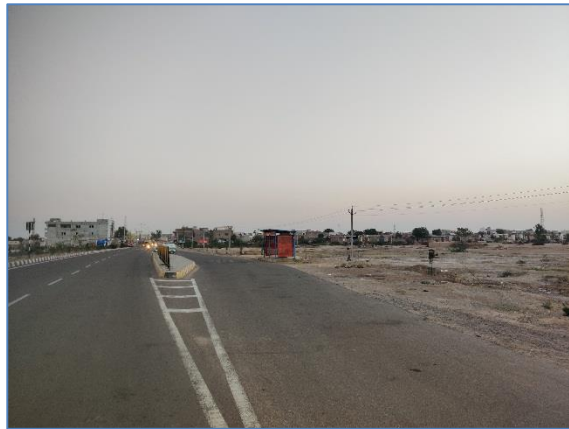
Bus shelter near km 346+450, RHS

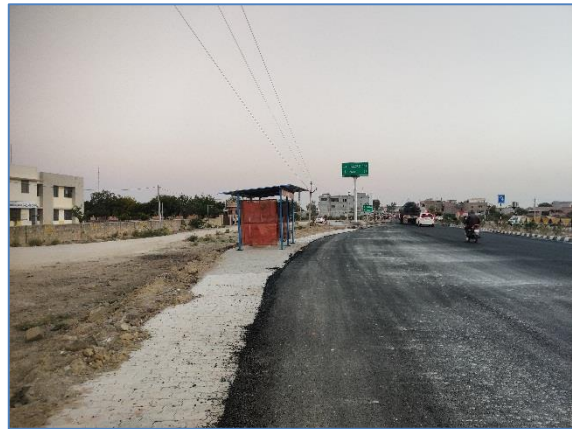
Bus Bay with Shelter near km 346.500, LHS

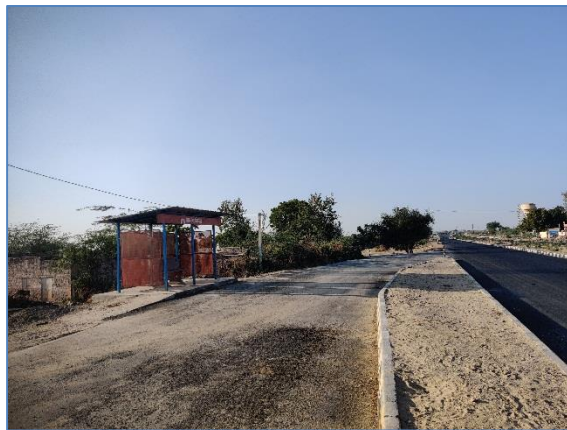
Bus Bay With Shelter near km : 336+450, RHS MC

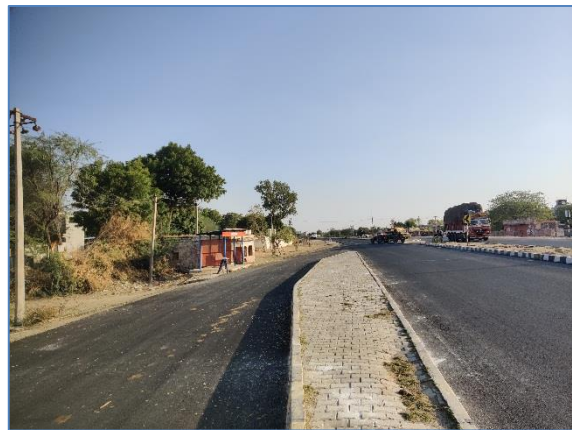
Bus Bay With Shelter near km 336+500, LHS MC

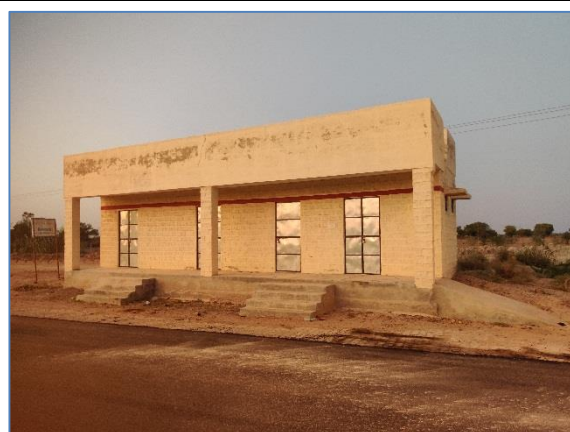
Toilet Block at Truck Lay bye on LHS km 350.400
