Re: Submission of Final Report of Technical due diligence study for the project "Shillong Expressways Private Limited (SEPL)".

**Technical Diligence for 2-laning of Shillong
bypass connecting NH-40 and NH-44 from
km 61/800 of NH-40 to km 34/850 on NH-
44 in the state of Meghalaya on Build,
Operate and Transfer (“BOT Annuity”) Basis.**

**For Virescent Infrastructure Investment
Manager Private Limited (For the purpose of
Highways Infrastructure Trust)**

Final Report

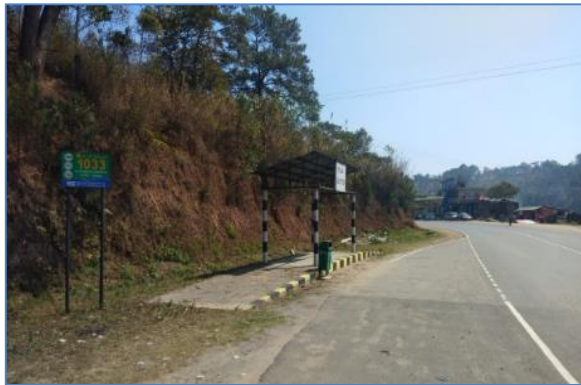
Bus Bay with Bus Shelter near km 1.500 LHS

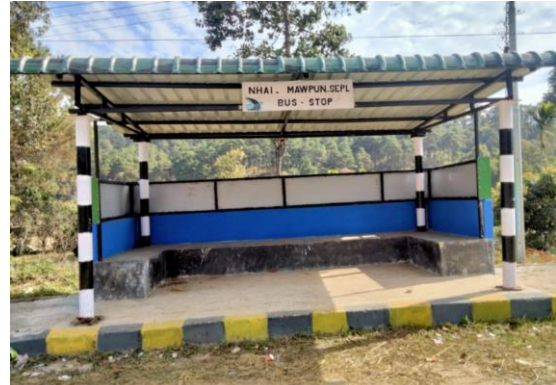
Bus Bay with Bus Shelter near km 4.450 RHS

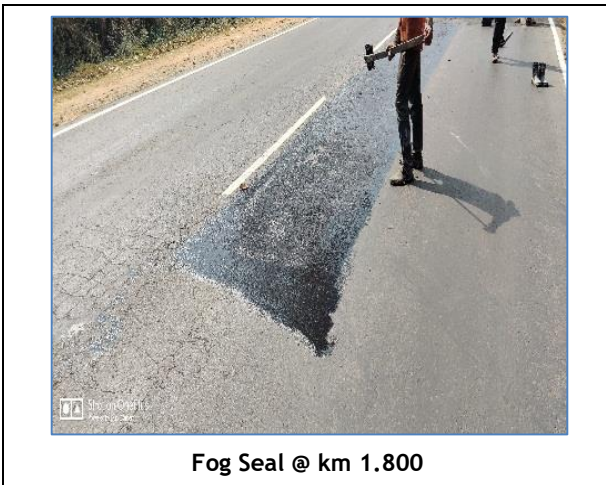
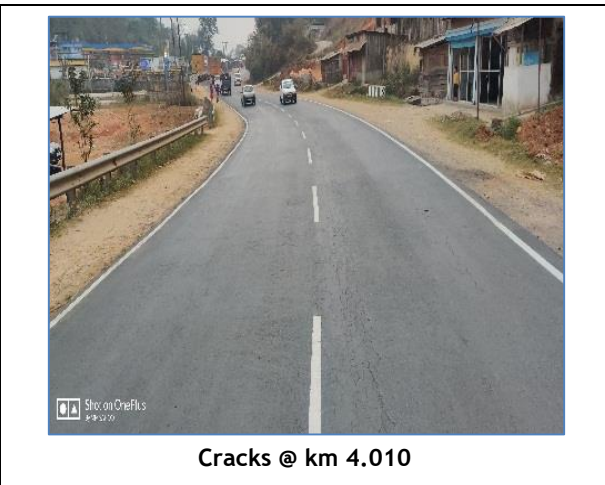
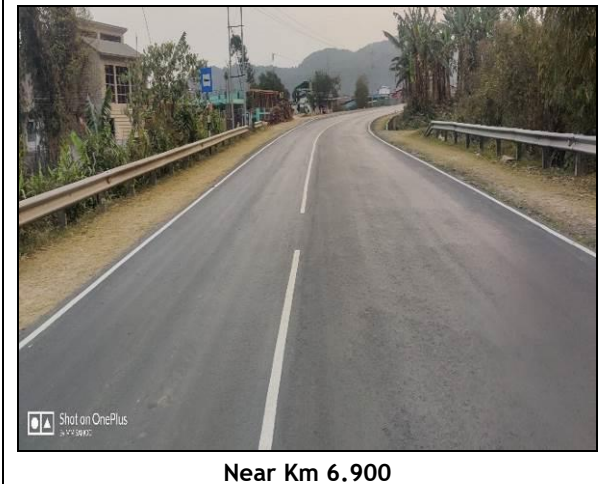
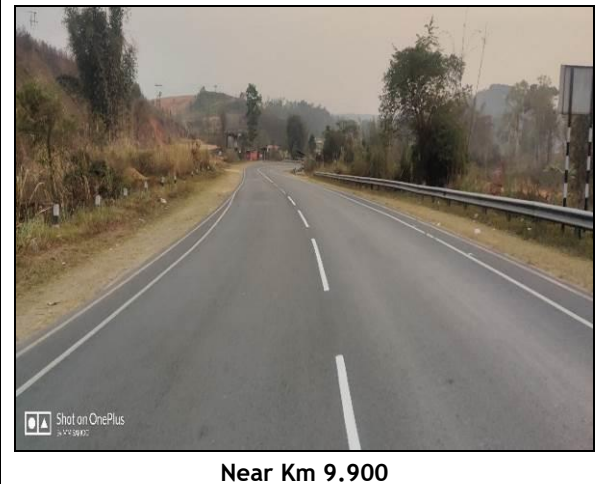
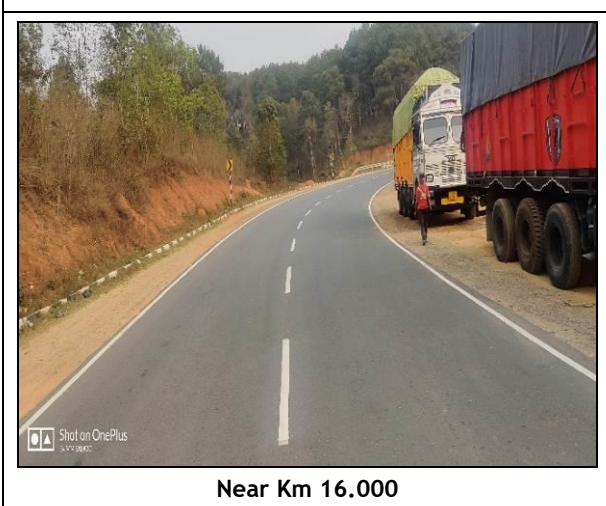
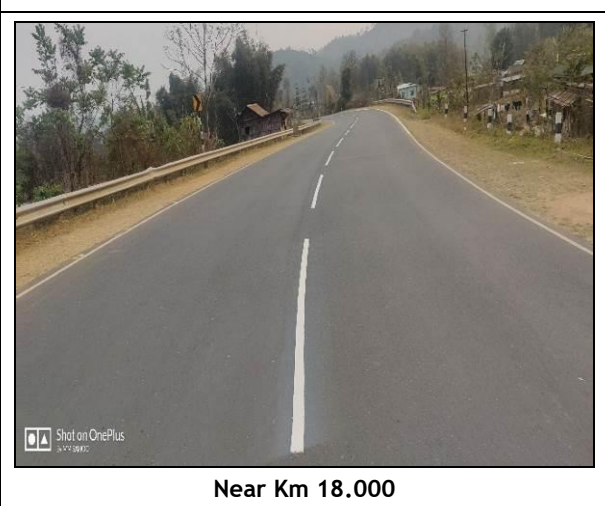
The present condition of pavement is fair along the project road. Cracking and raveling has developed on Carriageway at some locations. These are mainly surface related distresses and the cracking appears to be top-down cracking. Crocodile cracking is noted at isolated locations. Crack sealing is also being done / in progress at some of the locations along the project corridor. The present surface condition appears slightly dry surface; because of which the cracking might have initiated at most of the locations. Crack sealing is also being done / in progress at some of the locations along the project corridor. The present surface condition appears slightly dry surface; because of which the cracking might have initiated at most of the

locations. No potholes are seen along the project. Remedial treatment at distressed locations carried out with BC material.

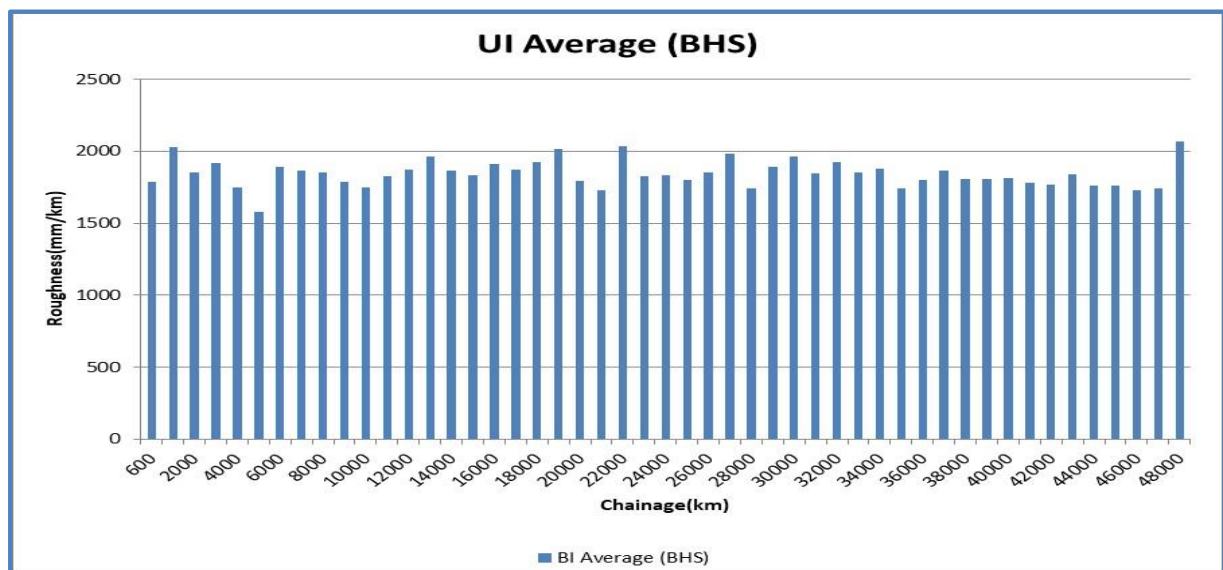
It can be seen from the above pie charts that all the kilometers in LHS lane and RHS lane having roughness values less than 2500mm/Km. Even average of both lanes is also indicating that the project road has roughness values within the permissible limits as per the provision of Concession Agreement i.e., less than 2500mm/Km. Bar diagrams showing the Kilometer wise roughness along the project road are presented below:

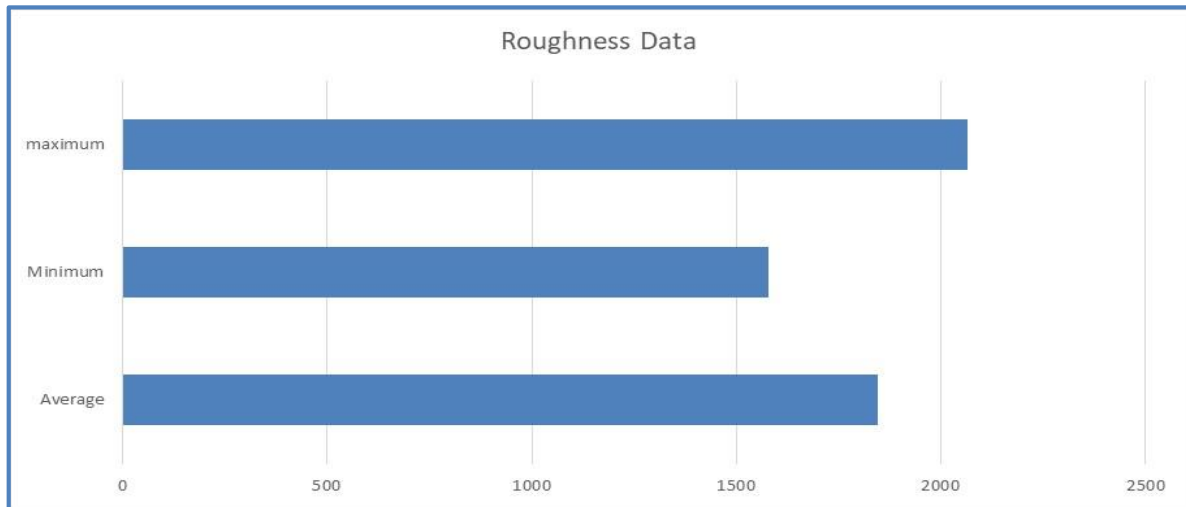
From the above it can be noticed that the Average Roughness values along the project road are 1844 mm/Km. The maximum Roughness Values are around 2065 mm/Km. From the above it can be concluded that none of the section of the project road requires functional overlay as unevenness Index (UI) is less than 2500 mm/km.

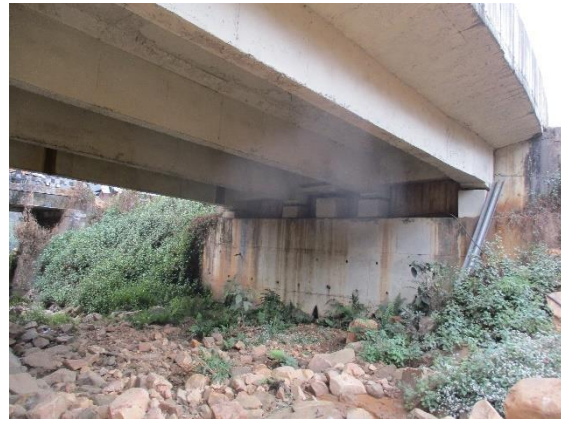
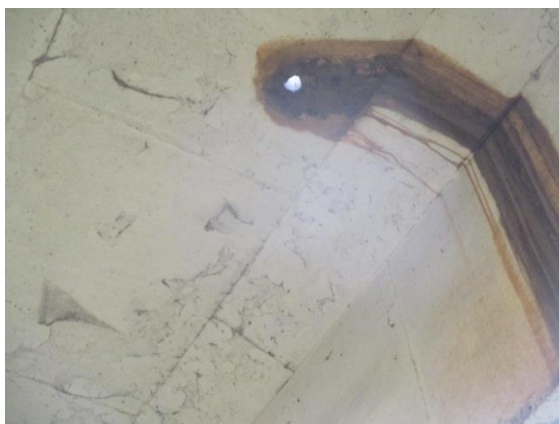
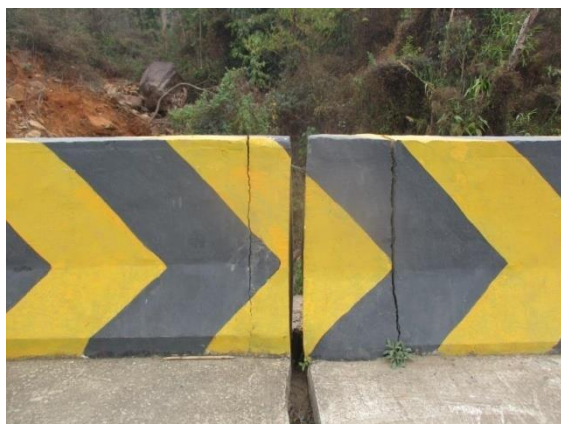
Km 37+020

Visual Observations on condition of the bridge are as below:

- Overall Structure Condition is good
- Minor Crack observed on crash barrier wall at some locations.
- Minor Cracks observed on expansion joints sides.

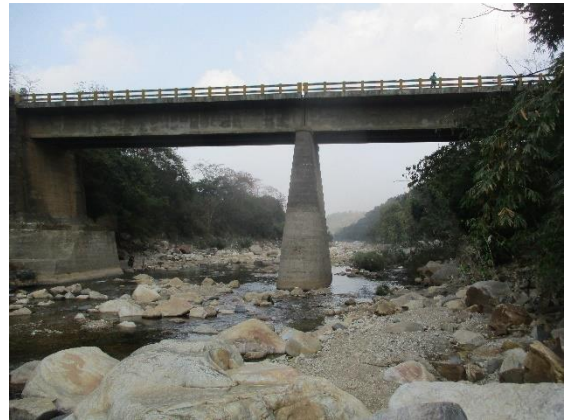
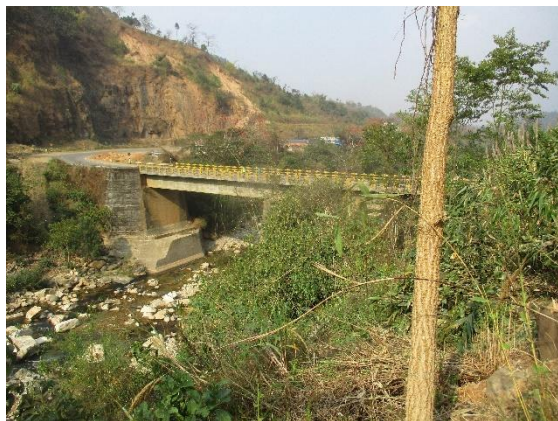
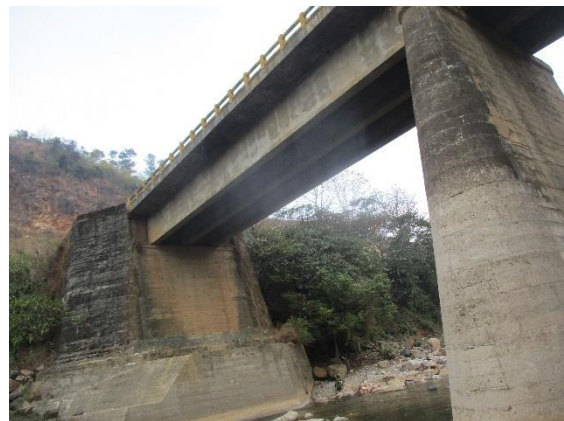
Km 37+600

Visual Observations on condition of the bridge are as below:

- Overall Structure Condition is good
- Expansion joints rubber joints sealing is damaged.
- Minor damage on head wall at small portion

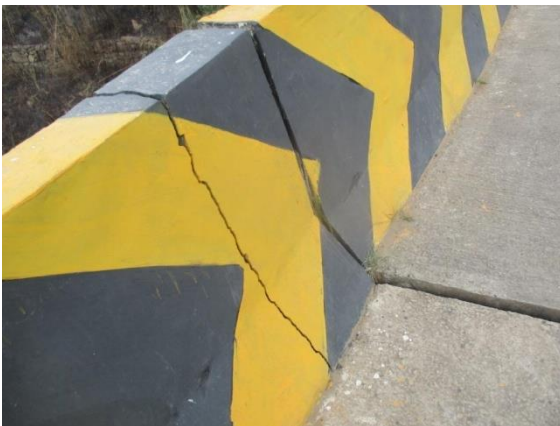
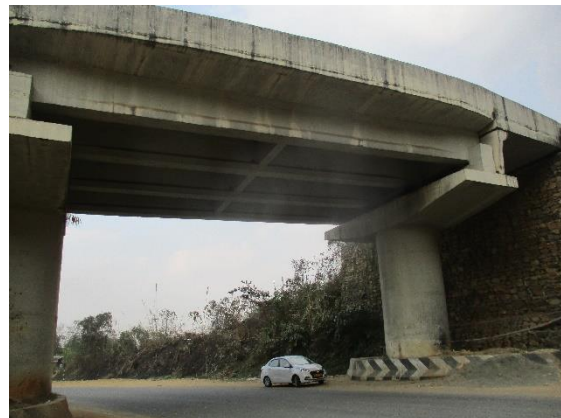
Km 38+750

Visual Observations on condition of the bridge are as below:

- Overall Structure Condition is good
- Drainage spout down take pipes are not provided.
- Expansion joints are buried with debris
- Minor crack observed on RCC crash barrier at some locations

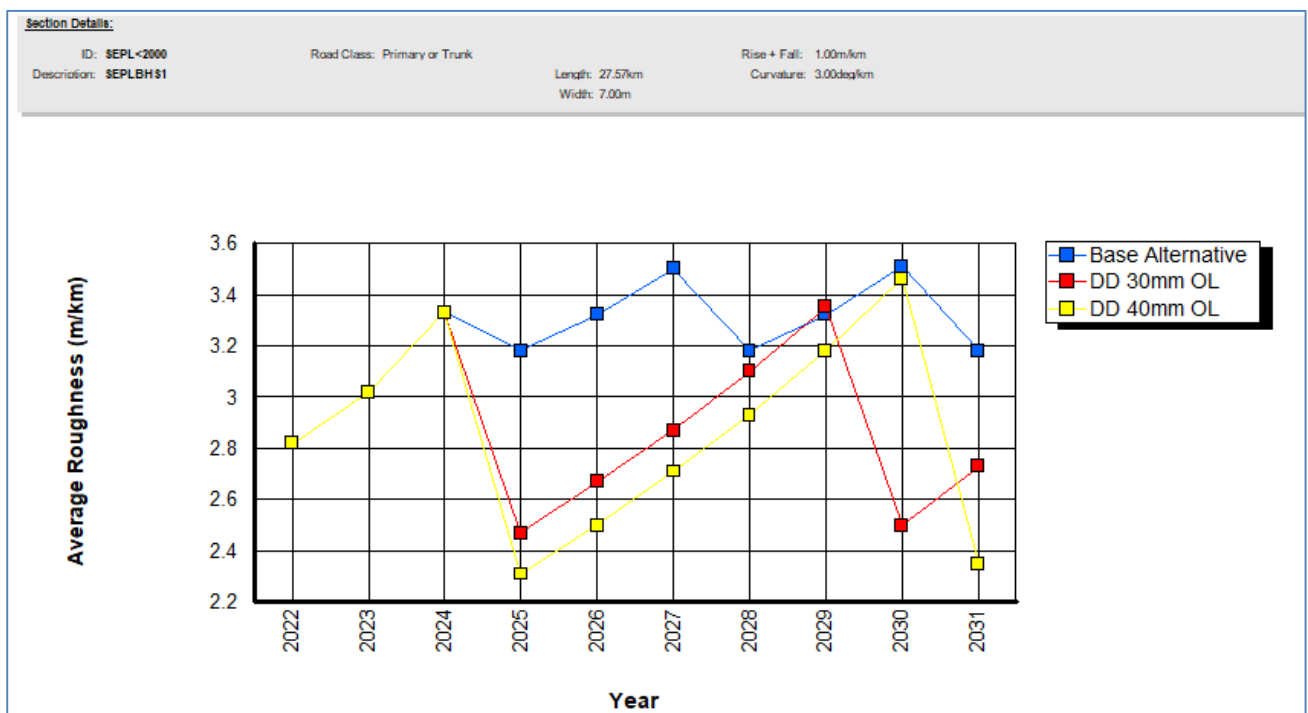
Figure 1: Average Roughness along the Project Road (No OL Section<2000mm/Km)

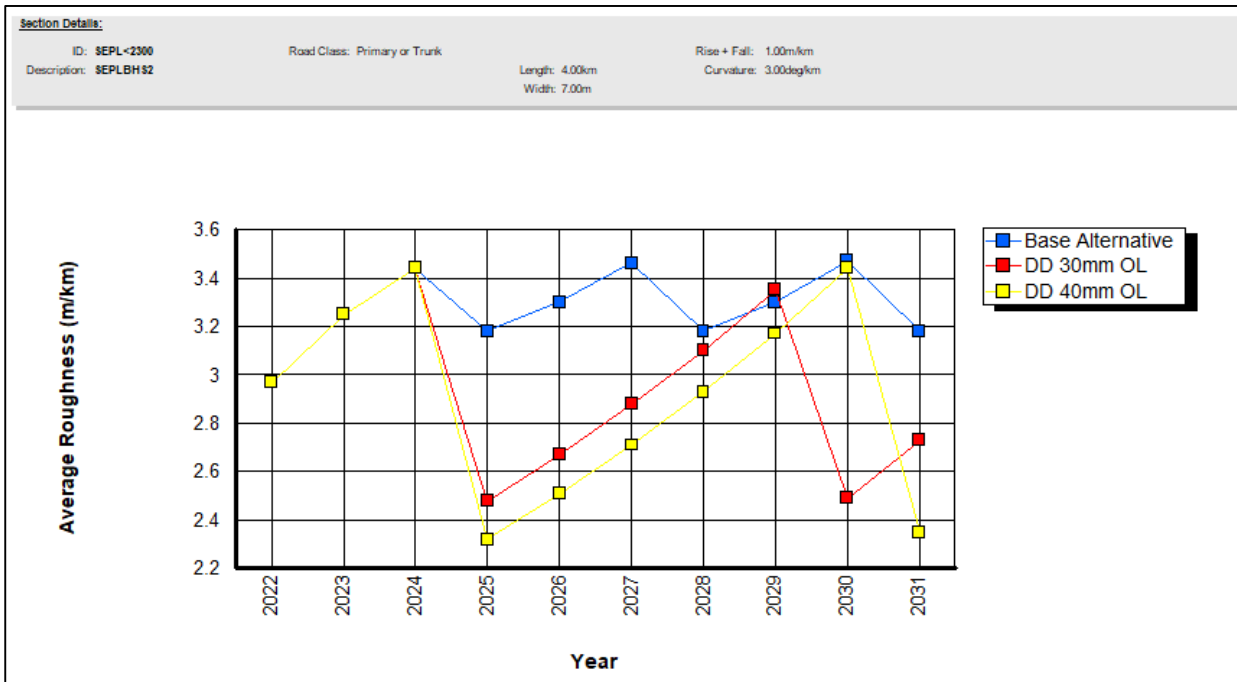
Figure 2: Average Roughness along the Project Road (No OL Section<2300mm/Km)

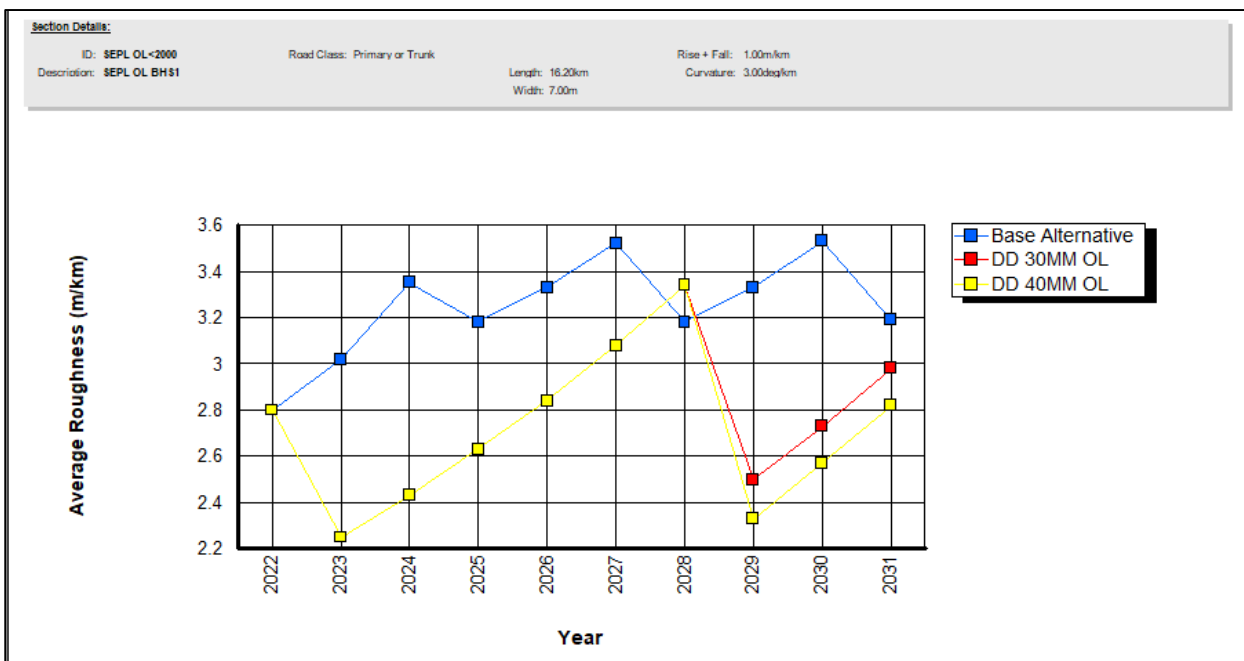
Figure 3: Average Roughness along the Project Road (OL Section<2000mm/Km)

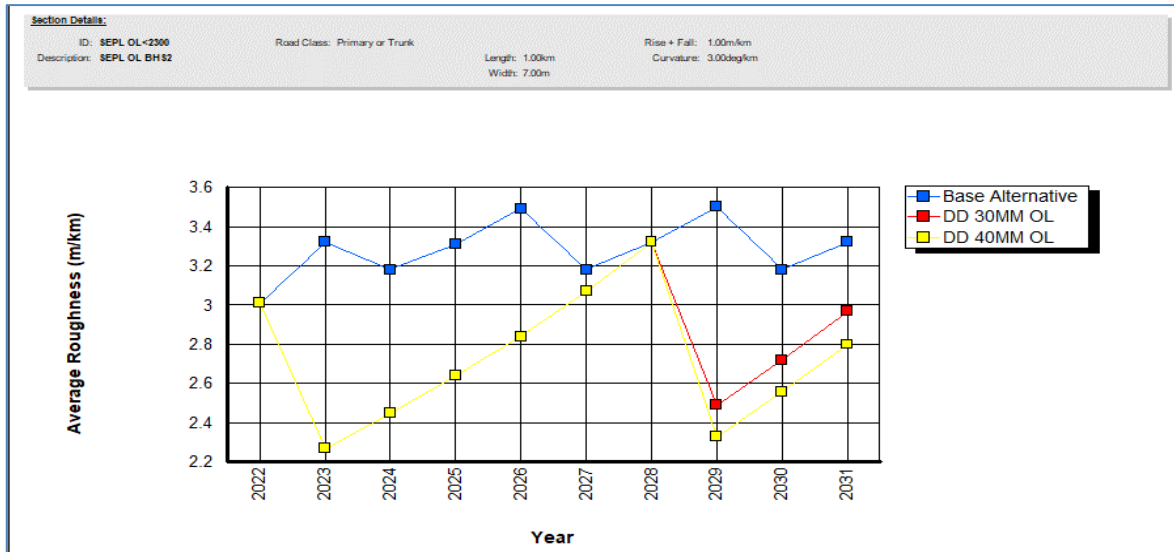
Figure 4: Average Roughness along the Project Road (OL Section<2300mm/Km)
