Re: Submission of Final Report of Technical due diligence study for the project "Ulundurpet Expressways Pvt. Ltd (UEPL)".

**Technical Due Diligence for Tindivanam
to Ulundurpet section of NH-45 from km
121.000 to km 193.900 of Length
72.900 kms in the State of Tamil Nadu.**

**For Virescent Infrastructure Investment
Manager Private Limited (For the purpose of
Highways Infrastructure Trust)**

Final Report

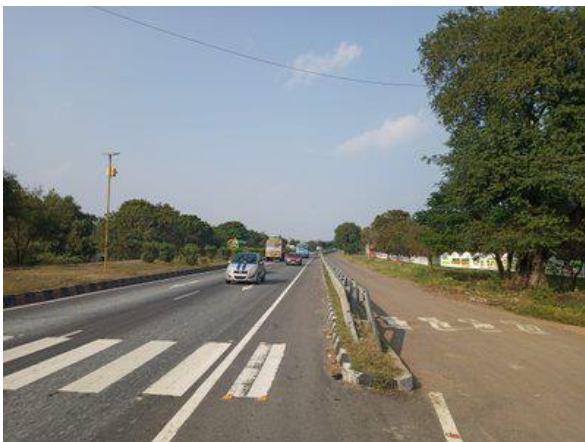
Good Condition km 128+870

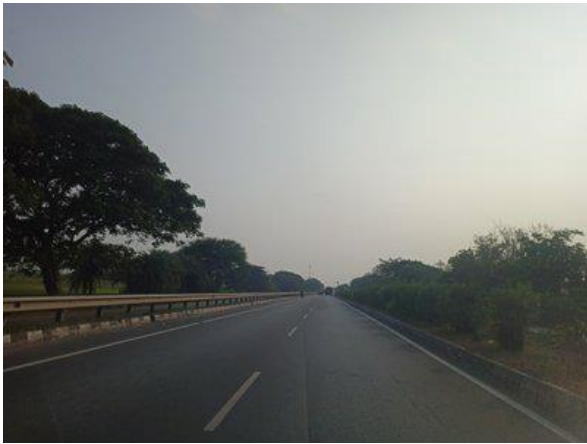
Good Condition @ km 142+450

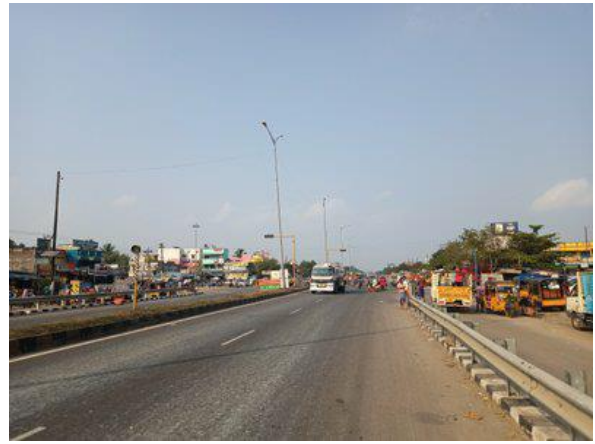
Good Condition km 133+770

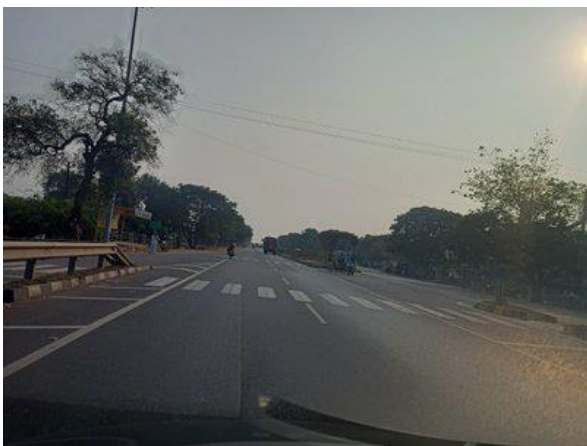
Good Condition km 144+860

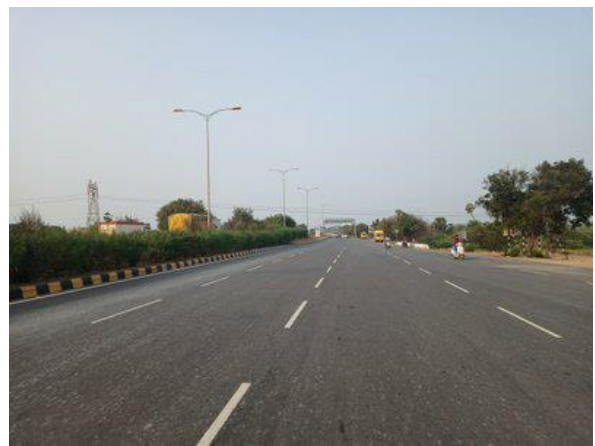
Good Condition @ km 149+880

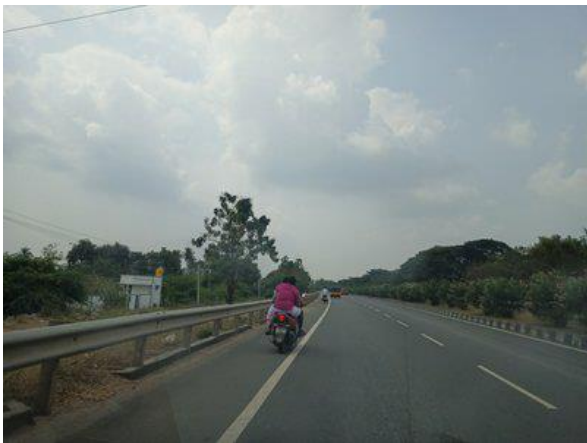
Good Condition km 161+000

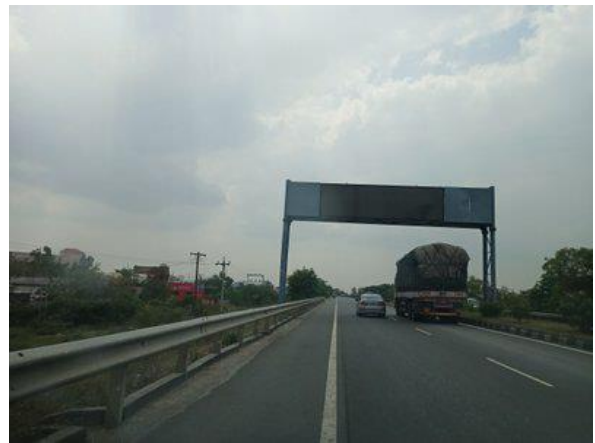
Good Condition km 165+030
