**Re: Submission of Final Report of Technical due diligence study for the project "Jodhpur Pali Expressways Pvt. Ltd".**

**Technical Due Diligence for 4 Laning of Jodhpur to Pali Section of NH 65 from Km 308 to Km 366 & includes bypass to Pali starting from Km 366 of NH-65, connecting NH-14 at Km 114 in the State of Rajasthan**

**For Virescent Infrastructure  
Investment Manager Private Limited  
(For the purpose of  
Highways Infrastructure Trust)**

# **Final Report**

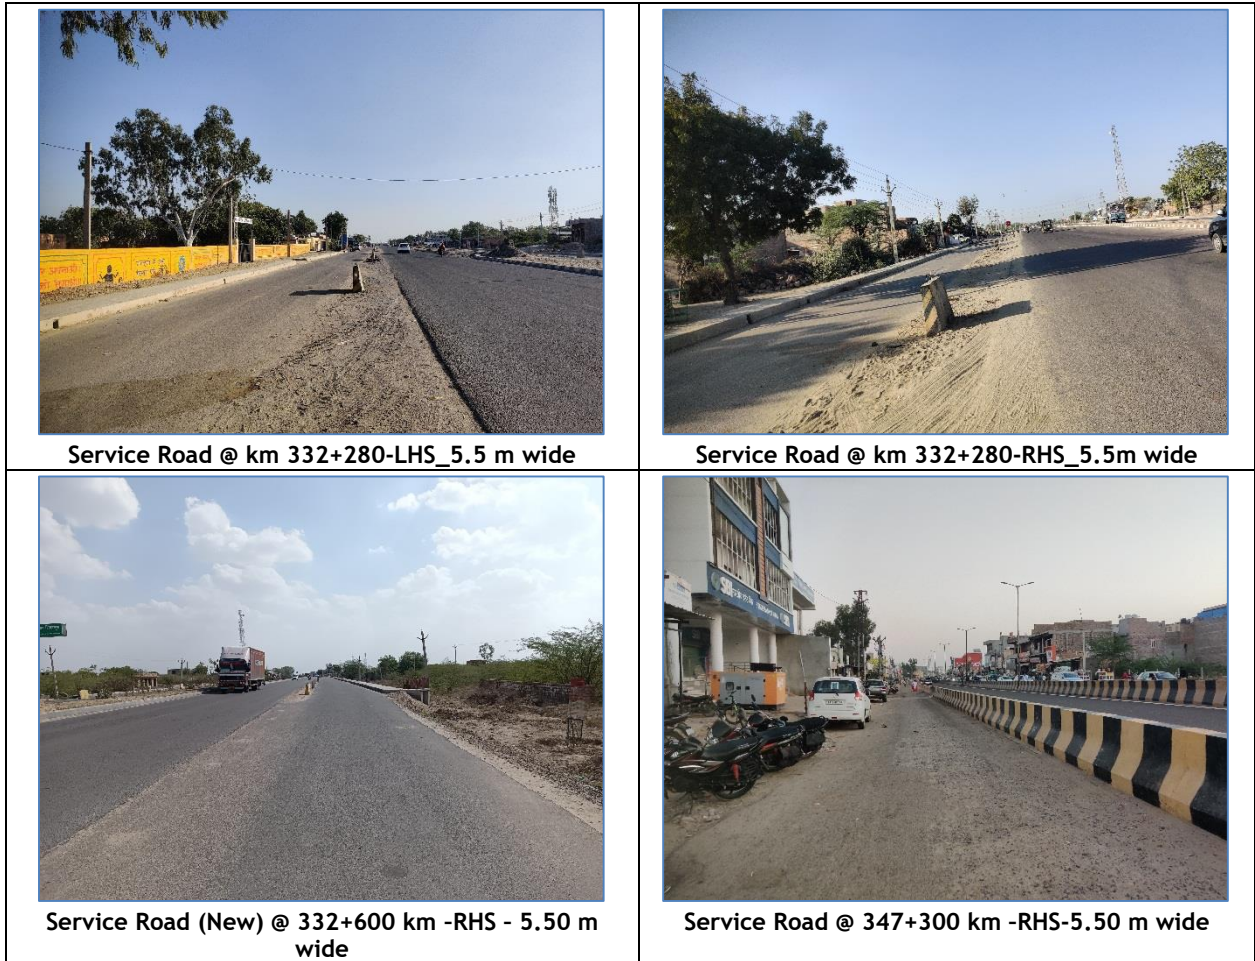
Service road/slip roads have been observed between km 315+300 to 316+650, at km 323+300 to km 324+700, at km 332+280 to 333+100(New), 346+680 to 347.450 & 372.510 to 373.448(New) which covers a small built-up area and a Flyover. Few photos depicting the service road pavement surface type, condition and the other associated features like covered drain, pedestrian guard railing are presented below.

Service Roads exist only at Flyover and Built-Up Area.
