Re: Submission of Final Report of Technical due diligence study for the project "Ulundurpet Expressways Pvt. Ltd (UEPL)".

**Technical Due Diligence for Tindivanam
to Ulundurpet section of NH-45 from km
121.000 to km 193.900 of Length
72.900 kms in the State of Tamil Nadu.**

**For Virescent Infrastructure Investment
Manager Private Limited (For the purpose of
Highways Infrastructure Trust)**

Final Report

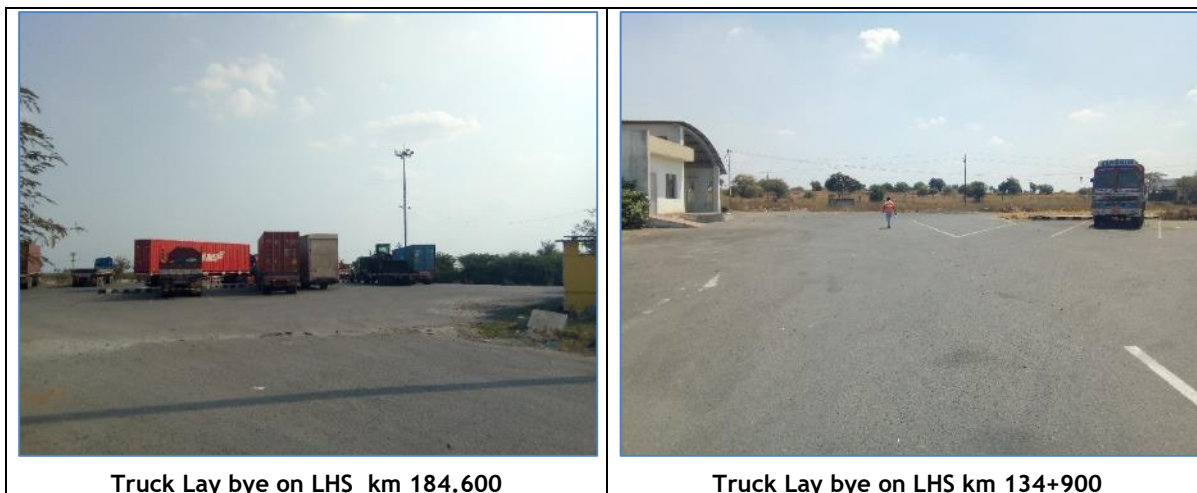
The Project Road has 3 Truck lay Bye at km 134.900 on LHS side & at km 184.600 on Both Sides. It has been provided with Flexible Pavement and the condition appears to be good. Toilet blocks and 6 High Mast Lighting have been provided at truck lay byes which are in good condition.

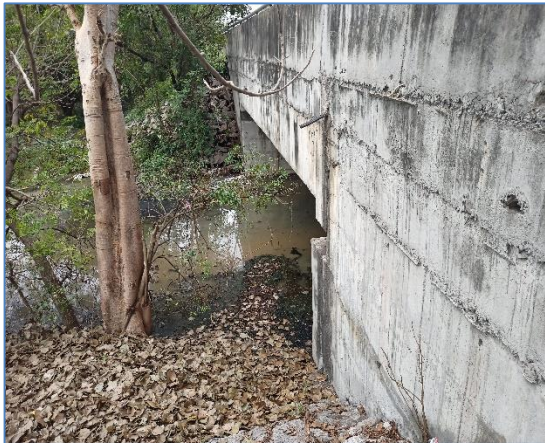
166+348 MNB (LHS)

- Structure is good in condition.

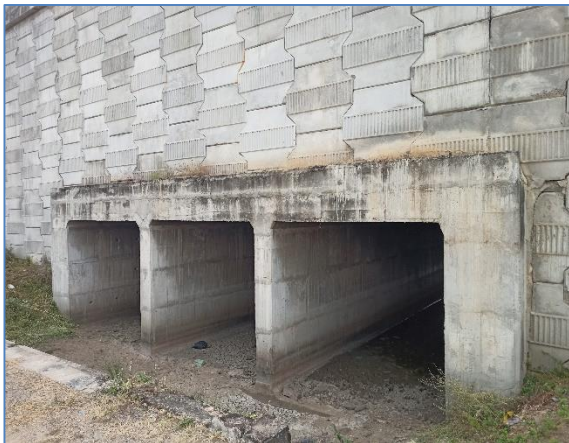
167+750 MNB (LHS)

- It comes under approach of ROB.
- Structure is in good condition.

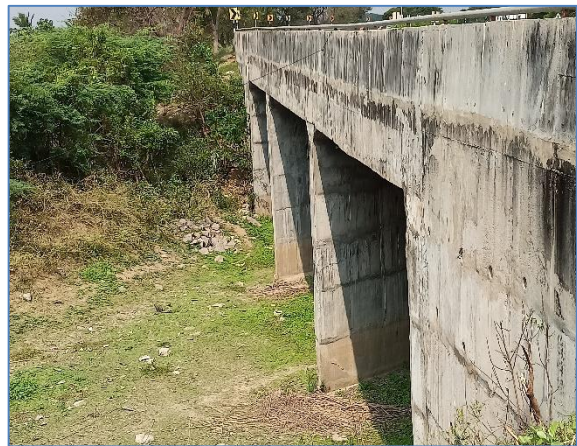
170+950 MNB (RHS)

- Overall condition good.
- Cleaning of Drainage Spouts is required.

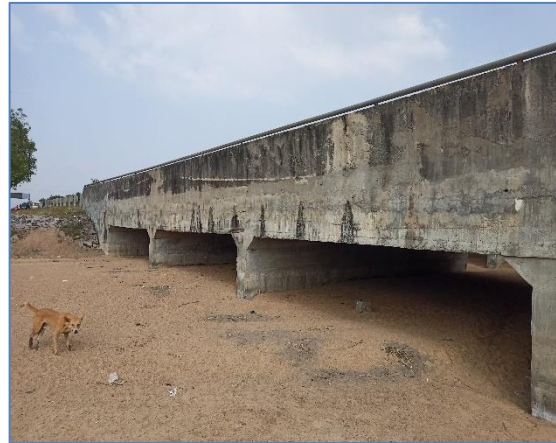
176+120 MNB (RHS)

- Portion of the Quadrant pitching damaged on LHS.
- Structure is good in condition.

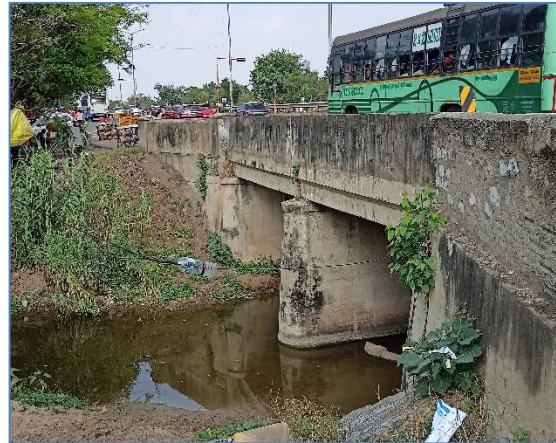
176+415 MNB (RHS)

- Stone pitching damaged on LHS.
- Reinforcement exposed at face of the slab on LHS.

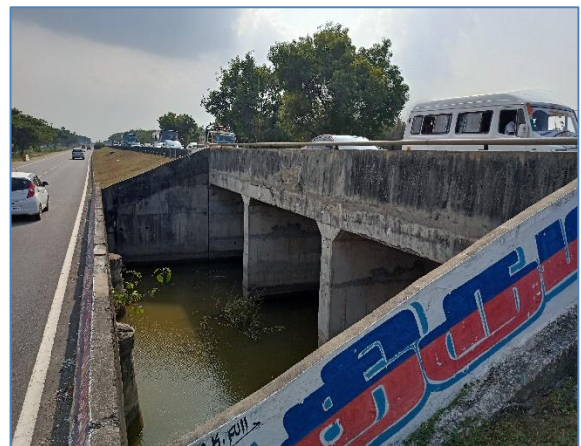
184+054 MNB (LHS)

- repair works done already done, the Condition of Bridge is Good.

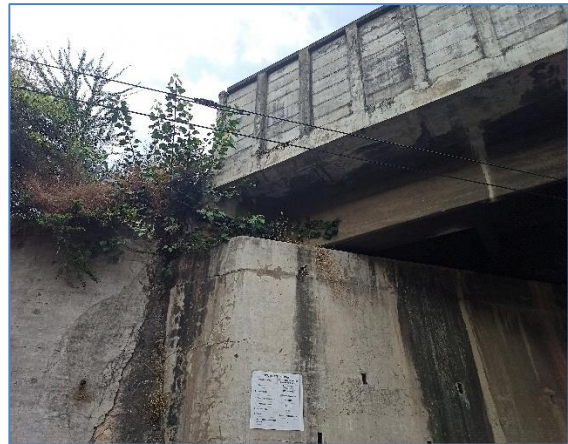
157+433 ROB (RHS)

- ROB on RHS is old ROB and it is under railway maintenance. Concessionaire paying the maintenance fee. ROB on LHS is constructed and maintained by Concessionaire
- Minor damage in Mid span end girder resting portion is noticed.
- Reinforcement Exposed near the Cantilever Portion of 1 m² and Abutment for 0.5 m² - RHS
- Wing wall damaged on RHS.
- Cleaning of Expansion joints is required

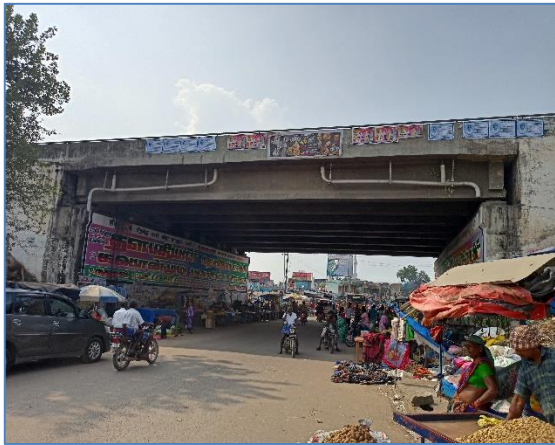
181+430 VUP (LHS)

- Structure seems to be in Good Condition.

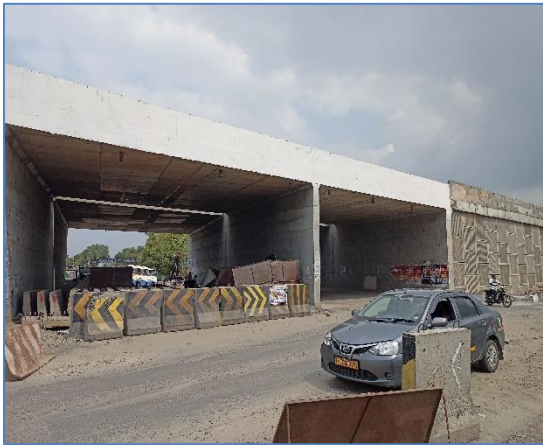
159+853 VUP (LHS)

- Construction completed and opened to traffic.

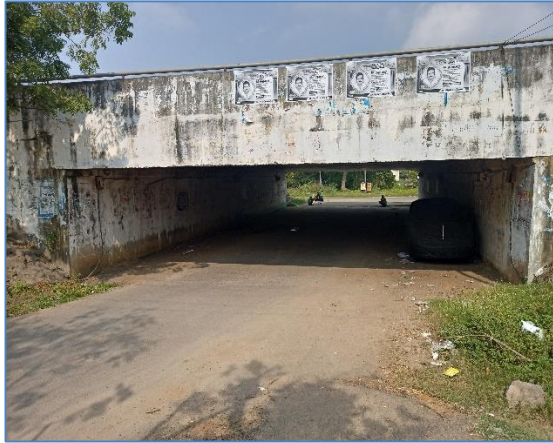
121+700 PUP (LHS)

- By Visual observation seems to Good Condition.

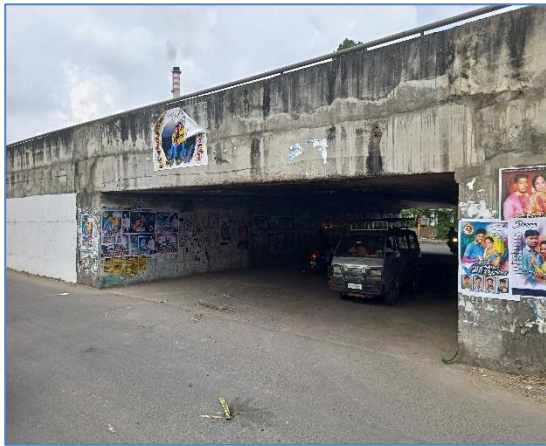
153+030 PUP (LHS)

- By Visual observation seems to Good Condition.

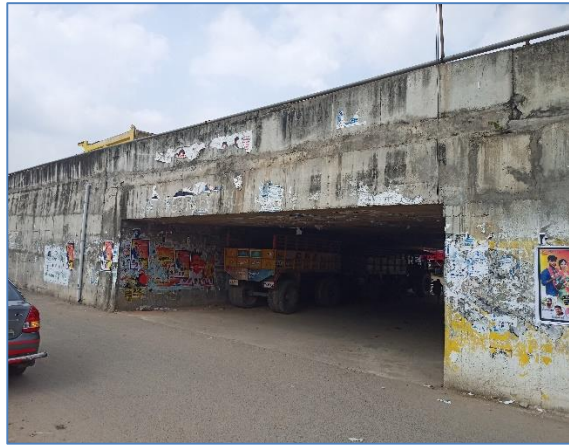
155+681 PUP (LHS)

- By Visual observation seems to Good Condition.

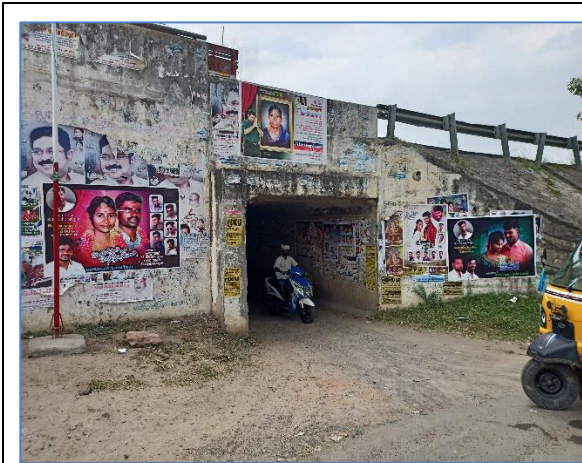
167+247 PUP (LHS)

- Comes under approach of ROB.
- By Visual observation seems to Good Condition.

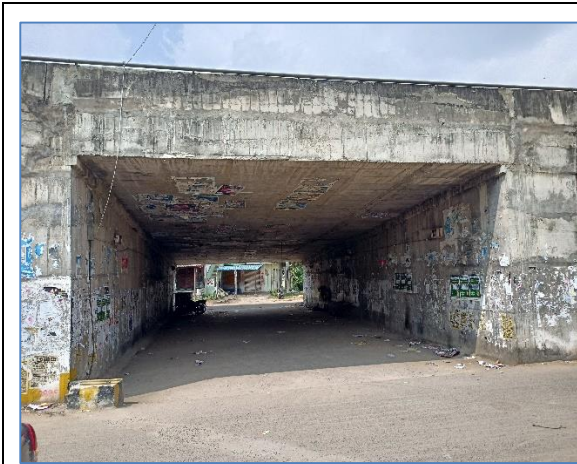
169+990 PUP (LHS)

- By Visual observation seems to Good Condition.

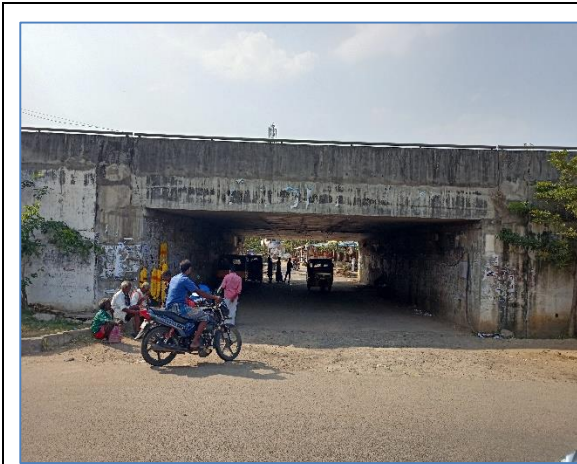
185+774 PUP (LHS)

- By Visual observation seems to Good Condition.
